**STREAMLINED**  
**REMEDIATION SYSTEM EVALUATION (RSE-LITE)**

**BENFIELD INDUSTRIES SUPERFUND SITE**  
**WAYNESVILLE, NORTH CAROLINA**

Report of the Streamlined Remediation System Evaluation  
Conference Call Conducted August 21, 2007

Final Report  
September 2007

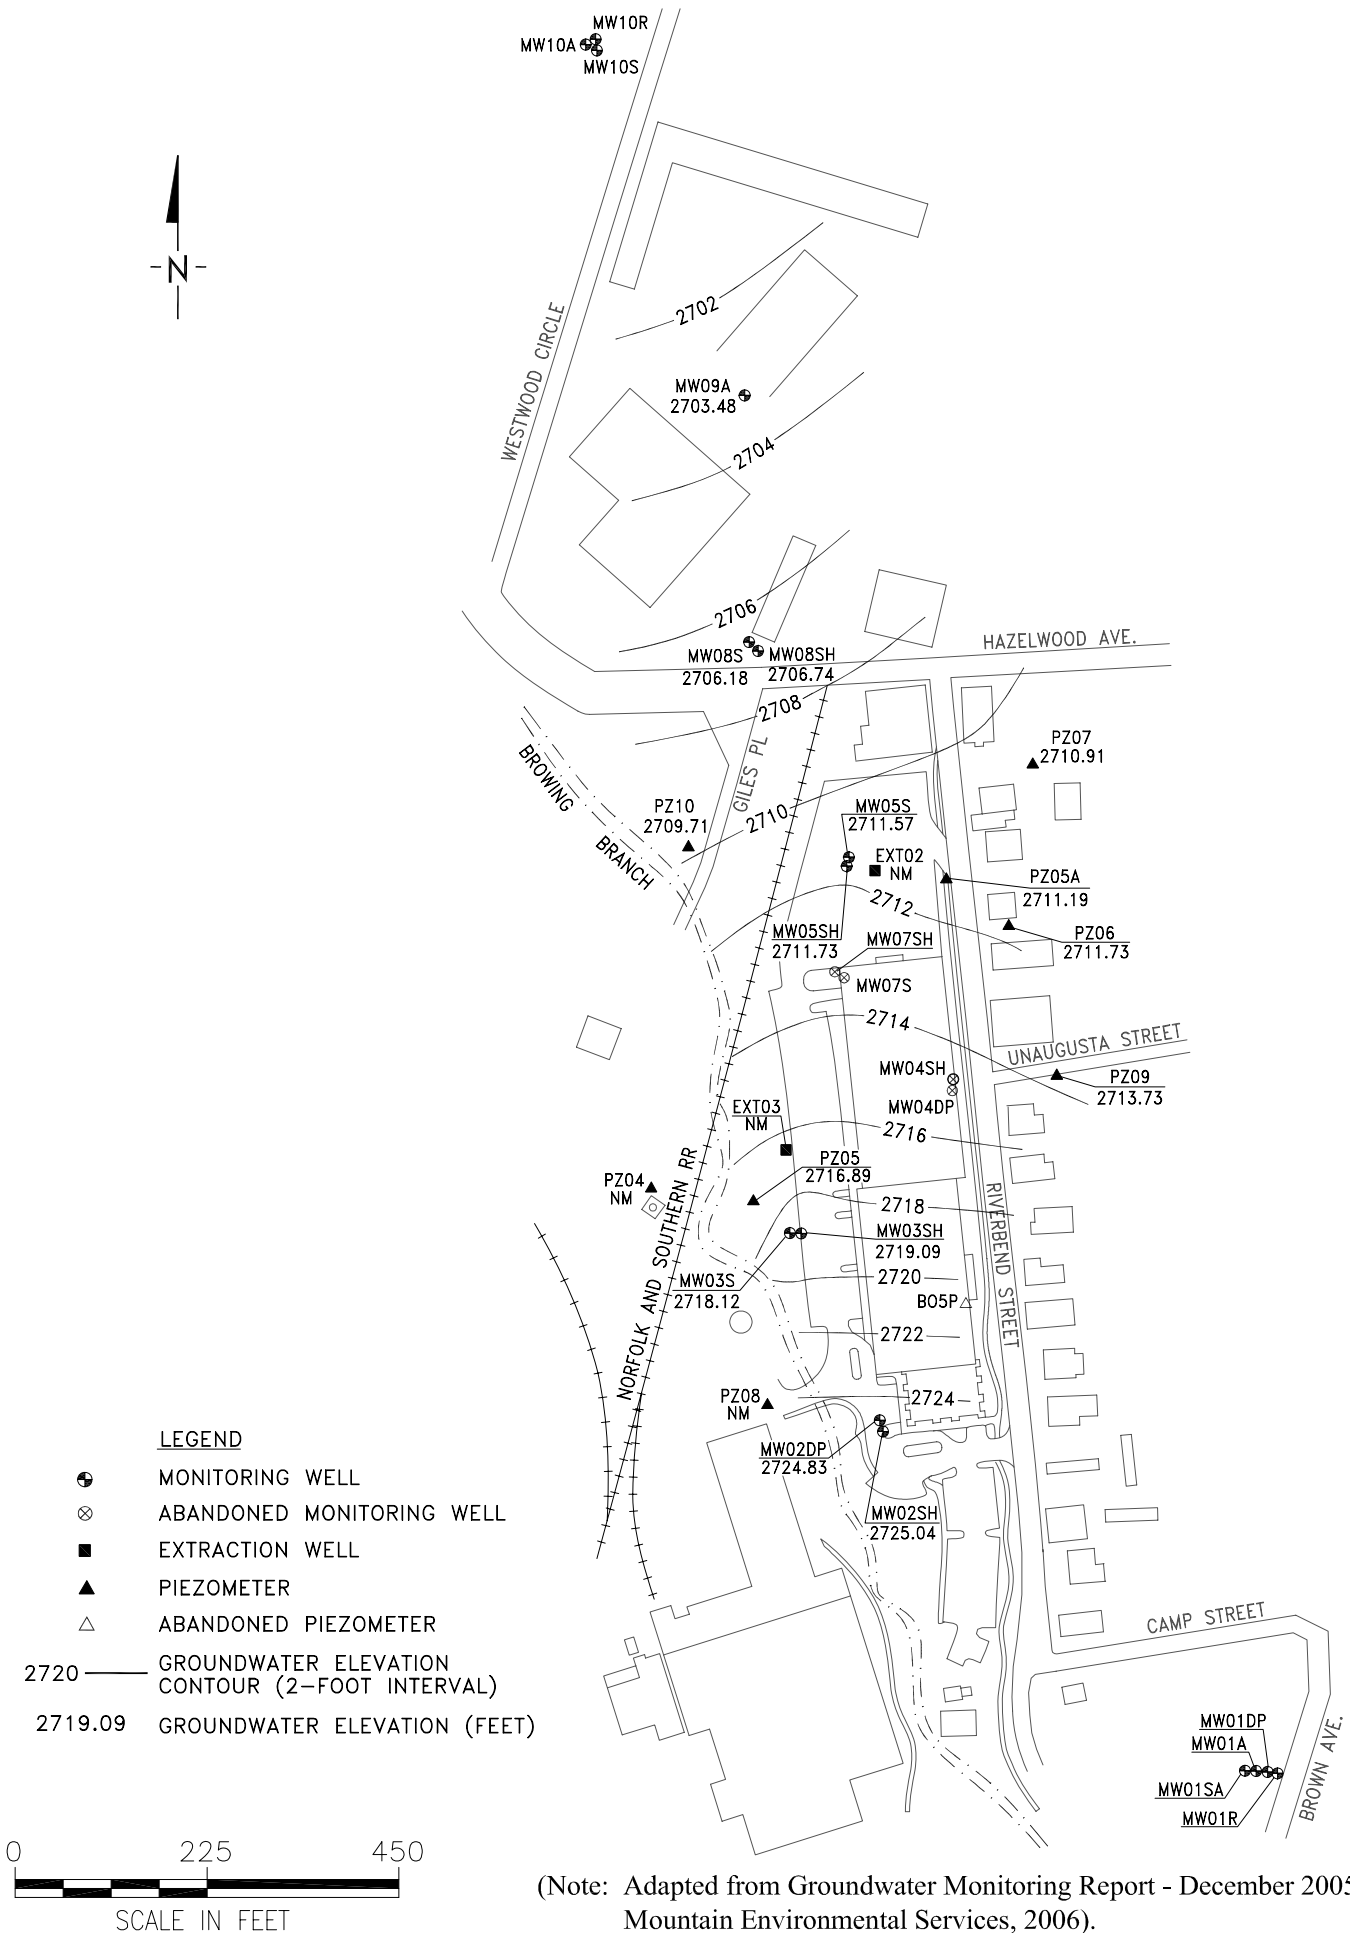
**FIGURE 1-2. SITE LAYOUT SHOWING WELL LOCATIONS AND GROUNDWATER ELEVATIONS.**

- An area in the west-central portion of the site near a former packaging building and former creosote storage tanks (near MW03SH on **Figure 1-2**).
- An area in the northern portion of the site near a former warehouse (near MW05SH).

For the last site-wide sampling event in December 2006, the only well with concentrations exceeding cleanup criteria was well MW03SH. At that well, the concentrations of five PAHs and 1,4-dichlorobenzene exceeded remediation criteria. For several COCs, the cleanup level is below the reported analytical detection limit.

The two on-site extraction wells – EXT02 and EXT03 – are shown in **Figure 1-2**. These 8-inch diameter stainless steel wells are 36 and 31.5 feet deep, respectively, with 10-foot screens in the saprolite. Based on initial pumping tests, it was determined that a maximum withdrawal rate of 4 gpm could be sustained at EXT02. The maximum withdrawal rate at EXT03 was determined to be 12 gpm. Dedicated 0.5 horsepower submersible pumps were installed in each well – a 5 gpm pump in EXT02 and a 10 gpm pump in EXT03.
