COST AND PERFORMANCE REPORT

Electrical Resistive Heating and Biosparging
at the ICN Pharmaceutical Site
Portland, OR

November 2007

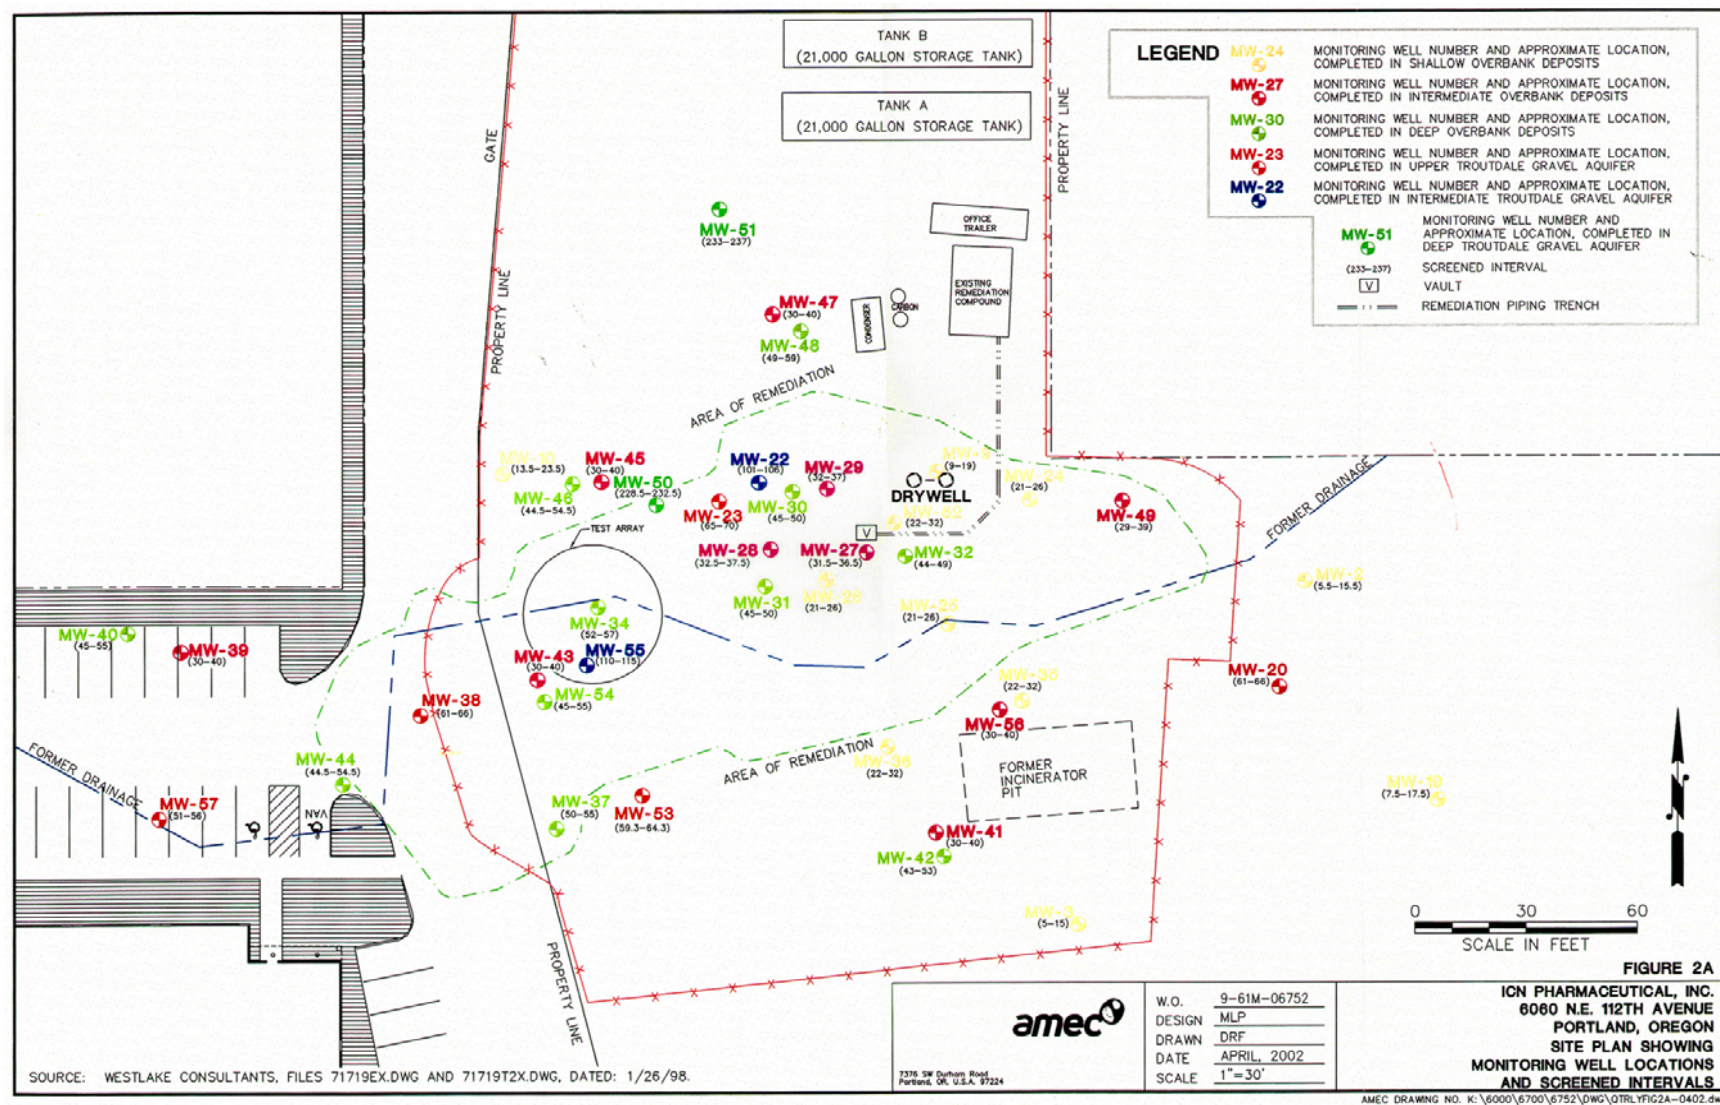
Figure 1. Application and Monitoring of ERH at the ICN Pharmaceuticals Site in Portland, Oregon [1]

Figure 1 shows the location of the shallow, intermediate, and deep monitoring wells at the site, relative to the area that was treated. TCE, DCE, and VC concentrations were monitored in the Overbank area and DCE, VC, and benzene concentrations were monitored in the TGA layer. Table 2 shows the maximum groundwater contaminant concentrations before treatment, when the ERH system was shut down (December 2001), and six months later (June 2002). As of December 2001, maximum groundwater contaminant concentrations in the Overbank area had been reduced from 150,000 µg/L to 100 µg/L for TCE; from 370,000 µg/L to 1,300 µg/L for DCE; and from 24,000 µg/L to 50 µg/L for VC. Through June 2002, TCE concentrations decreased to 8.11 µg/L while DCE and VC concentrations were unchanged. The concentrations of all three contaminants were above Oregon MCLs.

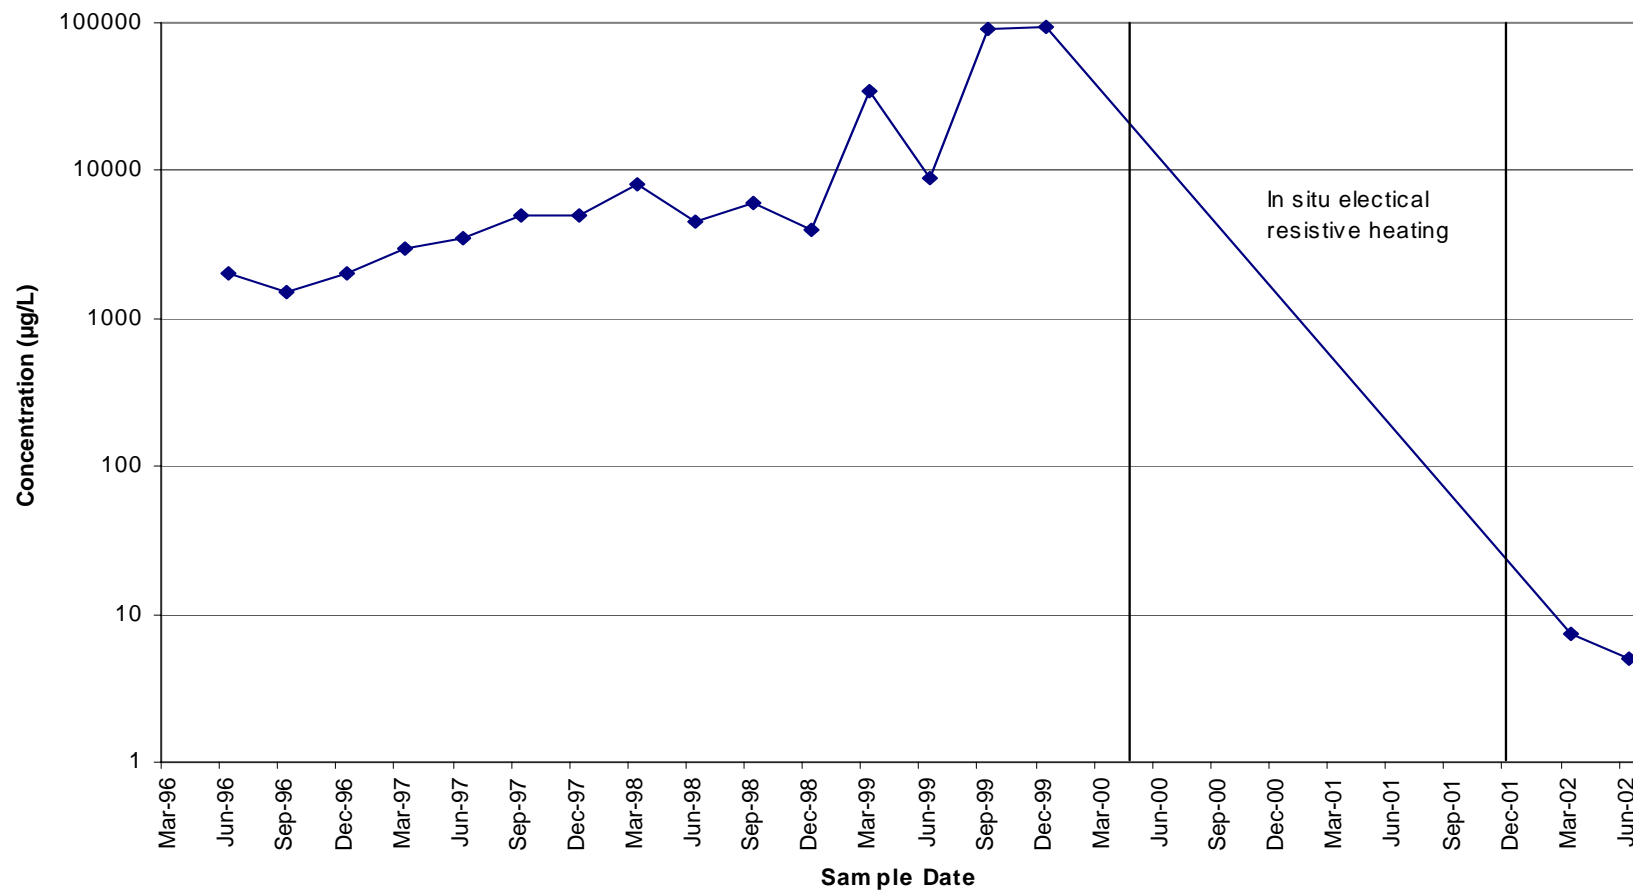
Figure 2. ICN Site: cis-1,2-DCE Concentrations in Source Zone (MW-28)
May 1996 - June 2002 (log scale) [1]

Figures 2 through 5 show the concentrations of DCE over time in the source zone (intermediate well MW-28 and deep well MW-31), the treated area outside the source zone (MW-25), and downgradient from the treated area (MW-53). As shown in these figures, DCE concentrations in the source zone treatment area wells decreased following ERH treatment of the source, with the concentrations in the downgradient wells remaining relatively level.
