# Autopsy of a Small UST Site in Bedrock: Implications for Remedial Effectiveness Case Study, Devens, MA

William C. Brandon, Hydrogeologist, US EPA Region 1

Federal Remediation Technology Roundtable Meeting Characterization and Remediation of Sites with Fractured Bedrock Washington, DC November 9, 2010

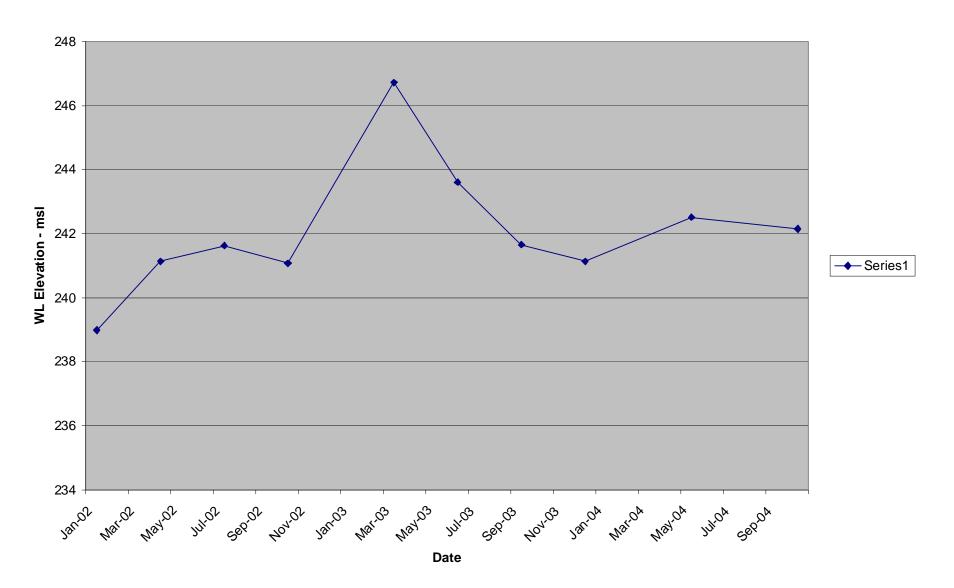
#### Water Levels - 32M-01-18XBR

- Is the apparent COC attenuation real?
- Or will the Oscillatory longer-term trends resume
- Does the site behave as a typical "drowned smear zone"?
- Delivery: Will future remedial efforts need to more carefully consider the bedrock fracture system?
- <u>Deliverance</u>: How might one increase the oxidant contact with residual contaminants?

- Install Transducers to evaluate long-term water level trends
- Determine whether additional remedial measures are needed
- Consider Injecting in down-dip directions
- Monitor in down gradient areas in consideration of bedrock ground water gradients and bedrock fabric
