COST AND PERFORMANCE REPORT

Electrical Resistive Heating at the
ICN Pharmaceutical Site
Portland, OR

June 2003

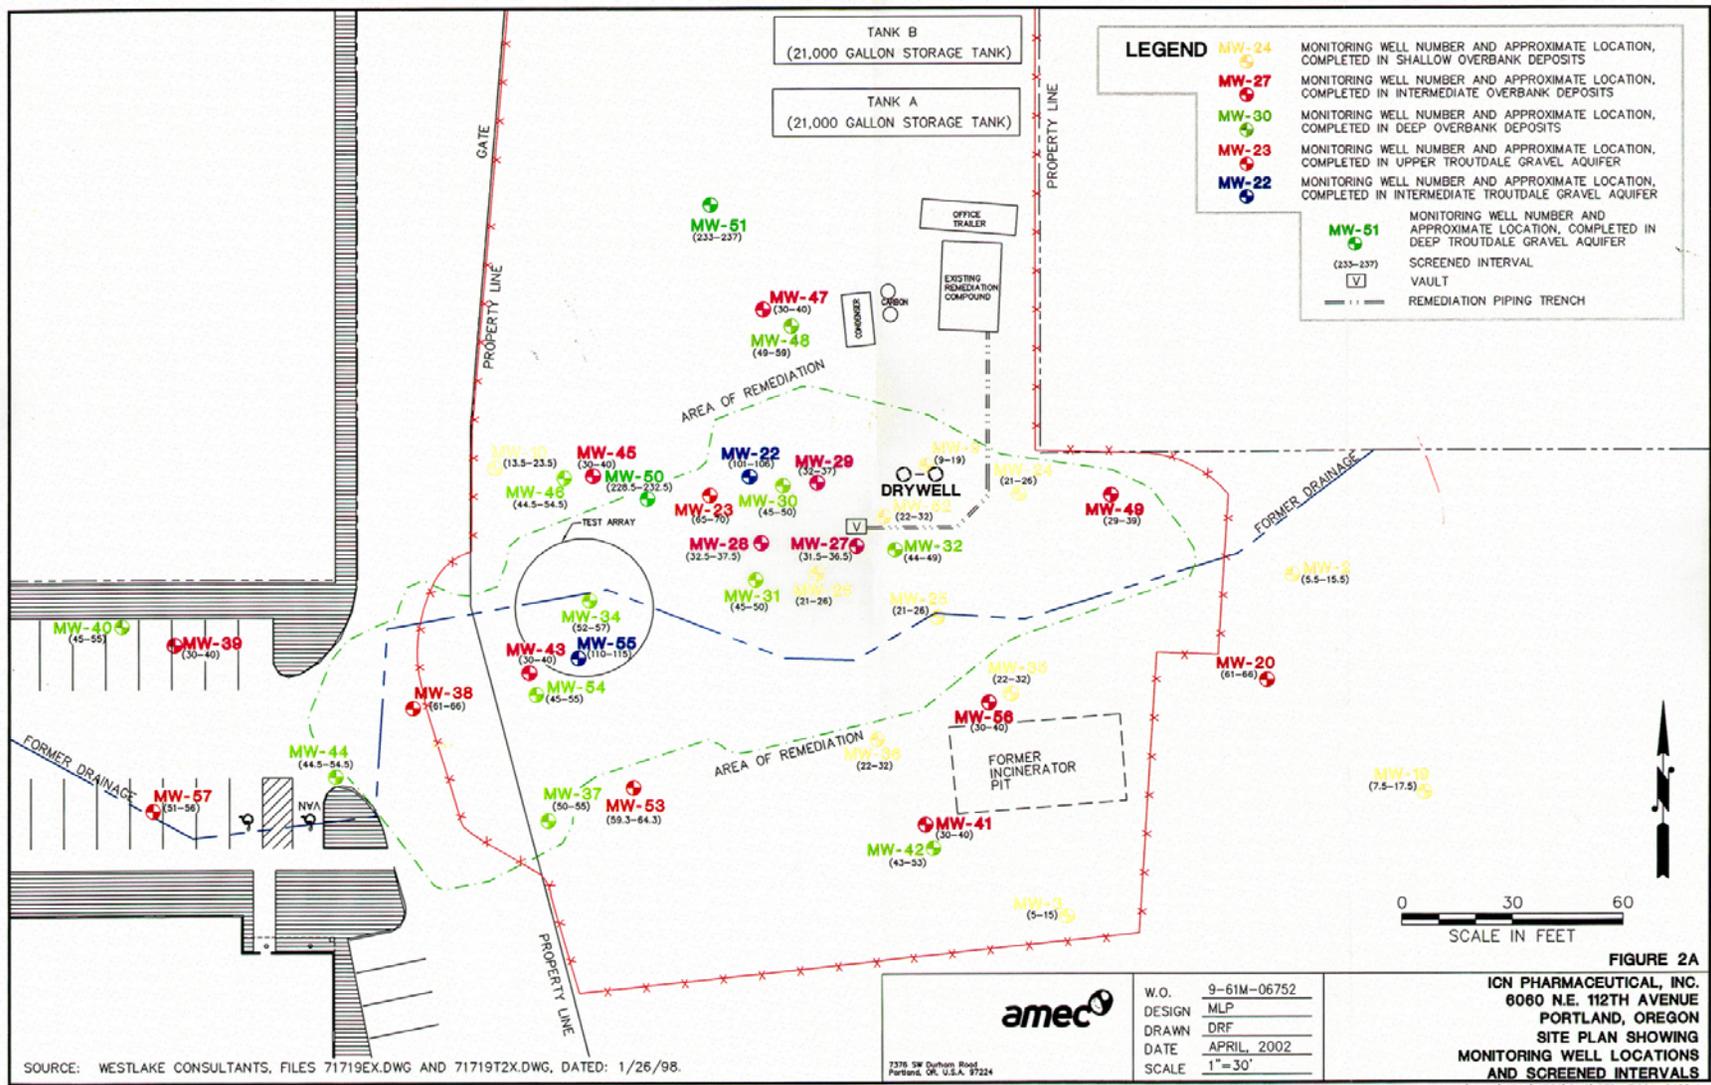
Figure 1. Application and Monitoring of ERH at the ICN Pharmaceuticals Site in Portland, Oregon [1]

Figure 1 shows the location of the shallow, intermediate, and deep monitoring wells at the site, relative to the area that was treated. TCE, DCE, and VC concentrations were monitored in the Overbank area and DCE, VC, and benzene concentrations were monitored in the TGA layer. Table 2 shows the maximum groundwater contaminant concentrations before treatment, when the ERH system was shut down (December 2001), and six months later (June 2002). As of December 2001, maximum groundwater contaminant concentrations in the Overbank area had been reduced from 150,000 µg/L to 100 µg/L for TCE, from 370,000 µg/L to 1,300 µg/L for DCE, and from 24,000 µg/L to 50 µg/L for VC. Through June 2002, TCE concentrations decreased to 8.11 µg/L while DCE and VC concentrations were unchanged. The concentrations of all three contaminants were above Oregon MCLs.

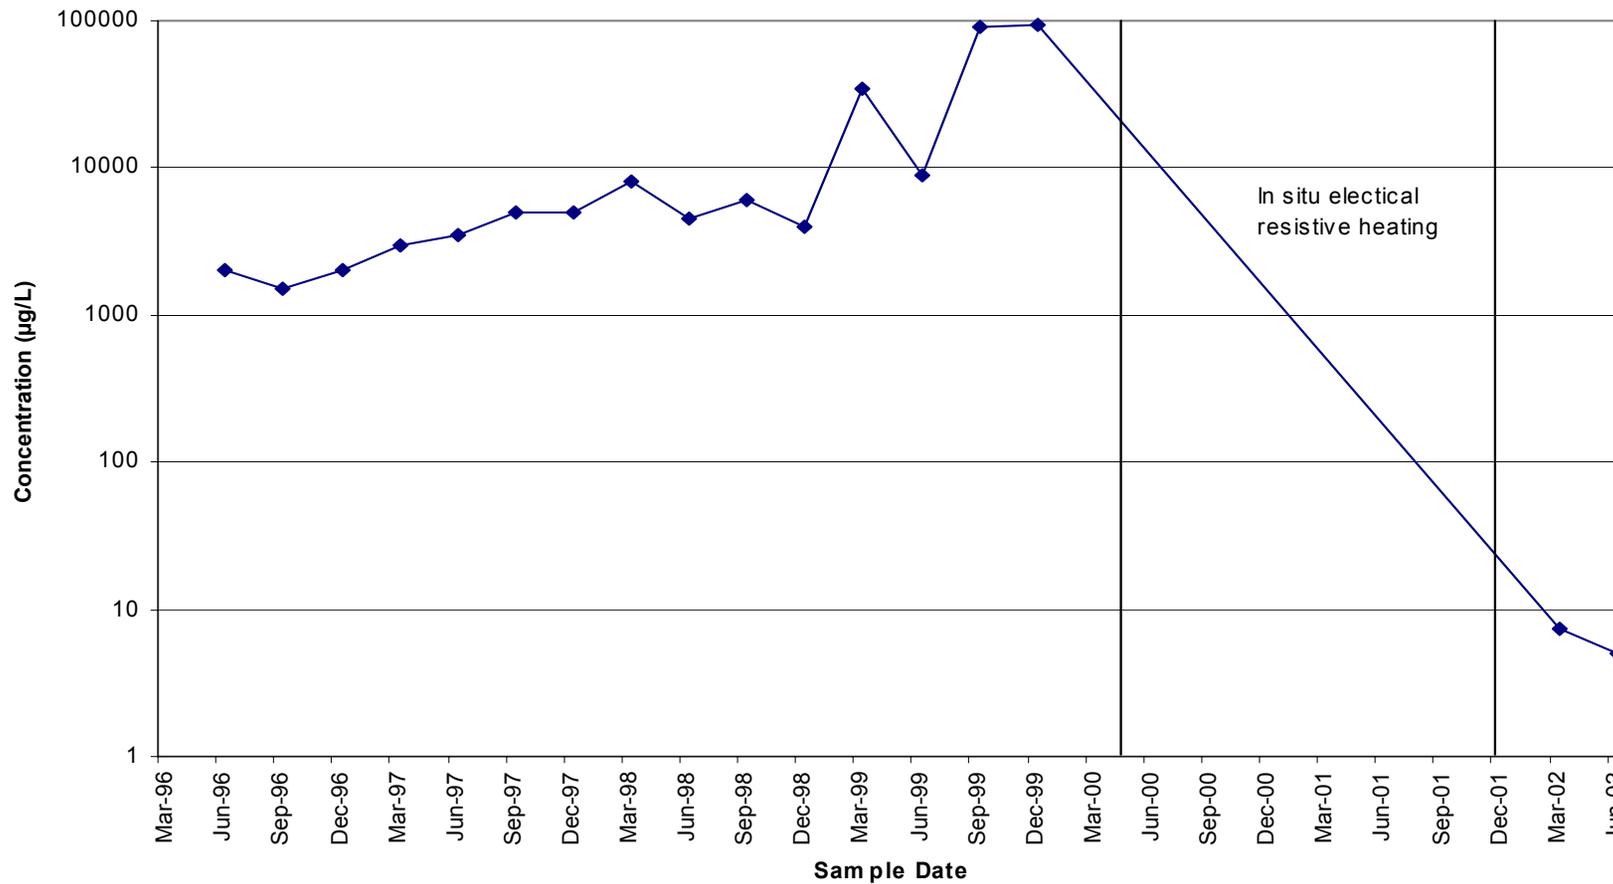
Figure 2. ICN Site: cis-1,2-DCE Concentrations in Source Zone (MW-28)
 May 1996 - June 2002 (log scale) [1]

Figures 2 through 5 show the concentrations of DCE over time in the source zone (intermediate well MW-28 and deep well MW-31), the treated area outside the source zone (MW-25), and downgradient from the treated area (MW-53). As shown in these figures, DCE concentrations in the source zone treatment area wells decreased following ERH treatment of the source, with the concentrations in the downgradient wells remaining relatively level.
