# Lessons Learned Applying Multiple Remediation Technologies at Air Force Plant 4

**Bruce Alleman, Oneida Total Integrated Enterprises (OTIE)**

**9 May 2018**

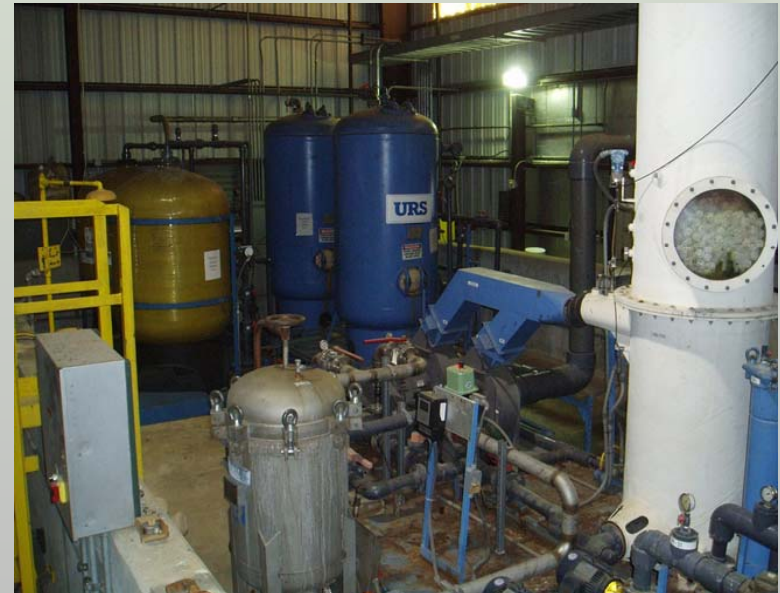
- Pump and treat
  - Installed in 1993 with 7 extraction wells
  - Expanded to 51 extraction wells in 1999
  - Down to 50 extraction wells in 2011
  - Down to 10 extraction wells in 2013
  - 8 extraction wells in 2014
  - System shutdown in 2015
    - EISB continues

- P&T operated ~25 years
- Design for 150 gpm, ~50 gpm max achieved
- Initial influent TCE concentrations ~10,000 to 15,000  $\mu\text{g/L}$
- Below 5,000  $\mu\text{g/L}$  in ~ 3 years
- Asymptotic at ~400  $\mu\text{g/L}$  for ~7 to 8 years
- Overall TCE mass removed estimated at ~4,500 lbs

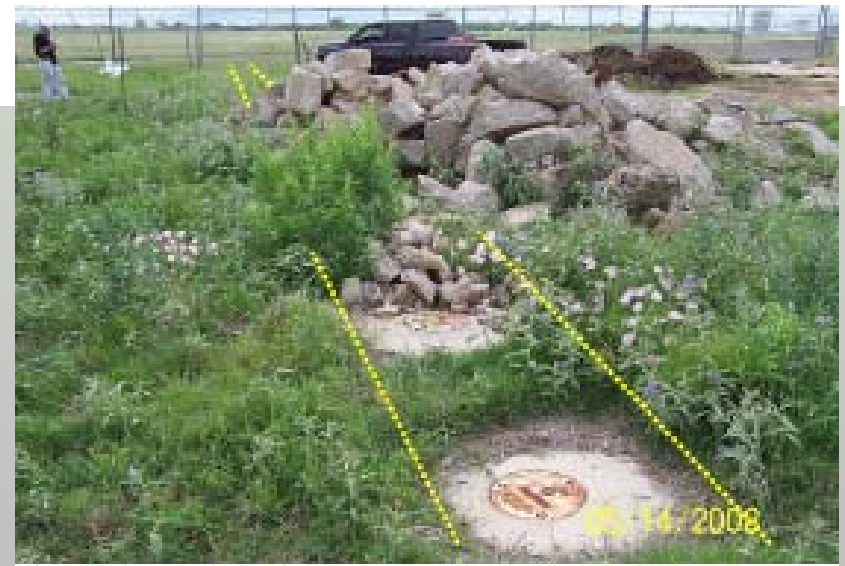
# CWA Systems Layouts

- ZVI PRB
- Designed to prevent further migration of TCE beyond installation boundary
- 1,170 foot long, 2 foot wide, 35 foot deep
- 50-50 mix of iron filings and sand
- Construction Completion on September 15, 2006

- PRB performance Assessment
  - Adversely effected GW flow pattern; violating design constraints
  - ZVI has lost its effectiveness
    - No method to effectively rejuvenate
  - Conversion to biobarrier
    - Downgradient VC concentrations increasing
  - Benefit for TCE degradation is not sustainable for long-term effectiveness

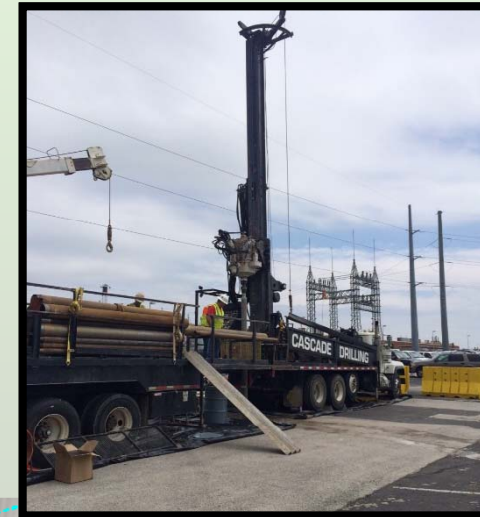
- Objective
  - Determine practicability of removing mass through DNAPL extraction wells
- Installed 4 new extraction wells in the Walnut Formation
  - Recover DNAPL via pumping or bailing
  - Frequency based on how quickly product accumulates in the well
- Monitor DNAPL thickness in neighboring Walnut wells monthly to determine how recovery is affecting surrounding area

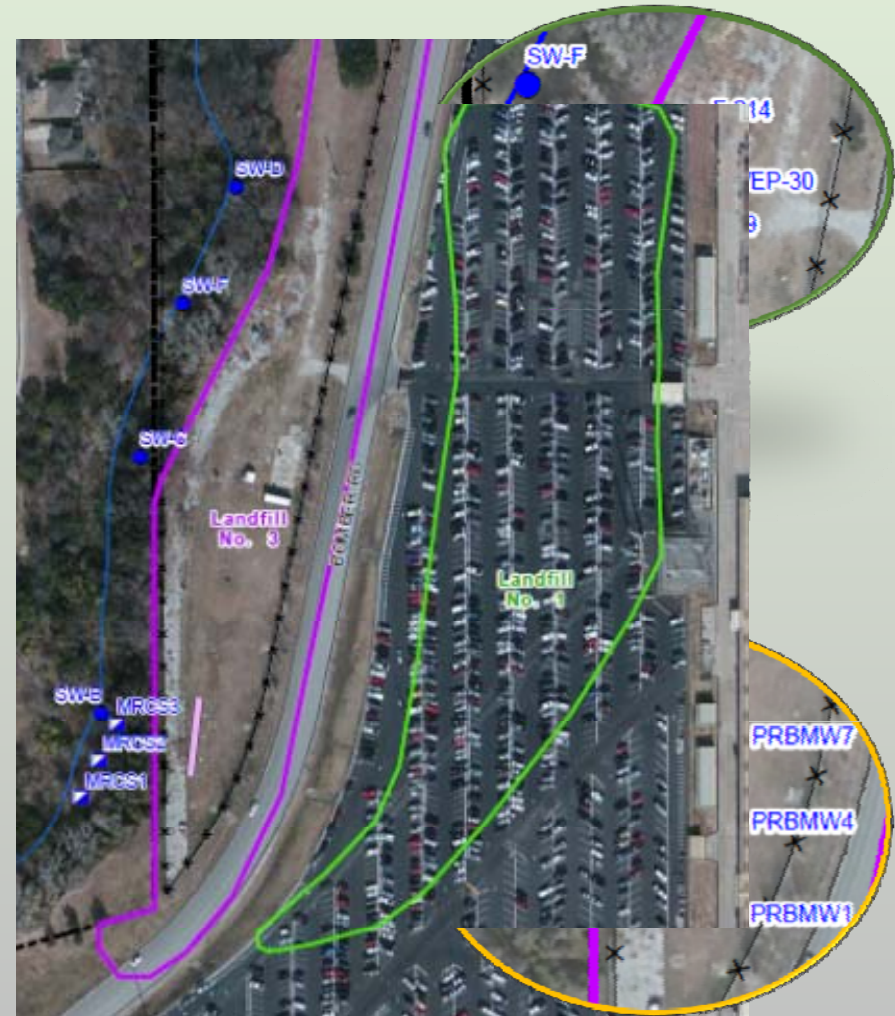
- Objective
  - Inject biostimulants into the biowall and ART well area to reduce LF3 groundwater cVOC concentrations
- Implementation Overview
  - First injections performed May - October 2013
    - EHC-L (*food*)
    - KB-1 (*bacteria*)
  - Second injections performed March - September 2015
    - EHC-L (*food*)
    - EHC (*food + ZVI*)
