Case Study on Remediation at a Sediment Site in Northern California with Radium-226 and Heavy Metal Contamination, including Use of SCM Technology to Expedite Remediation at the Source

**Seaplane Lagoon Site, former Naval Air Station
Alameda, Alameda, California**

Federal Remediation Technology Roundtable Meeting, November 8, 2017

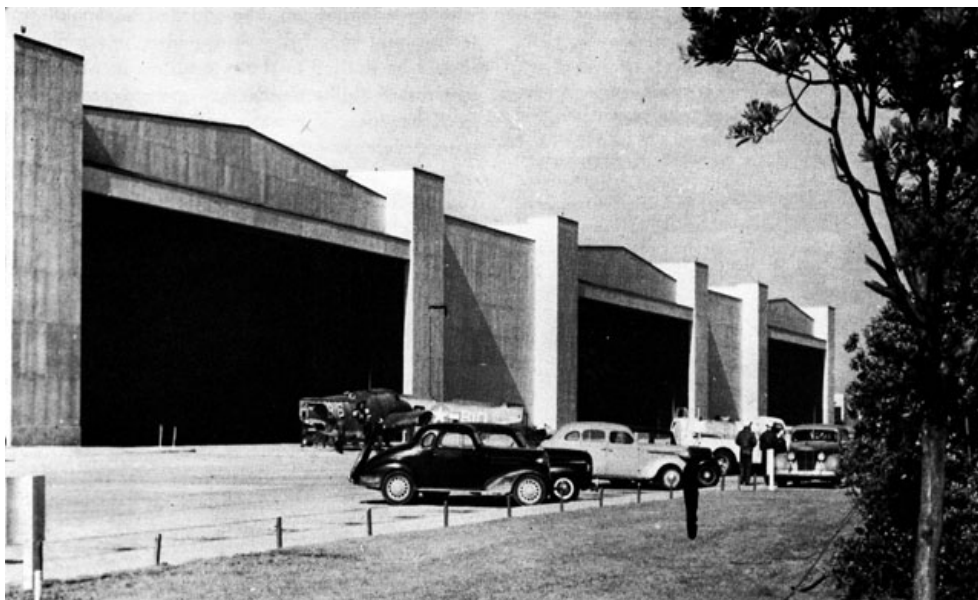
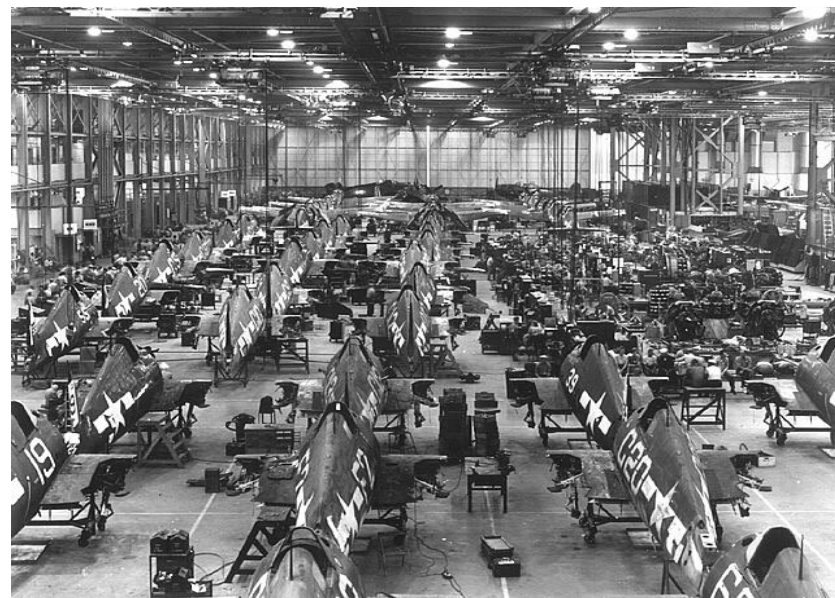
Primary source of the sediment contamination was maintenance activities for aircraft within Building 5 (~16 acres); Ra-226 paint was used on compasses and plane and ship instrument faces.

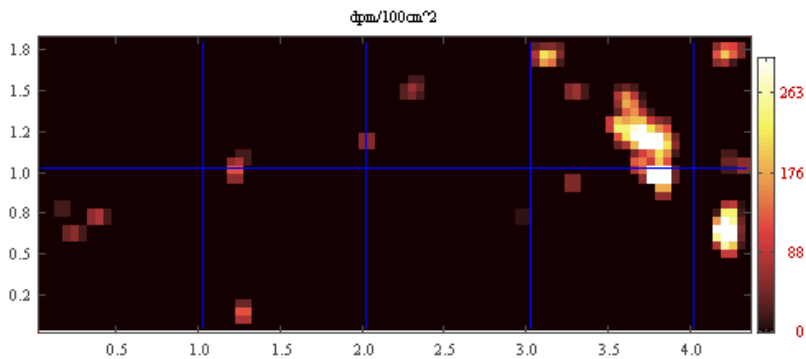
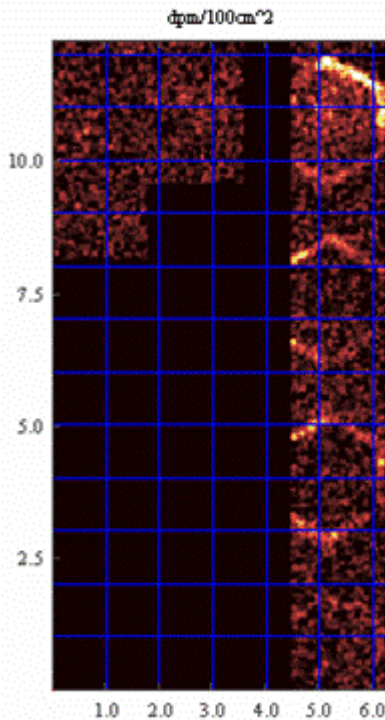
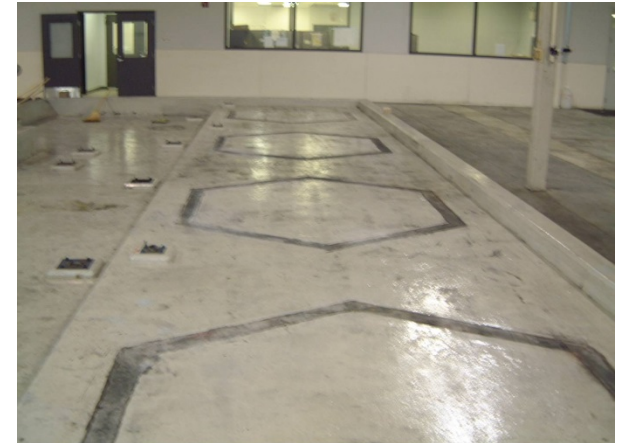
SCM Color Graphic Images of Radiological Contamination:
Left: Building 5 Ra-226 paint room contamination;
Right: Another project showing contamination beneath pads (SCM image, center, and photo to right)

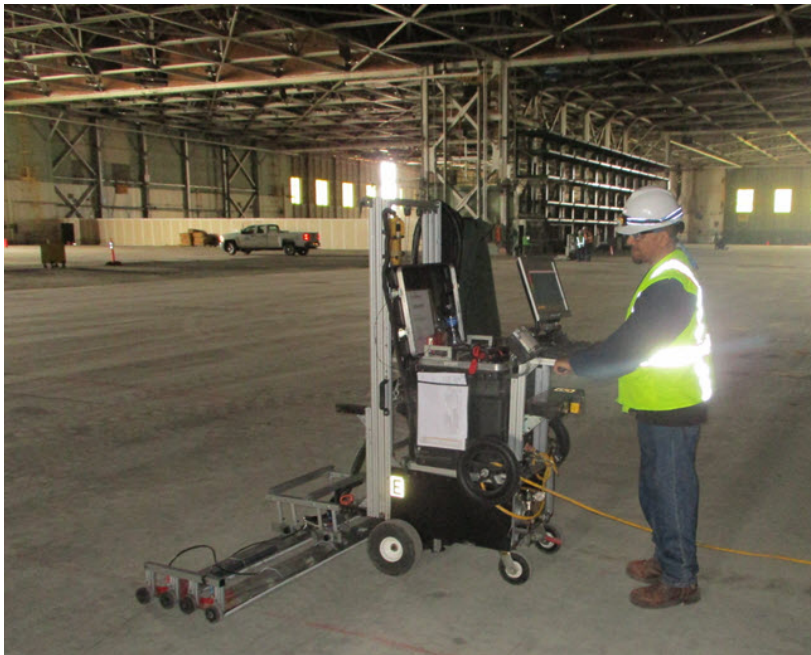
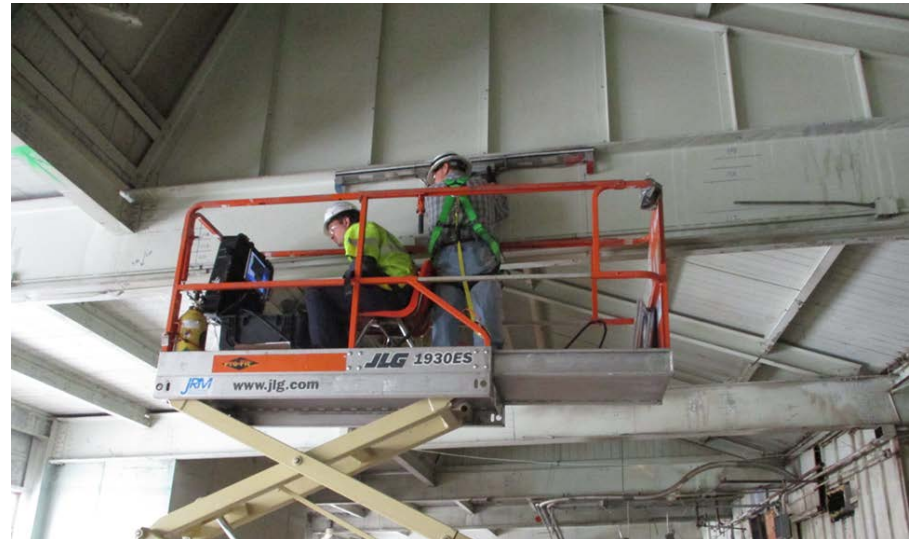
SCM Surveying Hangar Floor (left); SCM ~30 feet from floor, surveying I-beams and ceiling (right)

The Building 5 radiological remediation included use of a recently developed SCM model with:

- electronics package replaced with small computer chips
- computers with faster, more powerful systems (e.g. SurfacePro)
- battery power instead of AC and
- a weight less than one-third the weight of the older model SCM.

This results in significantly greater ease of use in the field; it was very efficient in this 2-story building with no electricity.

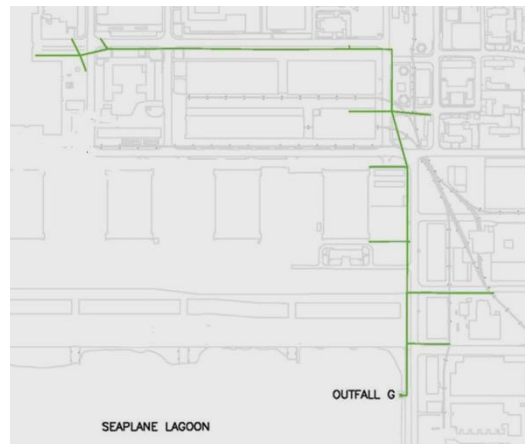
- Drain Line G (NE corner of lagoon) hydrojetted and surveyed; video confirmed removal of contamination (innovative); subsequent No Further Action Record of Decision for Line G.

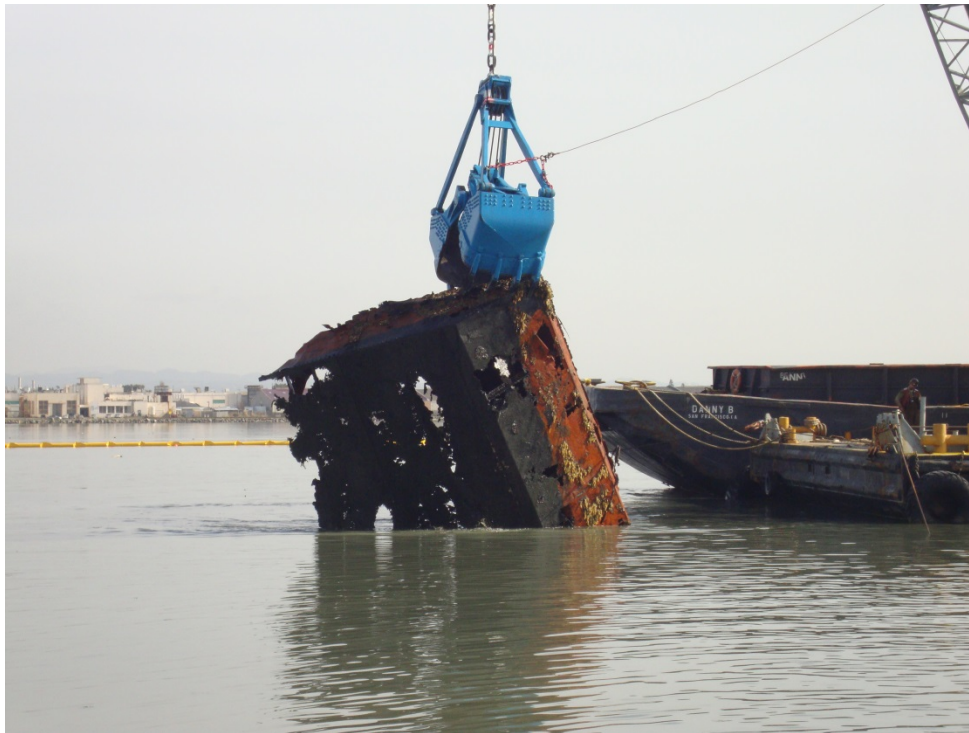
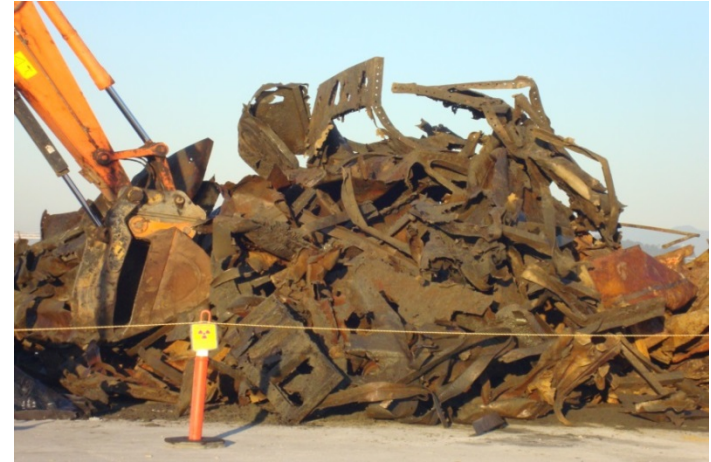
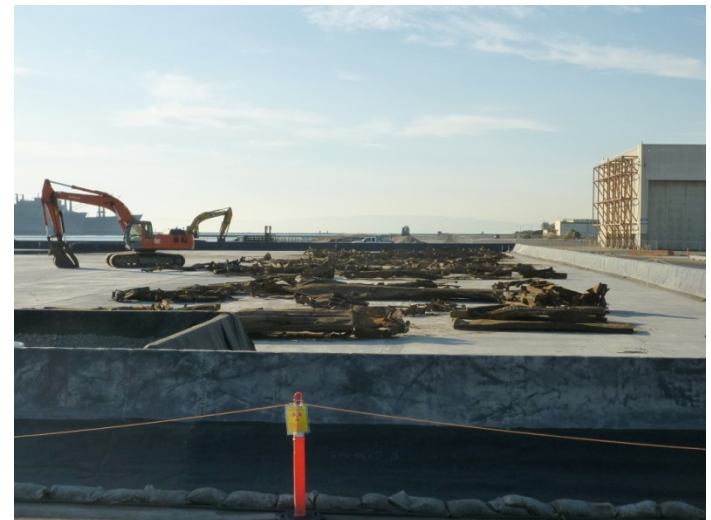
Barge removed; 66 tons of metal scanned and recycled;
ready for scanning (bottom right)

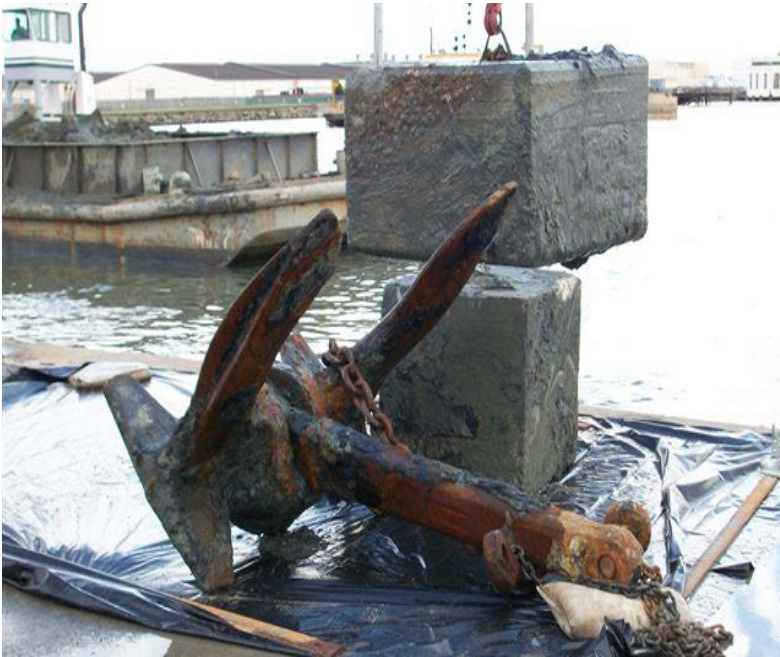
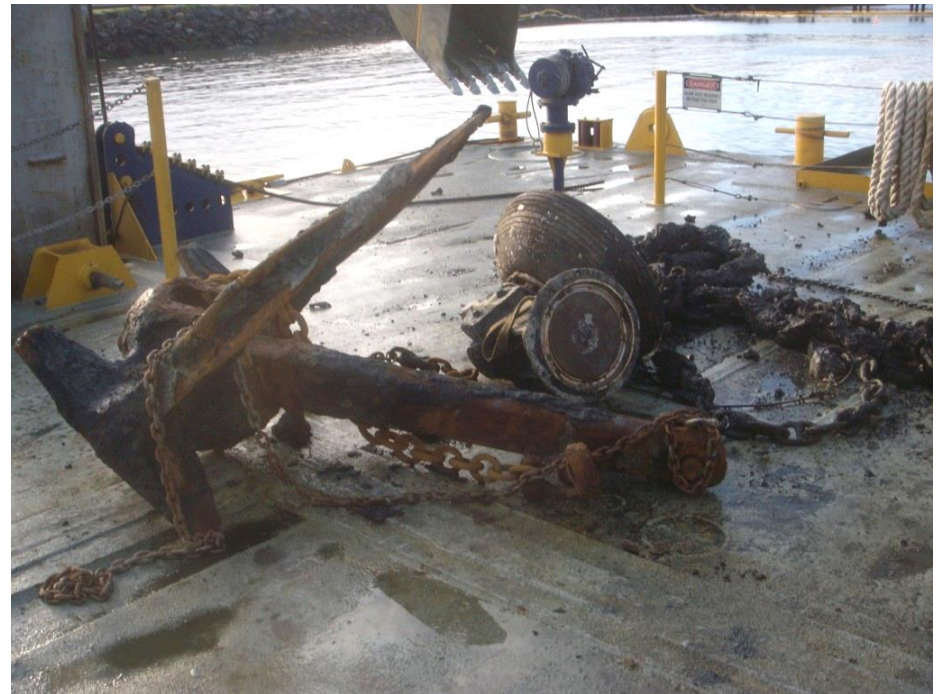
Concrete mooring blocks (left), 1943 anchor, and landing gear (right) removed from lagoon

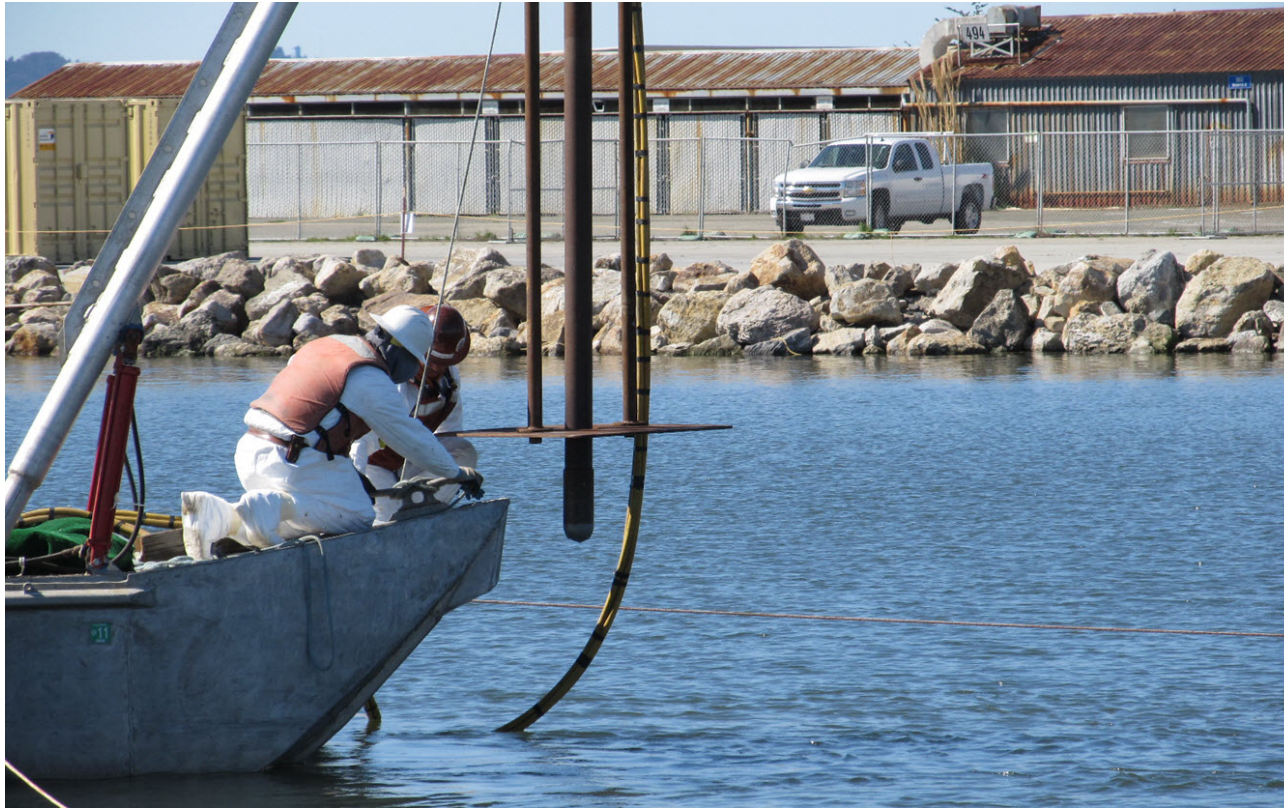
Post-dredge sampling results confirmed completion of the NE area remediation. Results for the NW area indicated that further dredging was necessary in a limited area.

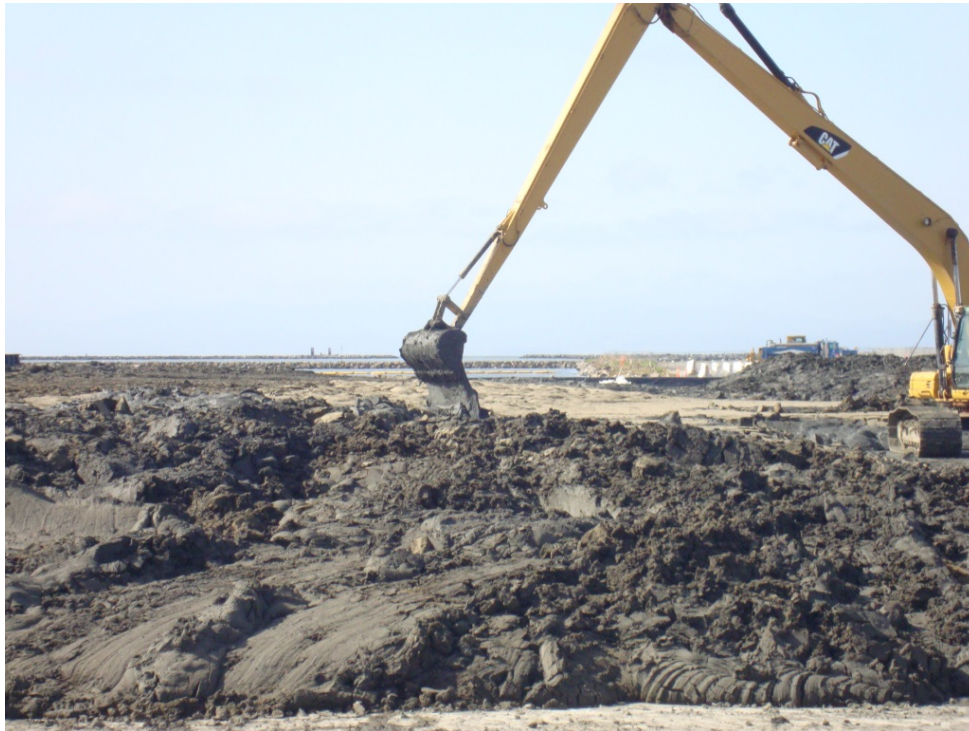
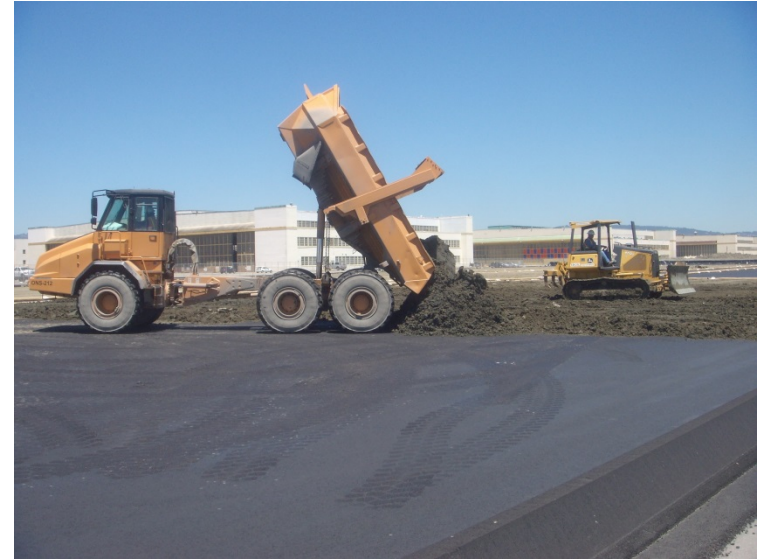
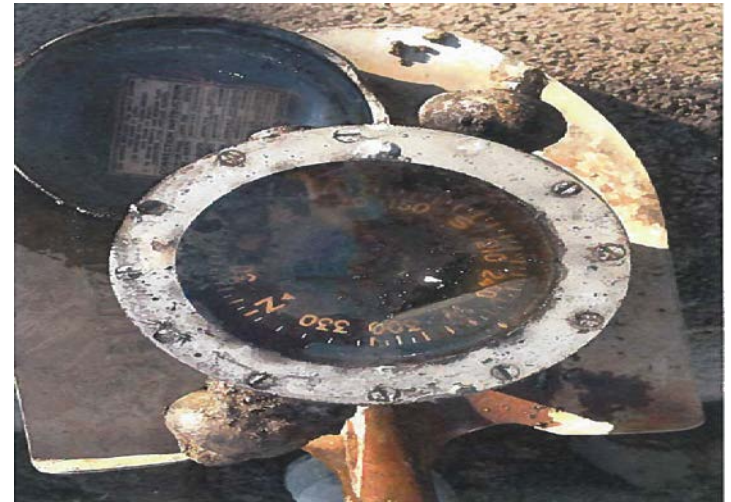
Sediment Processing (below and right)
- Compass recovered (bottom right)

- Sediment processing included dewatering, radiological surveying, systematic sampling, and re-use or disposal.
- Used SAM940 during Seaplane Lagoon remediation for field isotope identification of point sources; the RadEYE SPRD is an advancement that provides more data, can identify more isotopes, runs on batteries, and is the size of a pager.
- Optimizations included maximizing re-use/recycling for both the removed sediment and wastewater.
