*Summary Report* DOE/EM-0551

## **Cement Bentonite Thin Diaphragm Wall**

September 2000

*Demonstrated at*  
Dover Air Force Base  
Delaware

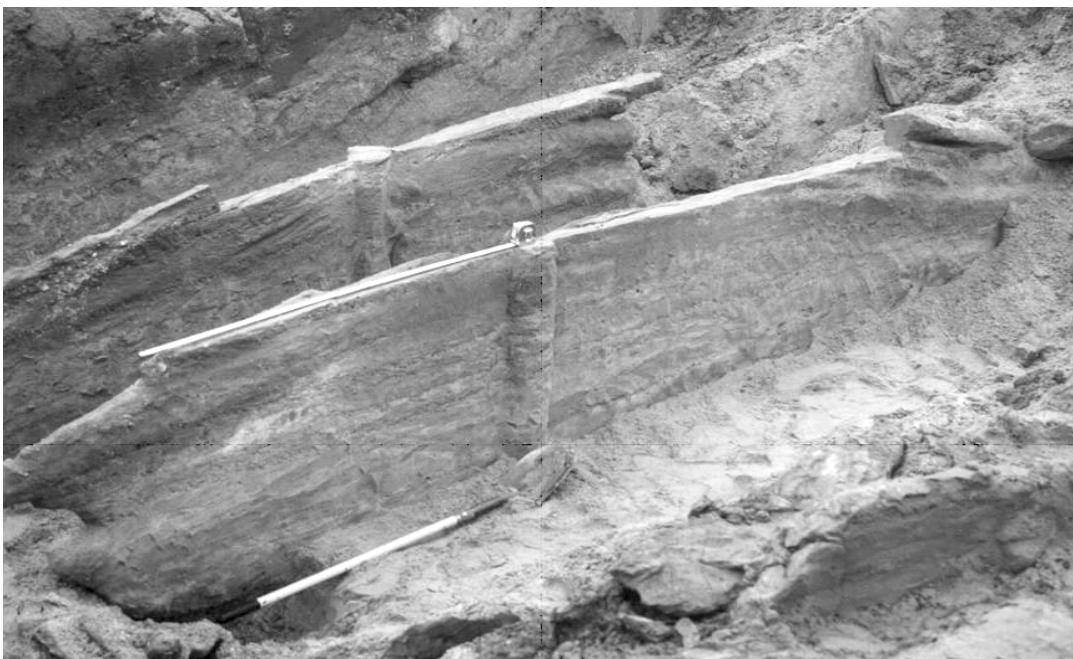
**Figure 1. Photograph of thin-diaphragm walls emplaced by using high-pressure jetting.**

High-pressure jet grouting has been demonstrated as an innovative and cost-effective emplacement method for the construction of subsurface physical, containment barriers, known as thin-diaphragm walls. The walls are emplaced by using high-pressure jetting of slurry into native soils in the target zone and when solidified create a low-permeability zone of minimal thickness (Figure 1). Continuous containment barriers to isolate subsurface contaminants are created by placing a series of intersecting panels in various geometries. Thin-diaphragm walls are emplaced by jetting through two relatively horizontal and opposing nozzles as the drill string is extracted without rotation. During injection, the high-pressure jet fluidizes or erodes a cavity in the soil into which the slurry solidifies.

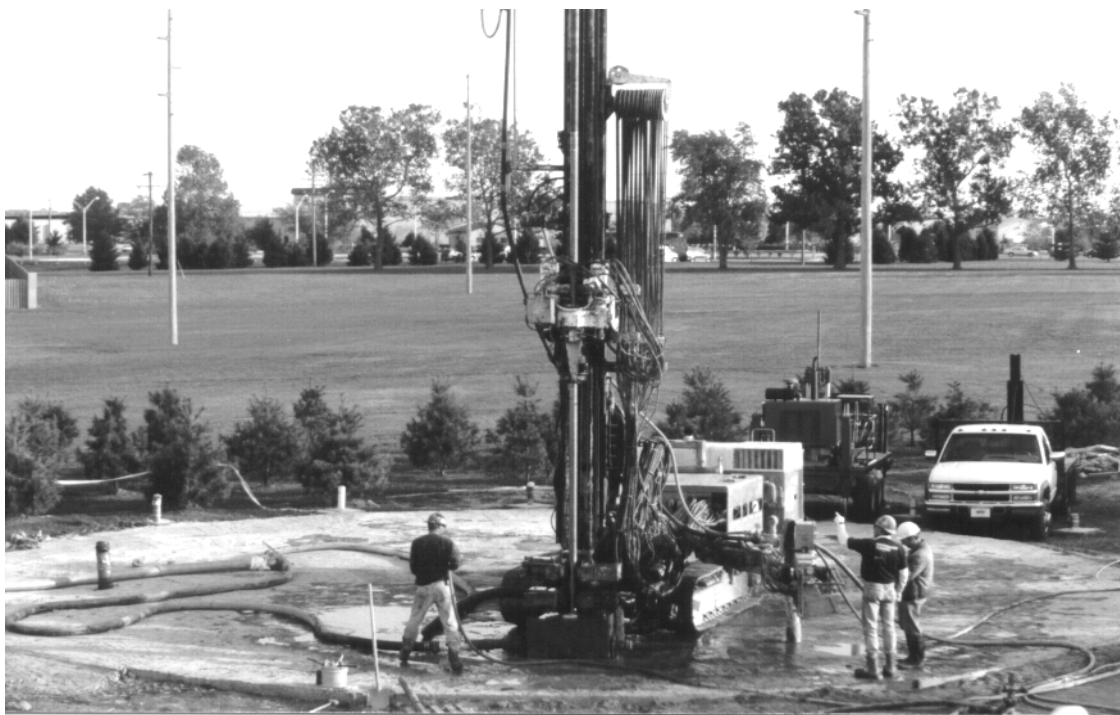
Figure 3. Photograph of jetting rig at the demonstration site.

- A double-fluid jet grouting system (air and cement/bentonite grout [Figure 3]) was used.
- Jetting nozzles were horizontally opposed by 180 degrees, each having a 4-mm diameter port.
- The two nozzle orientations were 5 degrees downward from horizontal.

- small to medium-sized jetting rig that can control rotation and drill-string extraction rates (Figure 3);
- data acquisition system to monitor the jetting parameters;
- bulk materials handling and slurry-mixing system (Figure 4);
- high-pressure pumping system (Figure 4);
- jetting-nozzle assembly;
- specialized drill string; and
- spoils control equipment (vacuum trucks and a spoils control box).

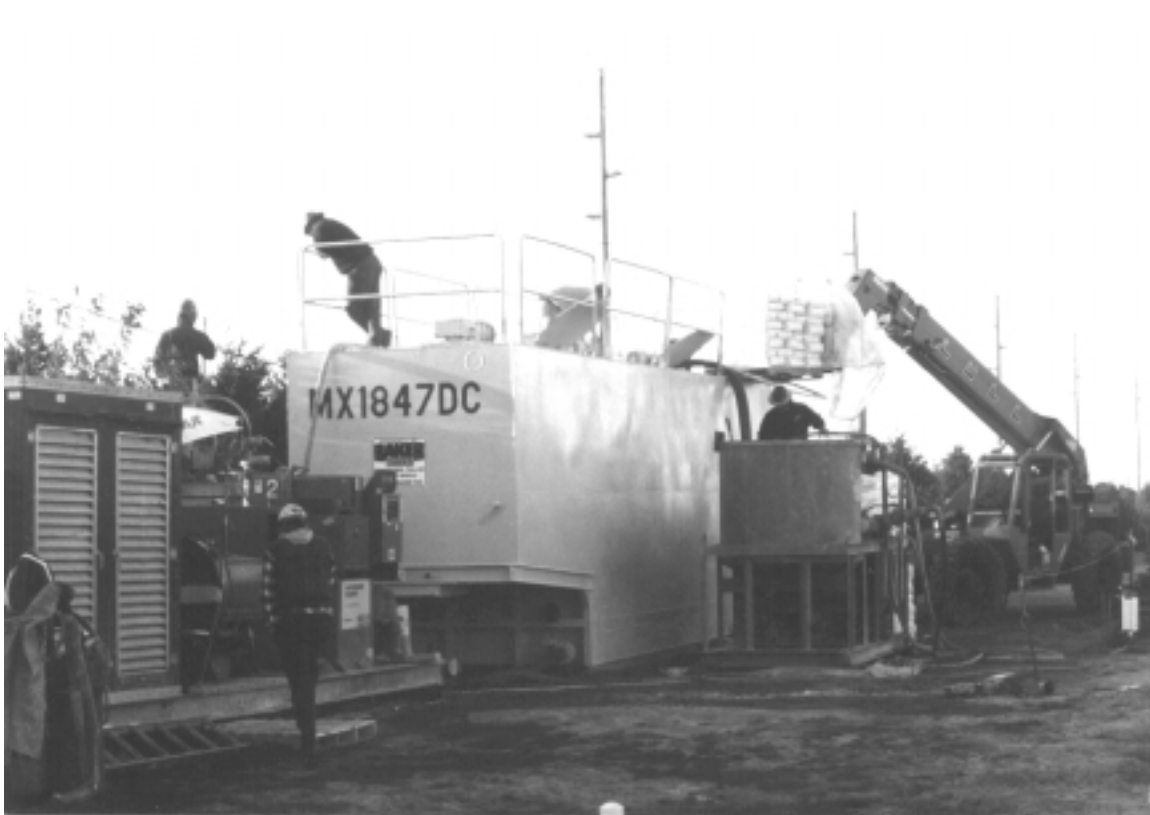
**Figure 4. Bulk materials handling, slurry mixing, and high pressure pumping systems.**

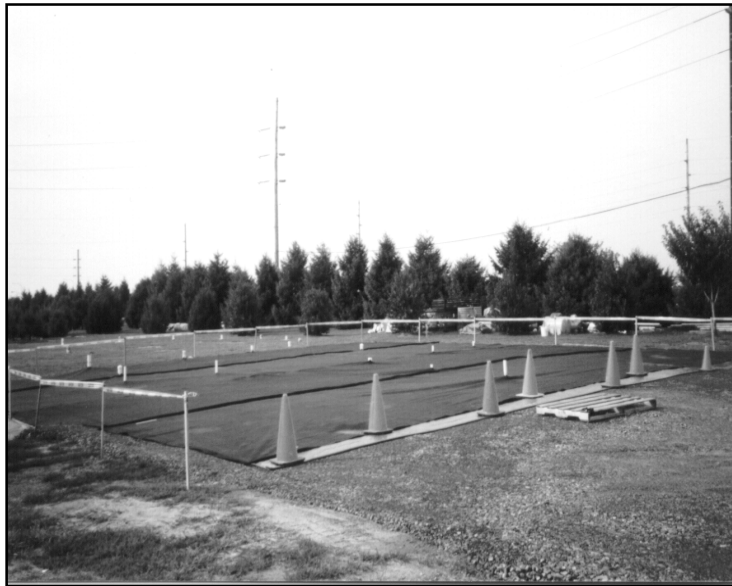
**Figure 6. Photograph of the geomembrane cover and piezometers.**

- Piezometers were to be installed in the cofferdam to monitor water levels inside and outside of the cofferdam to determine gradient across the cofferdam's walls.
- The cofferdam was to be covered by a geomembrane to minimize infiltration of precipitation (see Figure 6).
- Conventional and innovative hydraulic tests were to be performed to determine the bulk hydraulic conductivity performance of the cofferdam.
- Geophysical methods were to be utilized to validate the continuity of the barrier.

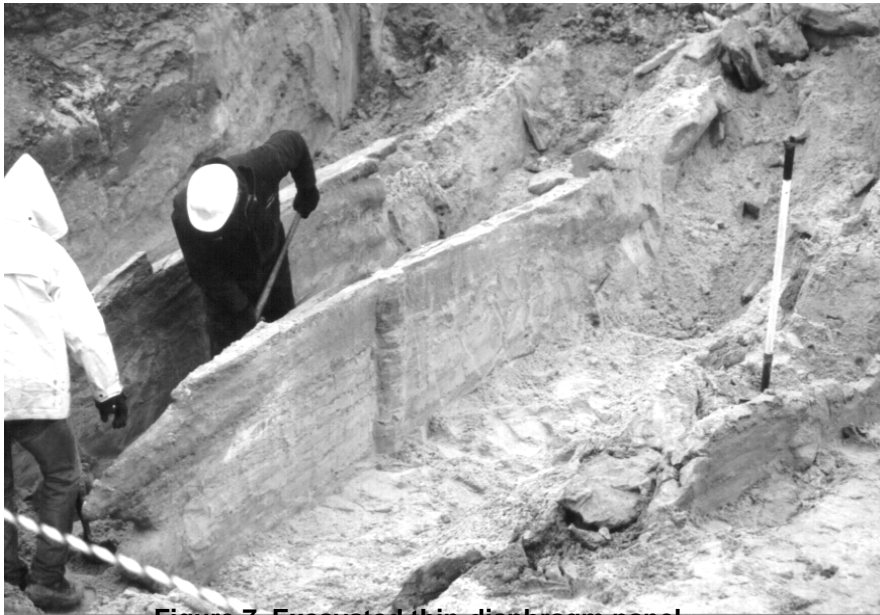
**Figure 7. Excavated thin-diaphragm panel emplaced using high-pressure jet grouting.**

Excavation of the barrier walls was conducted to visually confirm the construction and the geophysical, tracer, and hydraulic verification techniques (Figure 7). Generally, these verification technologies suggested flaws were present at the locations where flaws were observed during the excavation.

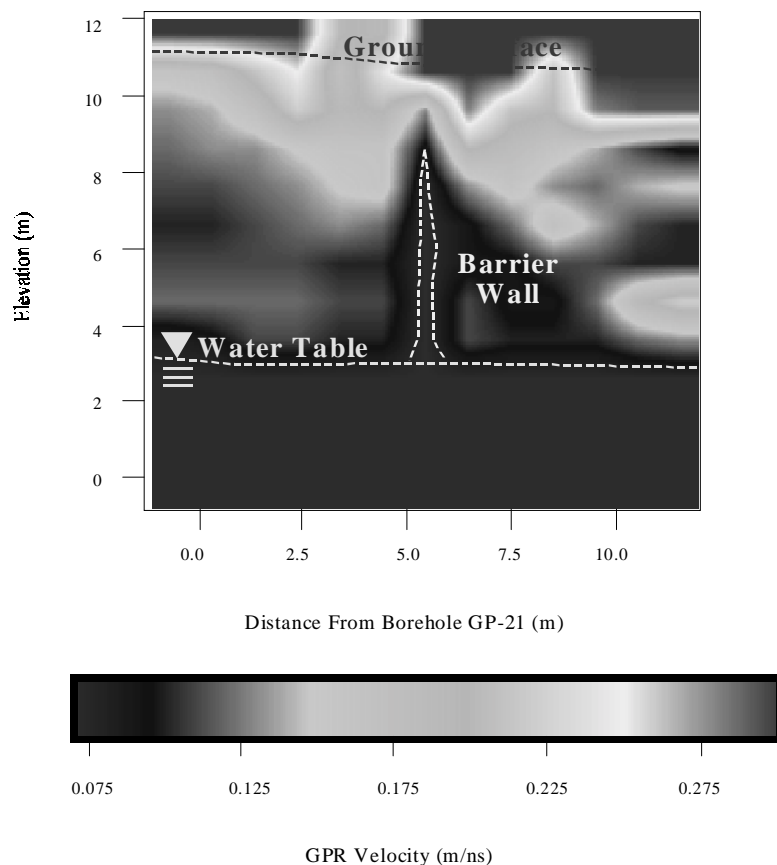
**Figure 13. GPR velocity distribution produced from tomography data.**

Cross bore-hole GPR tomography was used to image the barrier assuming a sufficient amount of data could be collected for suitable resolution. Velocity distribution cross-sections indicate a low velocity anomaly approximately midway between the two bore-holes, vertically oriented, and ~ 0.5 m thick (Fig. 13).
