COST AND PERFORMANCE REPORT

**Land Treatment
at the
Brown Wood Preserving Superfund Site
Live Oak, Florida**

*U.S. Environmental Protection Agency
Office of Solid Waste and Emergency Response
Technology Innovation Office*

March 1995

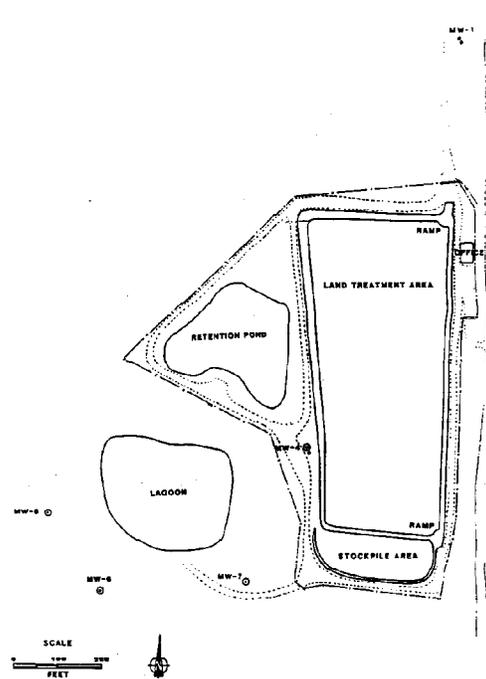
Figure 3. Land Treatment Area Location [12]

Construction of the land treatment area (LTA) involved site preparation, construction of the components of the LTA, construction of a retention pond, and installation of irrigation and drainage systems. The locations of the land treatment area, stockpile area, retention pond, and lagoon are shown in Figure 3. [12]

Site preparation activities included clearing vegetation and structures from approximately four acres. An estimated 200 yds³ of contaminated soil were excavated during the site preparation activities and stored in the central stockpile area. [2]

- A clay liner, which ranged from 1 to 3 feet in thickness.
- A compacted clay berm around the LTA that ranged in height from 2.5 to 7 feet and a 3-foot berm around the soil stockpile area.

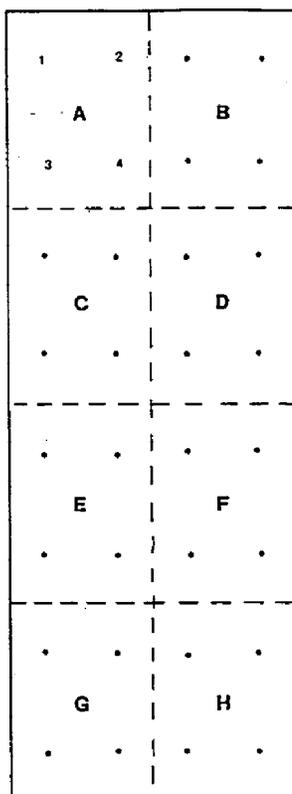
Figure 4. Subplot Locations [10]

Four Acre Land Treatment Area

A - H one half acre subplots

1 2 3 4 subplot composite locations

1 inch : 100 feet

System Operation: Land treatment was performed in three lifts. For sampling purposes, the LTA was divided into eight half-acre subplots, as shown in Figure 4. [10] A composite sample was collected from each subplot, during each quarterly sampling event, until the concentrations of TCICs contained in the soil within the subplot was less than 100 mg/kg. [1,8] An additional lift of soil from the stockpile area was then placed in the subplot and treated until the concentrations of TCICs in the soil were less than 100 mg/kg. This process was continued until all of the stockpiled soil had been treated. The three lifts are described below:
