Field Demonstration of Propane  
Biosparging for *In Situ* Remediation  
of N-Nitrosodimethylamine (NDMA) in Groundwater

ESTCP Project ER-200828

DECEMBER 2015

Paul B. Hatzinger, Ph.D.  
David Lippincott, P.G.  
CB&I Federal Services, LLC.

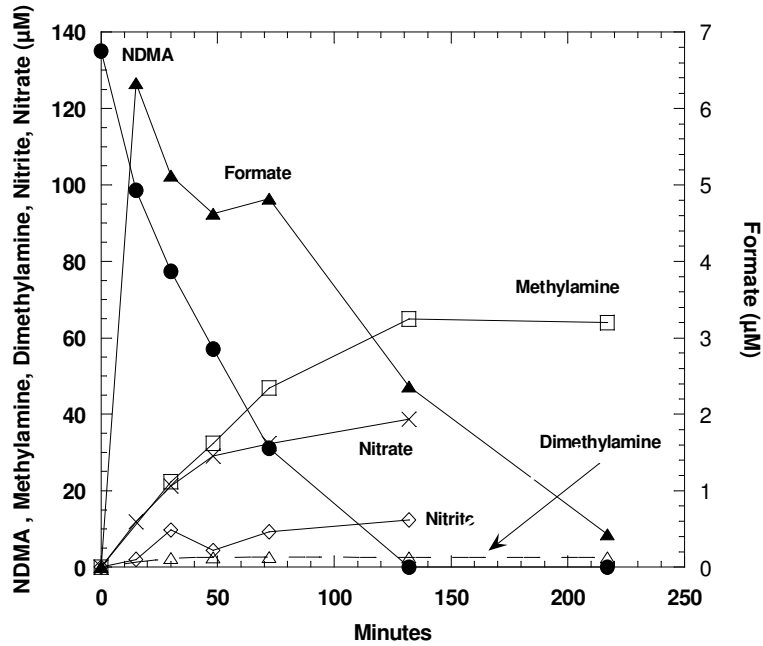
**Figure 2-2. Metabolites produced during the oxidation of NDMA by *R. ruber* ENV425 after growth on propane (modified from Fournier et al., 2009).**

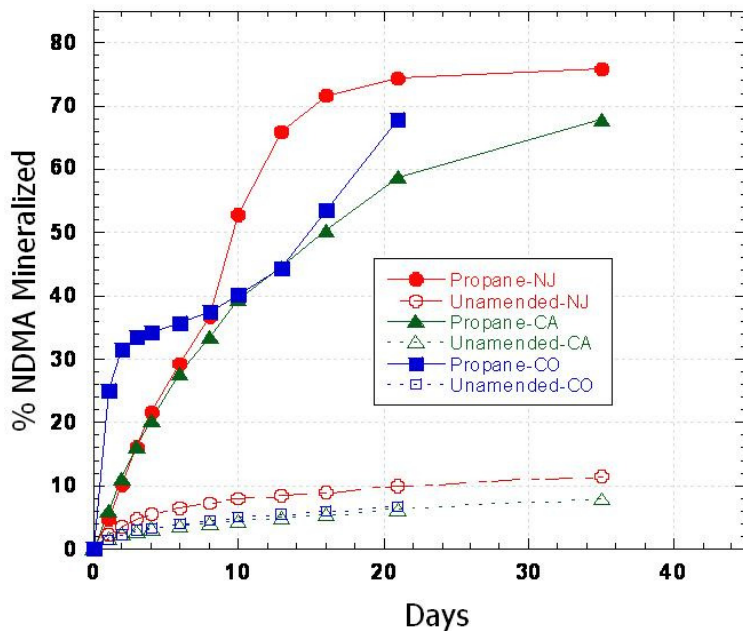
**Figure 2-4. Percent mineralization of  $^{14}\text{C}$ -NDMA to  $^{14}\text{CO}_2$  in microcosms prepared with aquifer solids and groundwater from three different states (NJ, CO, CA). Microcosms were pre-incubated with propane and oxygen (propane) or oxygen only (unamended) for three weeks, then amended with 50  $\mu\text{g/L}$  of NDMA. All propane-treated microcosms showed significant NDMA mineralization.**

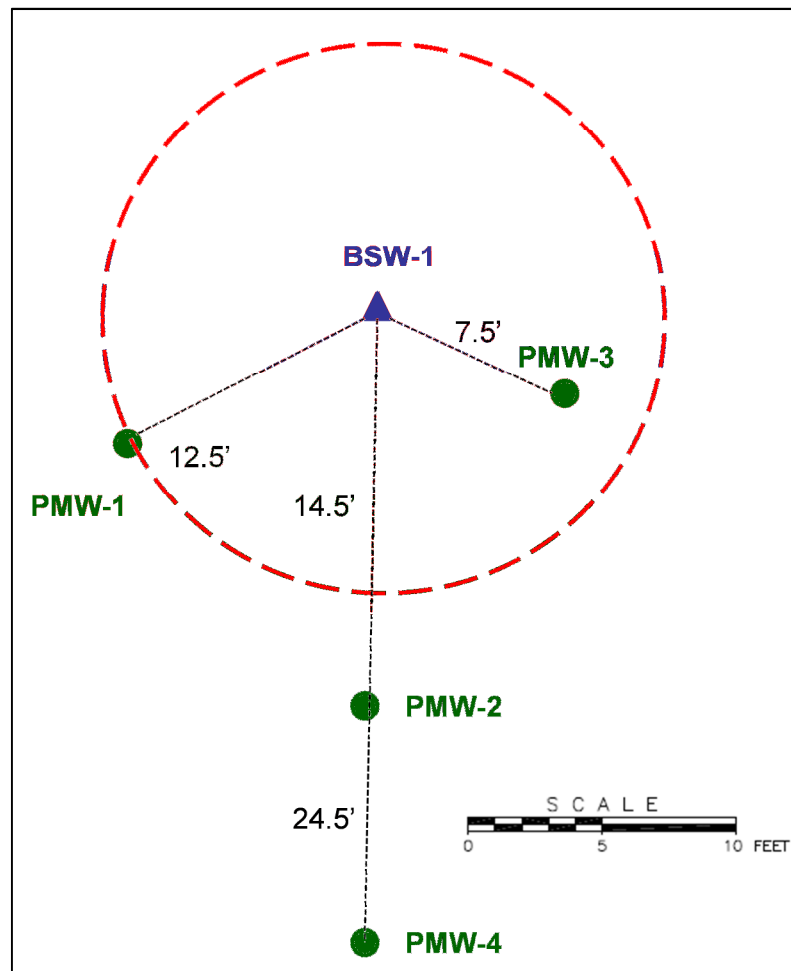
**Figure 3-2. Initial wells installed for gas distribution testing.**

The data requirements for the gas distribution testing in monitoring wells located nearby the gas injection well (7.5 ft, 12.5 ft, 14 ft and 24 ft from the injection well; **Figure 3-2**) were as follows: (1) the measurement of dissolved oxygen (DO) using a field meter, (2) qualitative descriptions of any observed bubbling (i.e., none, trace, low, moderate, rapid), and (3) any increase in water table elevation (which may indicate air pocket formation). ORP was also monitored in the field although changes may require a longer period than that allotted for the testing. The air injection pressure was monitored to ensure that the soil overburden pressure was not exceeded, and to provide an accurate measure of the pressure-adjusted gas flow rate. Calibrated YSI field meters were used to measure both DO and ORP during the initial injection test. The data collected from this test was used to locate the remaining sparge wells.

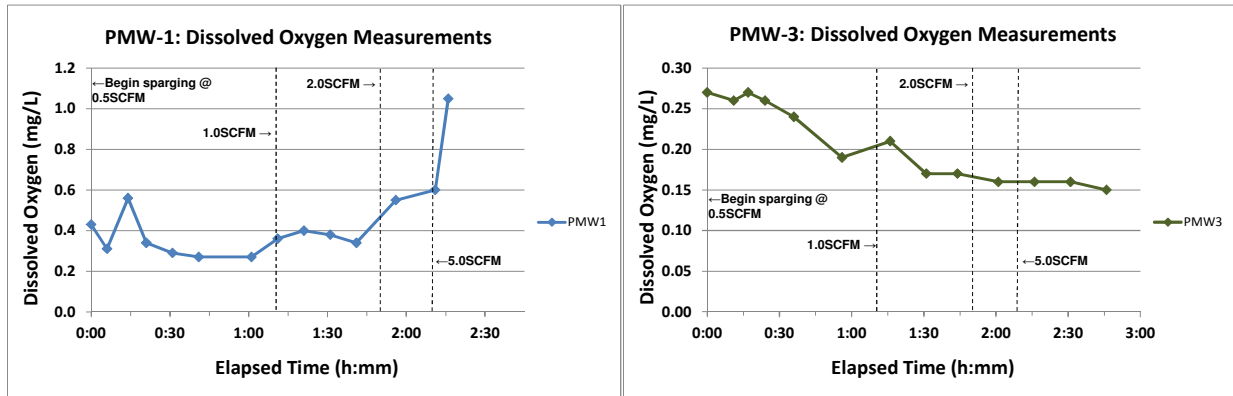
**Figure 5-2. Dissolved oxygen in PMW-1 and PMW-3 during air sparge testing at BSW-1.** The air flow rates are provided for each well.

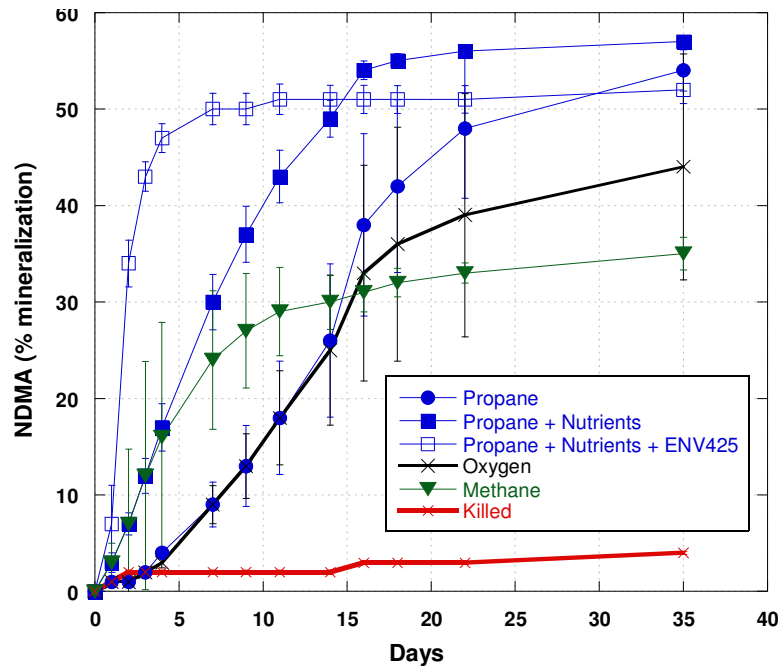
**Figure 5-5. Mineralization of  $^{14}\text{C}$ -NDMA to  $^{14}\text{CO}_2$  in Aerojet microcosms pre-incubated with propane, propane + nutrients (+/- ENV425), methane, or oxygen.**

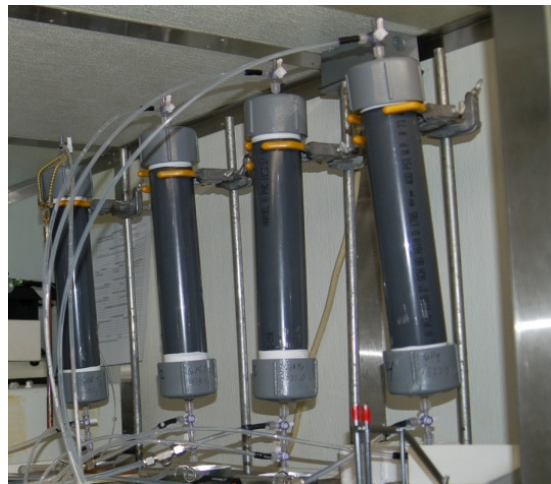
**Figure 5-6. Flow-through model aquifer columns used to evaluate NDMA biodegradation in site materials.**

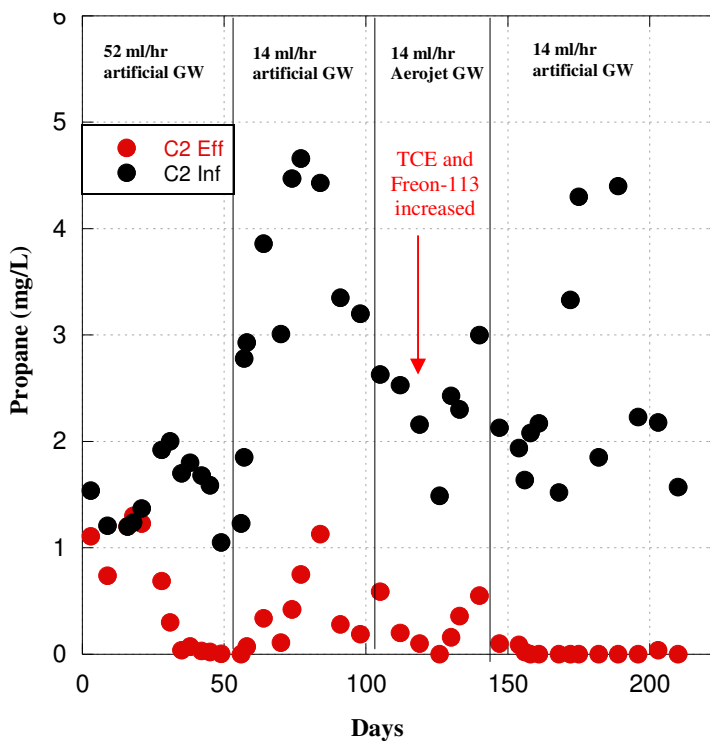
**Figure 5-12. Propane concentrations in influent and effluent water from Column 2 (C2: propane, oxygen).**

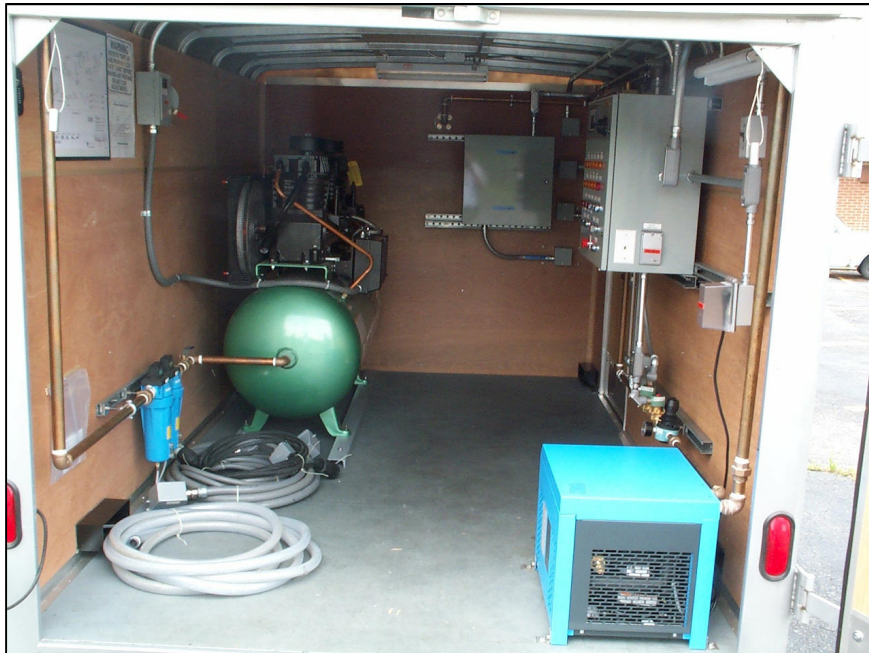
**Figure 5-19. Inside of Trailer #1 which houses the controls and air supply system.**

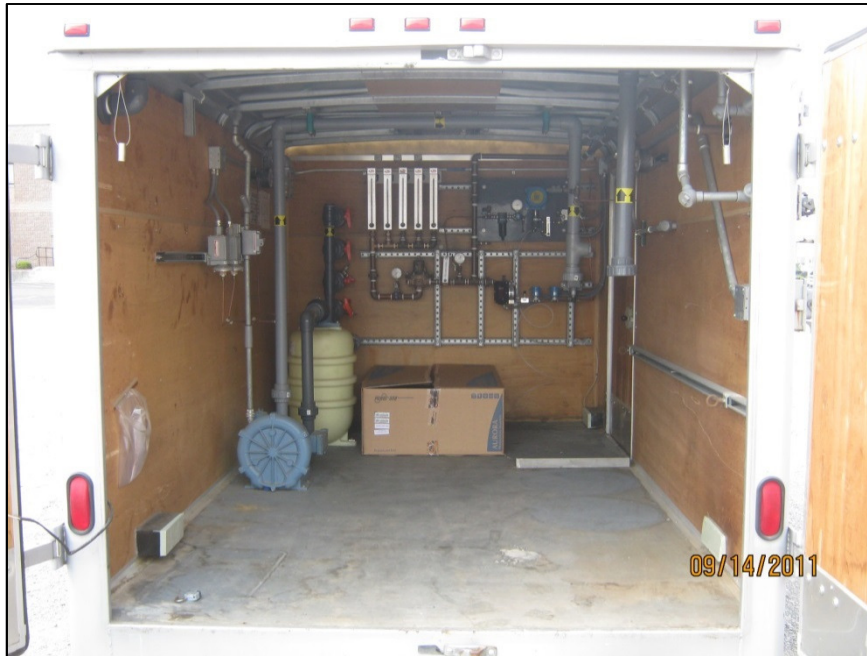
**Figure 5-20. Inside of Trailer # 2, which houses the propane feed and distribution as well as SVE equipment.**

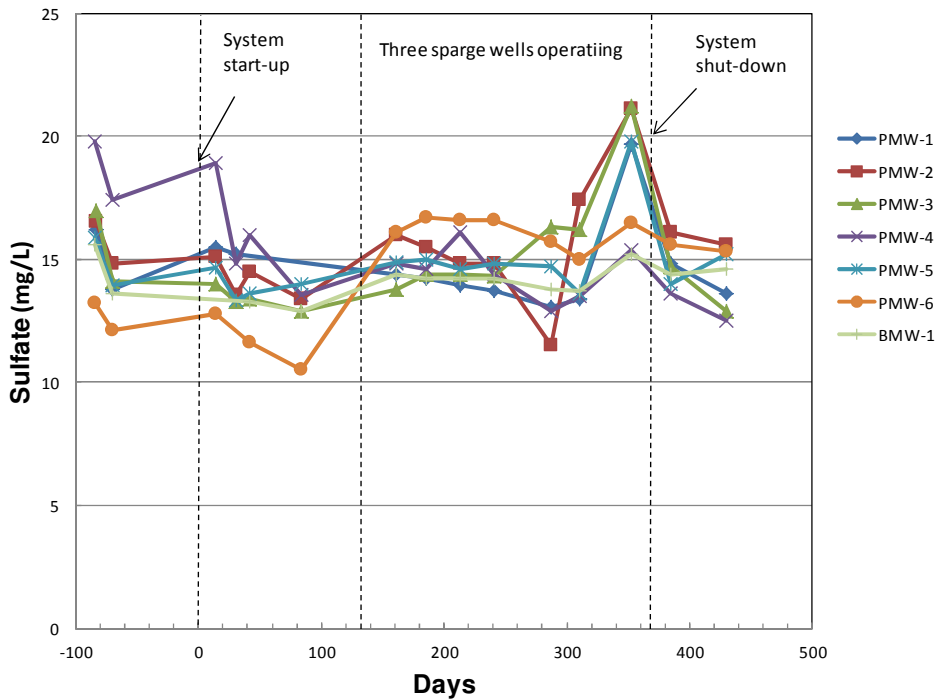
**Figure 5-30. Concentration of sulfate in the demonstration plot wells.**

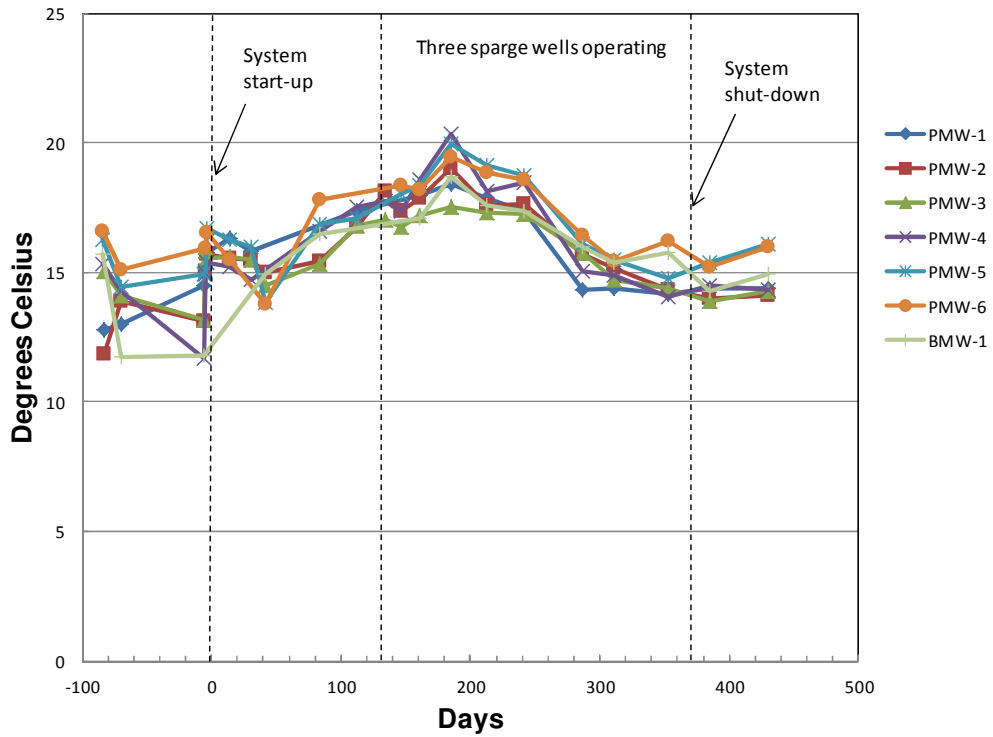
**Figure 5-32. Temperature of groundwater in the demonstration plot wells.**

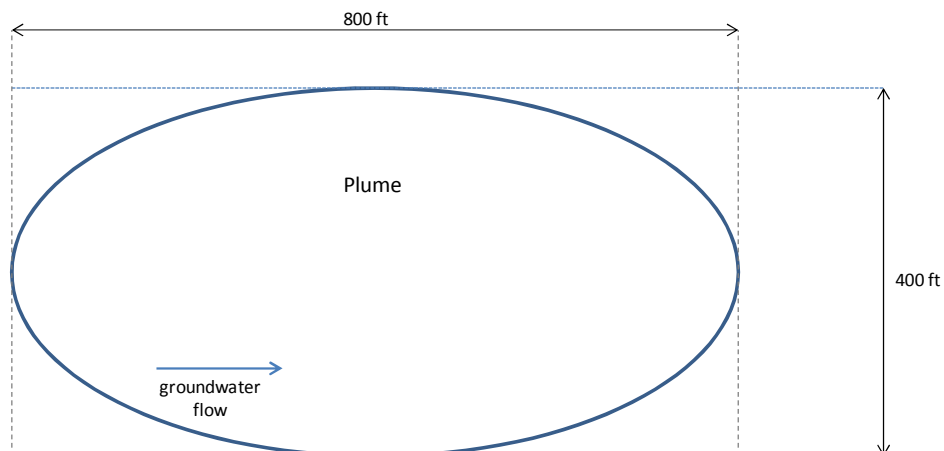
**Figure 7-1. Base case plume characteristics.**
