**Case Study on Remediation at a Sediment Site in Northern California with Radium-226 and Heavy Metal Contamination, including Use of SCM Technology to Expedite Remediation at the Source**

**Seaplane Lagoon Site, former Naval Air Station Alameda, Alameda, California**  
by  
**Mary Parker – Project Manager, Navy Base Realignment and Closure (BRAC) Office, San Diego, CA**  
and  
**Matthew Slack, NAVSEA Radiological Affairs Support Office (RASO), Yorktown, VA**

Federal Remediation Technology Roundtable Meeting, November 8, 2017

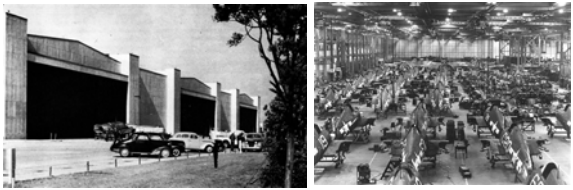
Primary source of the sediment contamination was maintenance activities for aircraft within Building 5 (~16 acres); Ra-226 paint was used on compasses and plane and ship instrument faces.

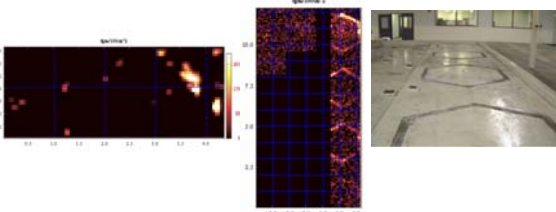
SCM Color Graphic Images of Radiological Contamination:  
 Left: Building 5 Ra-226 paint room contamination;  
 Right: Another project showing contamination beneath pads (SCM image, center, and photo to right)

Building 5 is an approximately 1 million square foot building with no power; the SCM was able to efficiently survey the first floor and identify contamination very quickly:

- A 180 cm detector will cover an area 6 times faster than a 30 cm detector (all other parameters being equal).
- Added benefits come from the equipment's sensitivity and ability to process data and provide color graphic images.

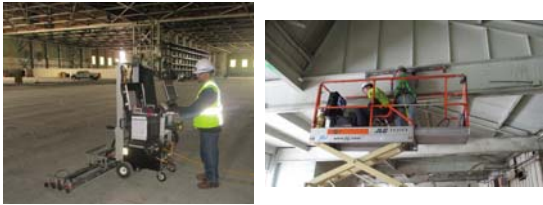
SCM Surveying Hangar Floor (left); SCM ~30 feet from floor, surveying I-beams and ceiling (right)

The Building 5 radiological remediation included use of a recently developed SCM model with:

- electronics package replaced with small computer chips
- computers with faster, more powerful systems (e.g. SurfacePro)
- battery power instead of AC and
- a weight less than one-third the weight of the older model SCM.

This results in significantly greater ease of use in the field; it was very efficient in this 2-story building with no electricity.

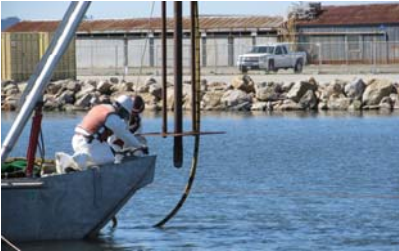
Post-dredge sampling results confirmed completion of the NE area remediation. Results for the NW area indicated that further dredging was necessary in a limited area.
