Site 11, Old Camden County Landfill Remedial Action Operation

SUMMARY REPORT

Remedial Action Operation Optimization

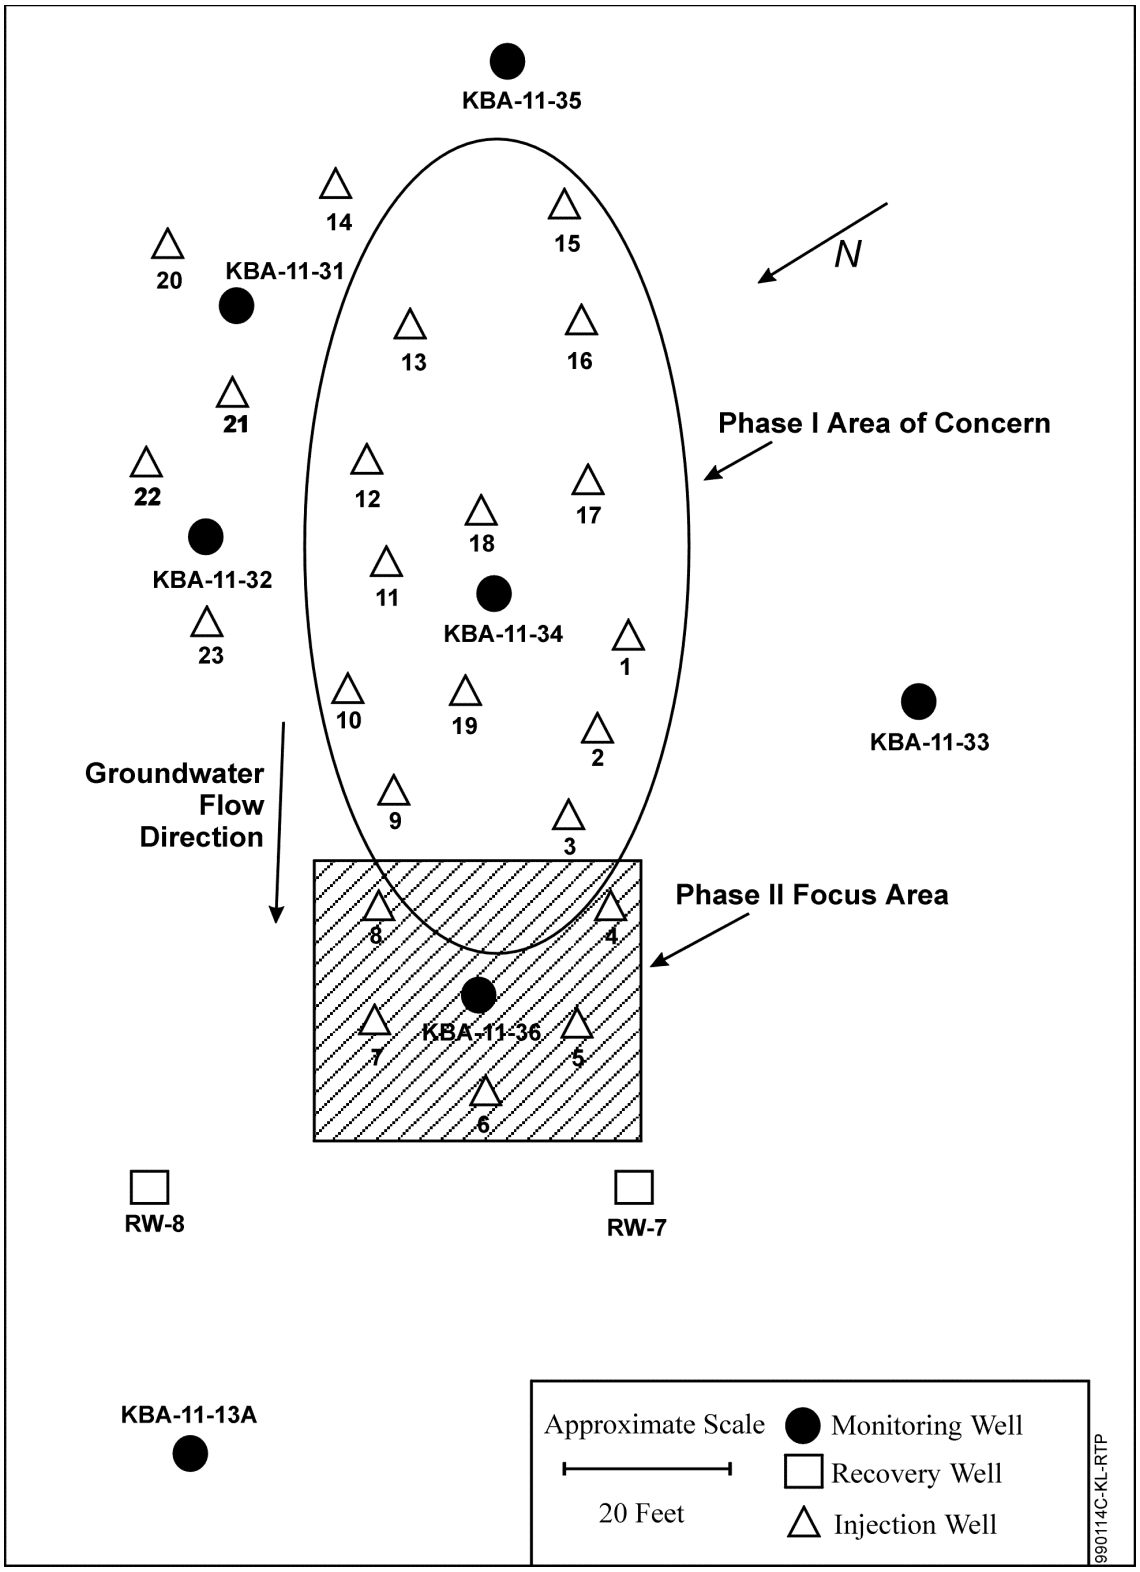
Figure 2. NSB Kings Bay Site Map

A two-phase treatment was completed at NSB Kings Bay in February 1999. Phase I treatment focused primarily on the central part of the contaminant plume. Phase II treatment focused primarily on the downgradient areas that were not the focus of the Phase I treatment. Figure 2 details the areas of concern for Phase I and II treatment. Further treatment of the downgradient area, as well as an adjacent, upgradient source area will be the focus of Phase III, scheduled for completion in July 1999.

As part of the *in-situ* chemical oxidation treatment program, twenty-three injectors distributed in two vertical levels were installed at the locations indicated in Figure 2. In addition to the injectors, six additional monitoring wells and two recovery wells were installed within or adjacent to the targeted treatment area. Monitoring of field data during injections includes collecting groundwater samples twice each day from monitoring wells. These samples were evaluated to determine if appropriate chemical conditions (e.g., pH, alkalinity and total iron) were established in the aquifer, reagents were dispersed effectively (e.g., hydrogen peroxide), and inert byproducts of CAC oxidation were generated. In addition to field data, pre-and post-treatment groundwater samples were collected to determine contaminant concentrations.

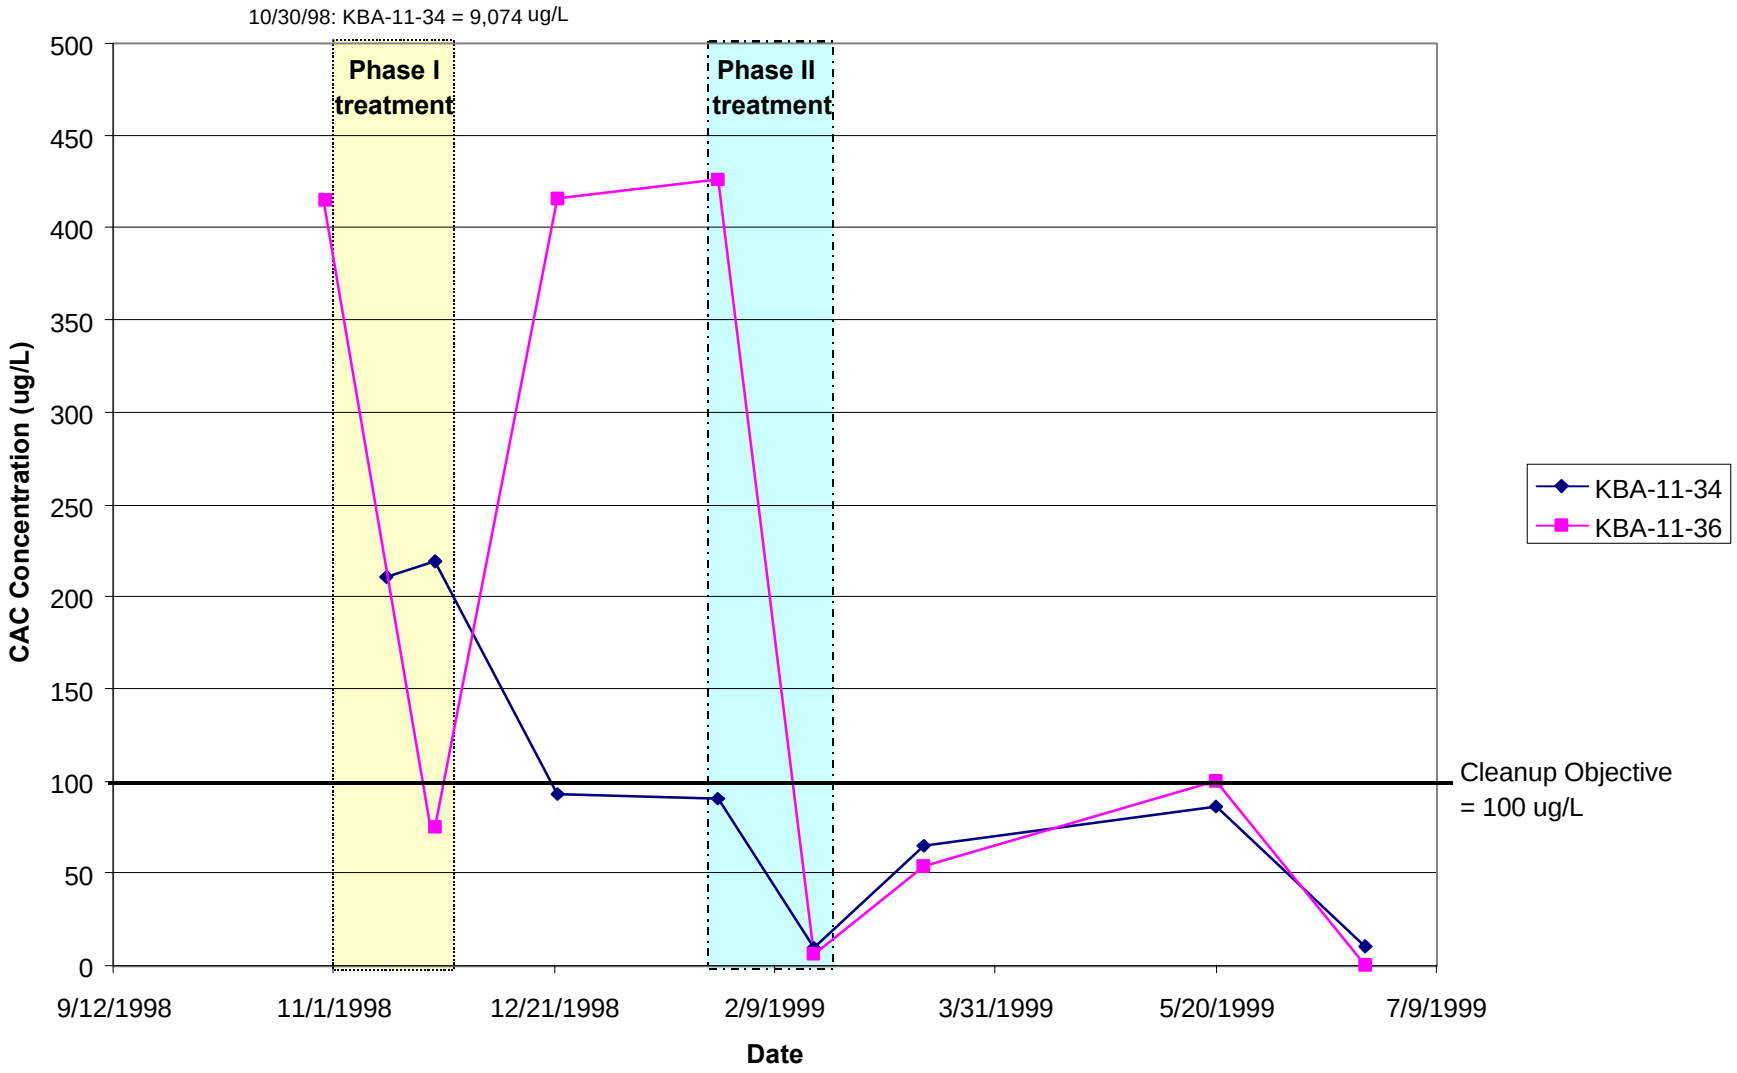
Figure 3. Monitoring Results at Site 11, NSB Kings Bay

The *in situ* chemical oxidation treatment has provided an effective and rapid solution to CAC contamination in the aquifer underlying the landfill. During Phase I treatment, sampling results indicate that the cleanup objective was achieved within the primary target area. Similar results were found during Phase II treatment. Table 2 details the analytical results of the pre- and post-Phase I and II treatment. Figure 3 provides a graphical representation of monitoring results at the landfill.

Total CAC (ppb)		
Well ID	Pre-injection	Post-injection Phase I	Post-injection Phase II
KBA-11-34	9074	93	9
KBA-11-36	512	416	6
