# Autopsy of a Small UST Site in Bedrock: Implications for Remedial Effectiveness Case Study, Devens, MA

William C. Brandon, Hydrogeologist, US EPA Region 1

Federal Remediation Technology Roundtable Meeting Characterization and Remediation of Sites with Fractured Bedrock Washington, DC November 9, 2010

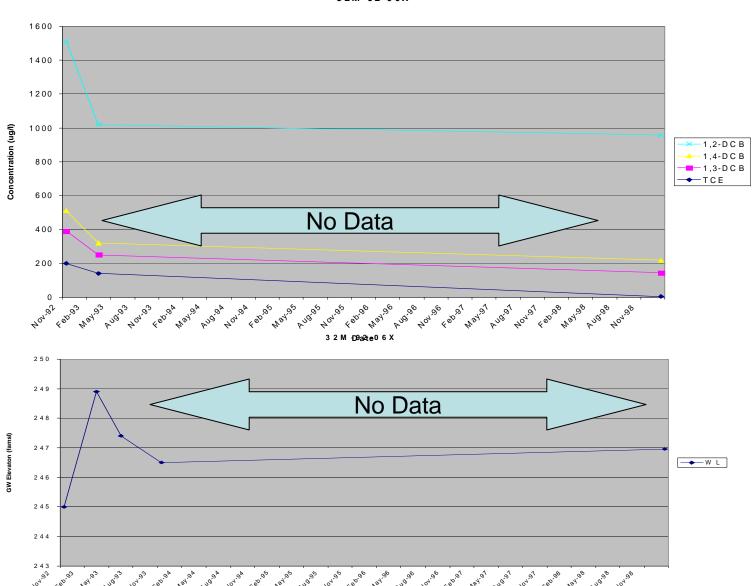
32M-92-06X

#### COC Trends (Pre-2000)

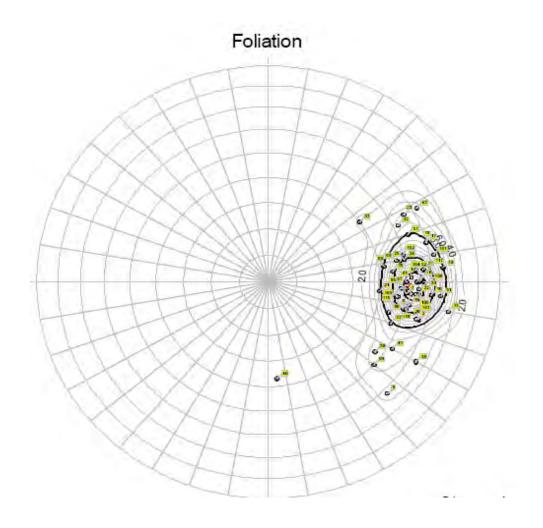
#### Stereoplot of Foliation Orientations

N=49 Strike ~ N3 Dip ~ 52 W

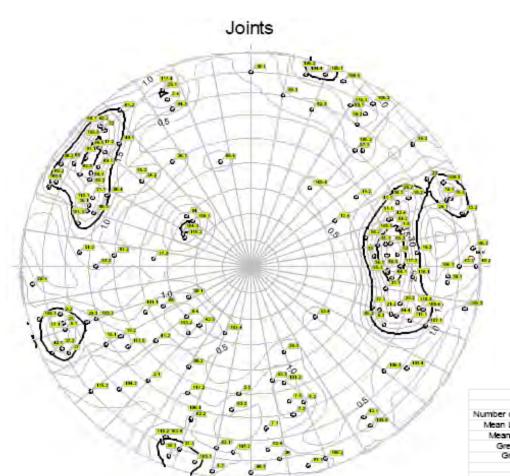
#### Stereo-plot of Joint Orientations

N=156 66 stations

- N3E +/-, 50-60 W (parallel to foliation)
- N45E +/-, 65-85 SE
- Near-surface sheeting joints at various orientations, Sub-parallel to former topography
- ~ N70W, Subvertical (weak)
- $\sim N30W$ , > 70-80 SE or SW Dips (weak)

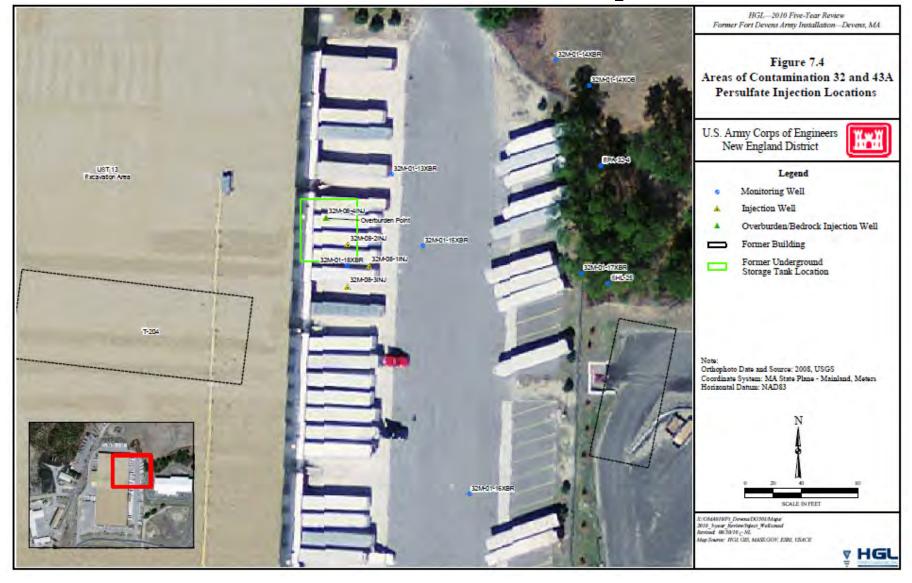
- Focus on "hotspot" near 32M-01-18XBR
- 3 shallow bedrock injection wells installed around 32M-01-18XBR
- Overburden injection well installed on Topof-bedrock in former tank grave
- 1800 gallons of water/sodium persulfate solution injected February 2009
- sodium hydroxide used as catalyst
