**REMEDIAL SYSTEM EVALUATION**

**AMERICAN CREOSOTE WORKS SITE  
PENSACOLA, FLORIDA**

Report of the Remedial System Evaluation  
Site Visit Conducted  
October 5, 2005

Final Report  
June 27, 2006

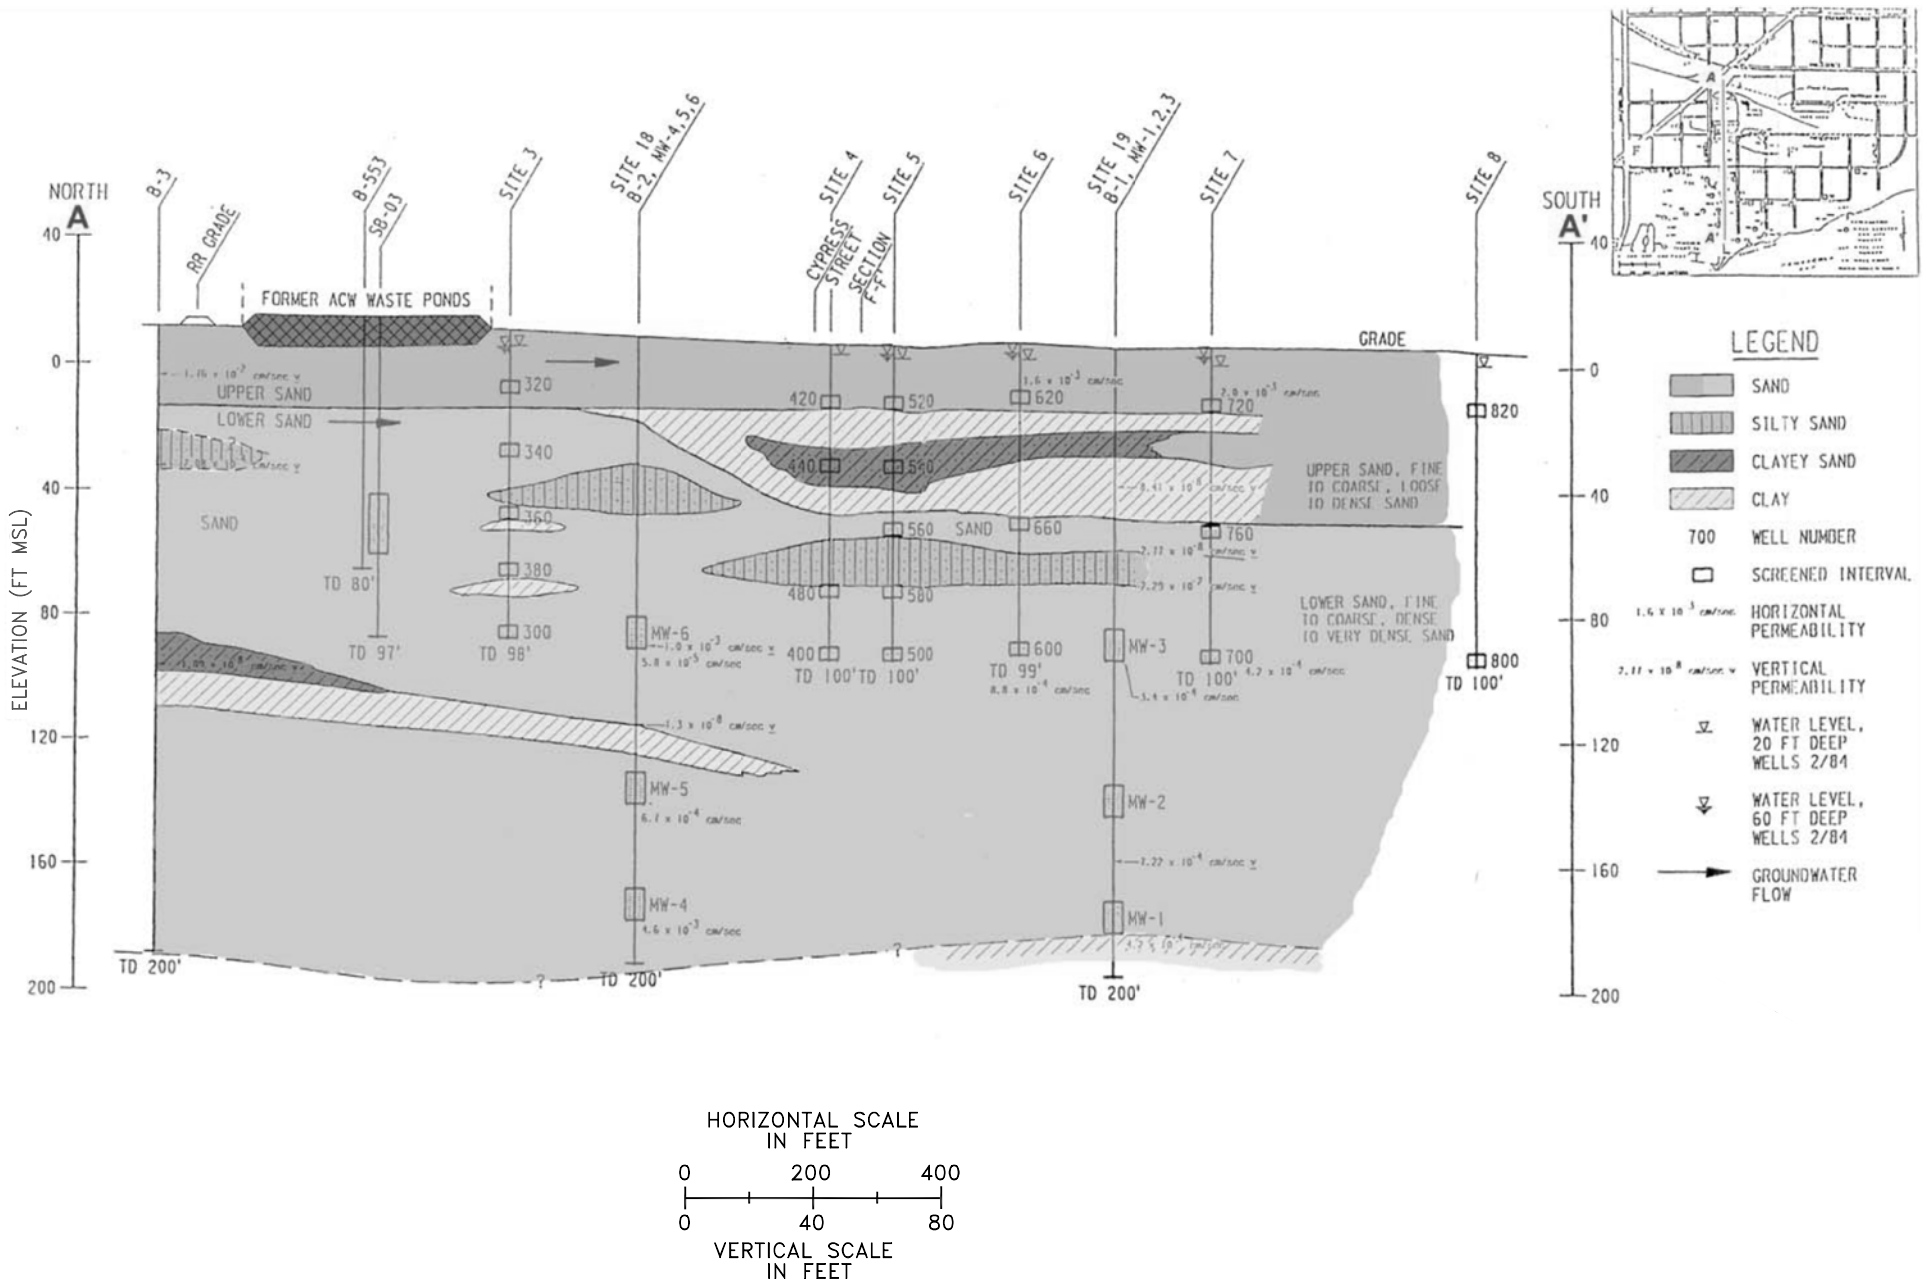
FIGURE 1-2. NORTH SOUTH GEOLOGIC CROSS SECTION (BECHTEL, 1996)

(Note: Figure originally generated by Bechtel, 1996, and extracted by the RSE team from the "SCAPS Investigation Report", USACE, 2002.)

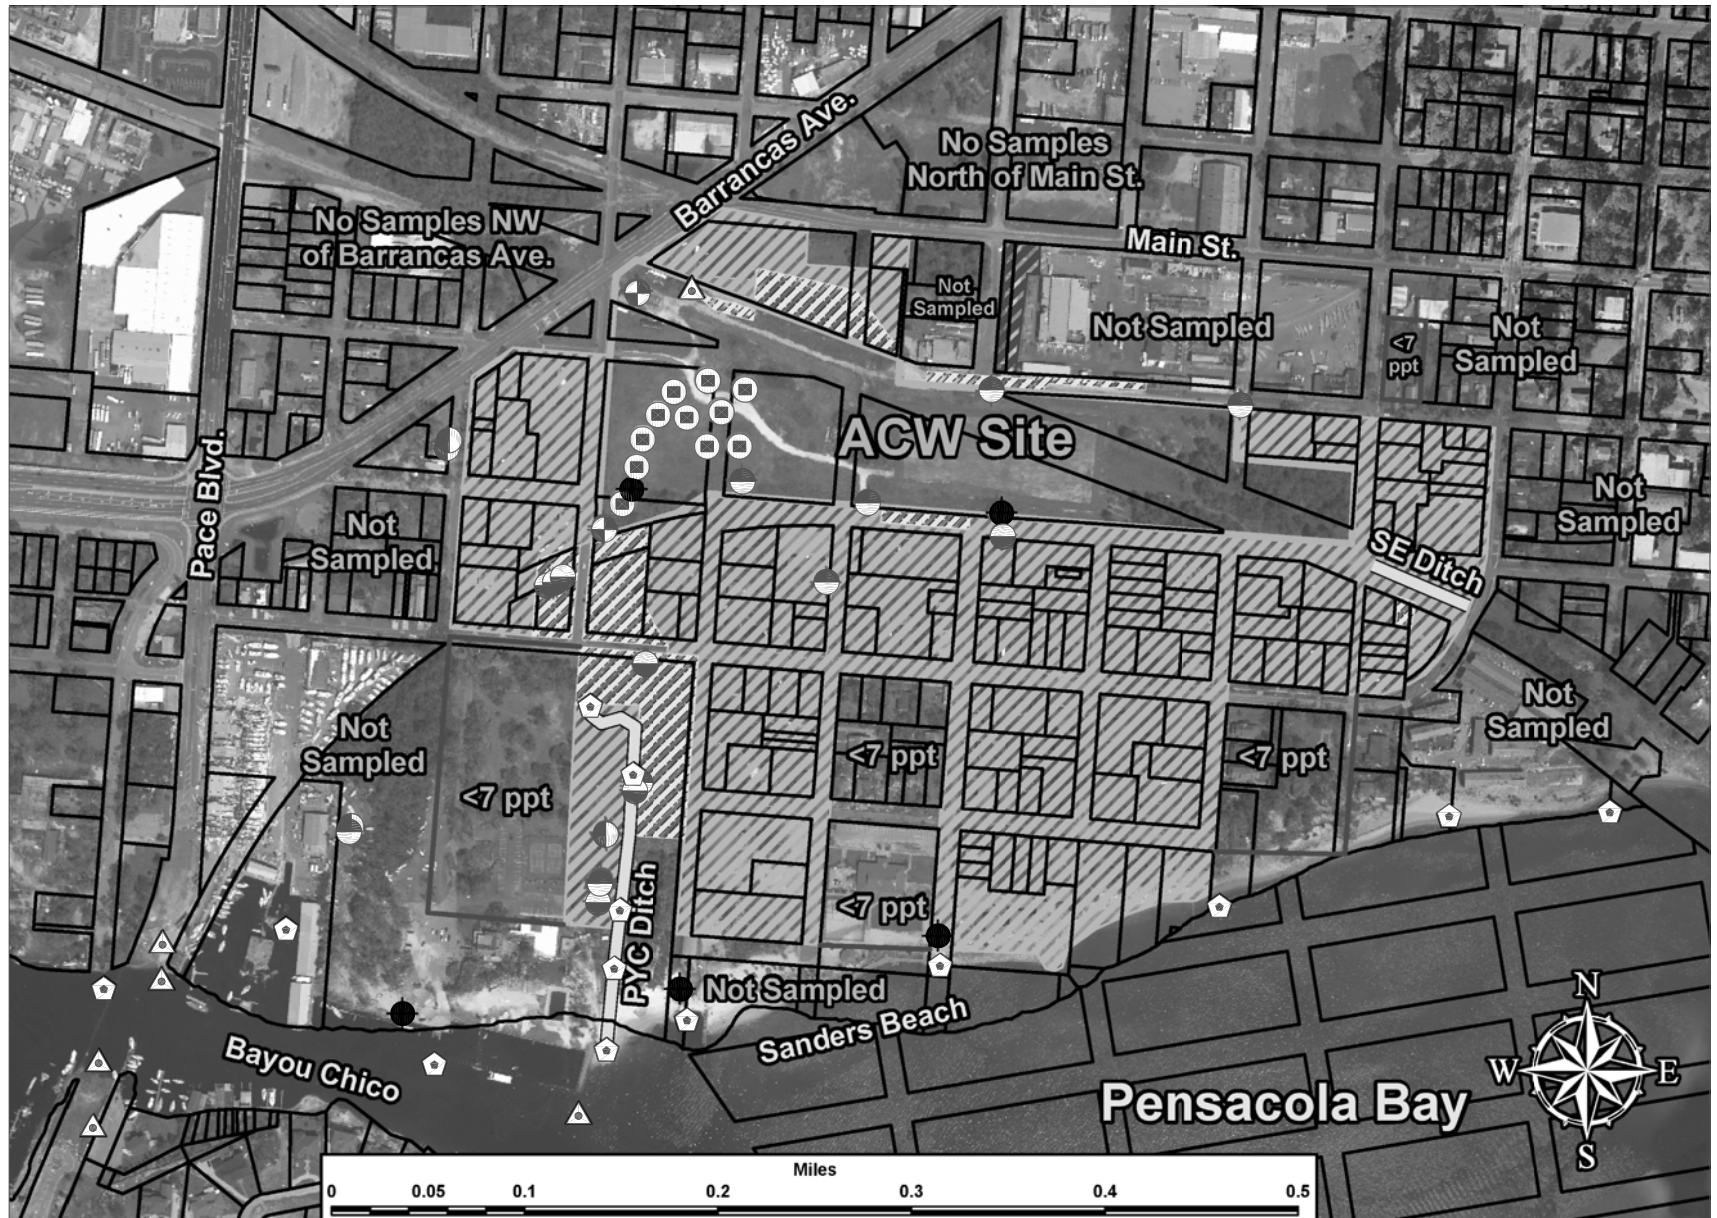
FIGURE 5-1. EXTENT OF SOIL EXCAVATION AND RESULTS OF SANDERS BEACH STUDY.

(Note: This figure was provided to the RSE team by the Florida DEP.)

On-site soil contamination from the three ponds has been addressed. In late 1983, the contamination in the ponds was removed, solidified, and capped. In addition, in 2003, contaminated surface soils from the condominium area just south of the site, in the PYC area, and in the east and west residence areas were excavated. Figure 5-1 illustrates areas where soil removal has been completed.

The residential areas downgradient of the site, shown on Figure 5-1, were investigated in 1997 during the “Sanders Beach Study”. During this study, dioxin TEQ concentrations up to 1 ppb were identified. In addition, the 1991 Phase III RI indicates TEQ concentrations as high as 1,500 ng/kg (i.e., 1.5 ppb) on residential property immediately south of the site. This surface soil contamination represents a potential human exposure pathway. For establishing cleanup criteria, the site team refers to the 1998 EPA Directive titled *Approach for Addressing Dioxin in Soil at CERCLA AND RCRA Sites* (OSWER Directive 9200.4-26), which established a TEQ concentration of 1 ppb as a starting point for establishing dioxin cleanup levels at CERCLA and RCRA sites. According to this directive, a TEQ of 1 ppb represents an increased cancer risk of  $2.3 \times 10^{-4}$ . If these levels are revisited along with the ACLs for ground water, the site team may find that remedial action of these surface soils is merited. The site team notes that a risk-based corrective action approach consistent with new Florida Department of Environmental Protection regulations may be appropriate for this soil contamination. This regulation sets a default soil cleanup target of 7 parts per trillion (ppt) for dioxin.
