**Streamlined Remediation System Evaluation**  
**Wash King Laundry Superfund Site**  
**Pleasant Plains Township, Michigan**

## **WASH KING LAUNDRY SITE PLEASANT PLAINS TOWNSHIP, LAKE COUNTY, MICHIGAN**

Report of the Streamlined Remediation System Evaluation  
Conference Call Conducted for the Wash King Laundry Site  
July 26, 2010

Revised Report  
February 18, 2011

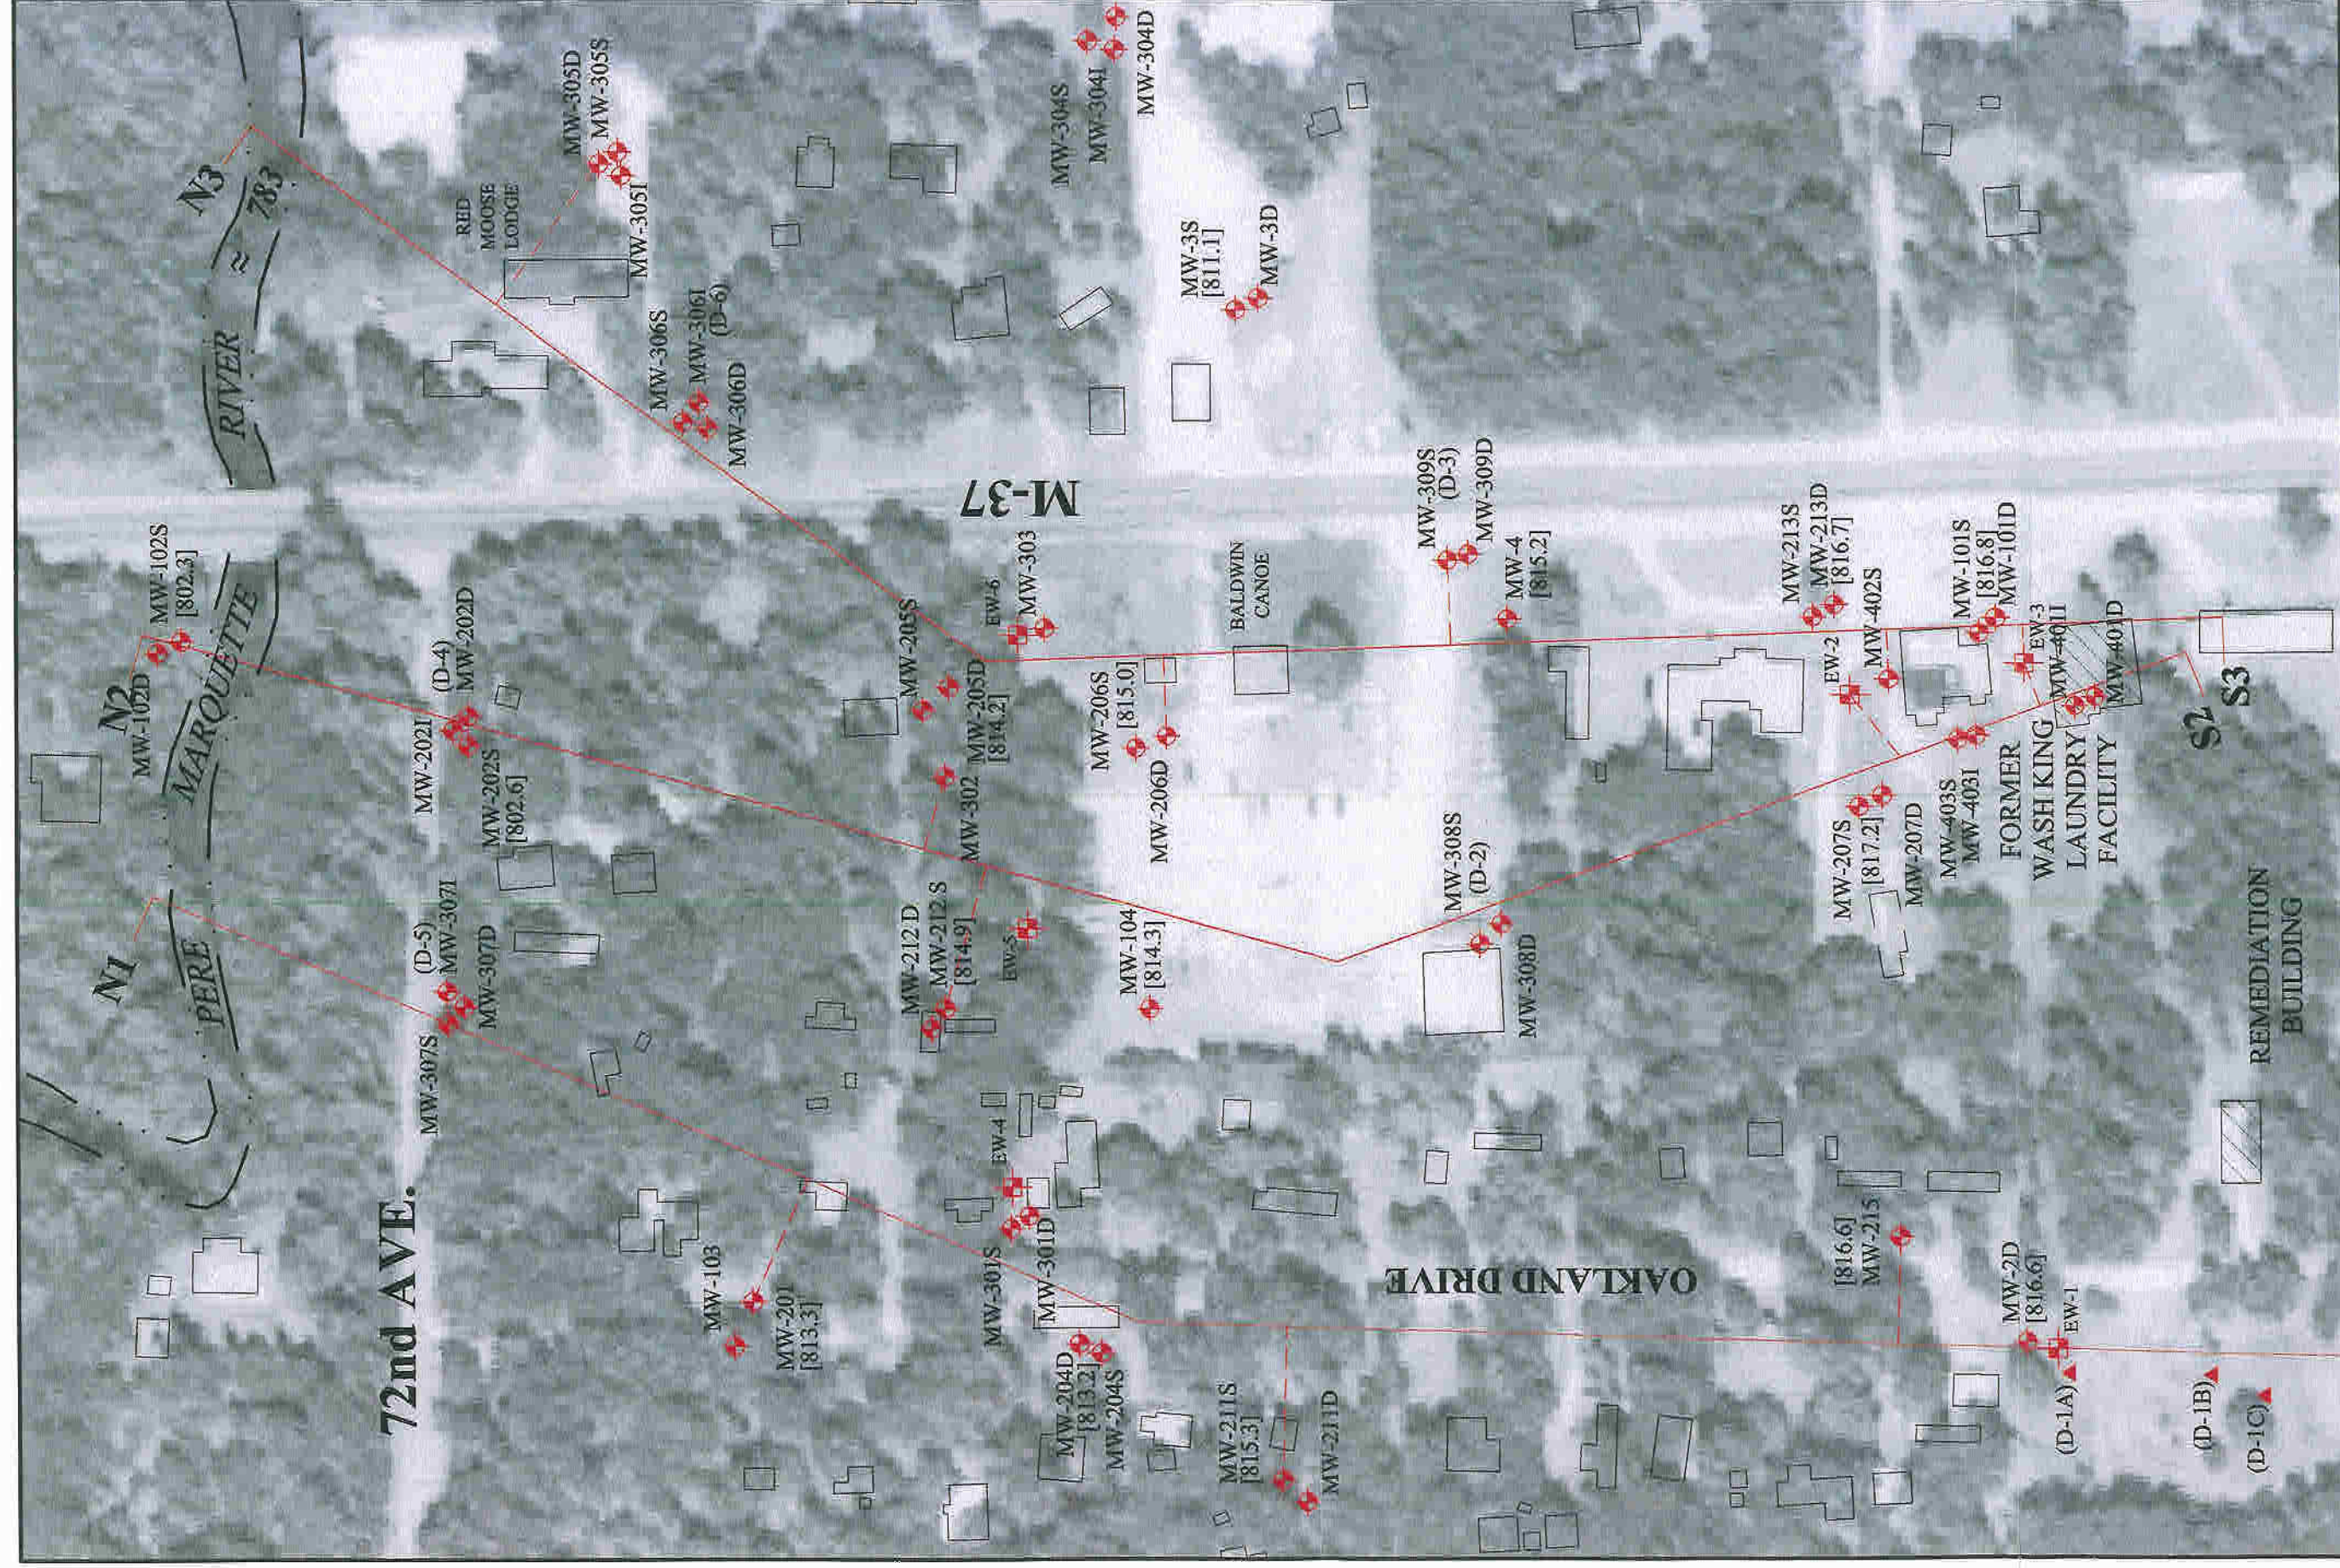
CROSS SECTION OUTLINE MAP

- MONITORING WELL
- EXTRACTION WELL
- SOIL BORING
- [802.6] GROUND ELEVATION

S1  
FORMER  
SEEPAGE  
LAGOONS

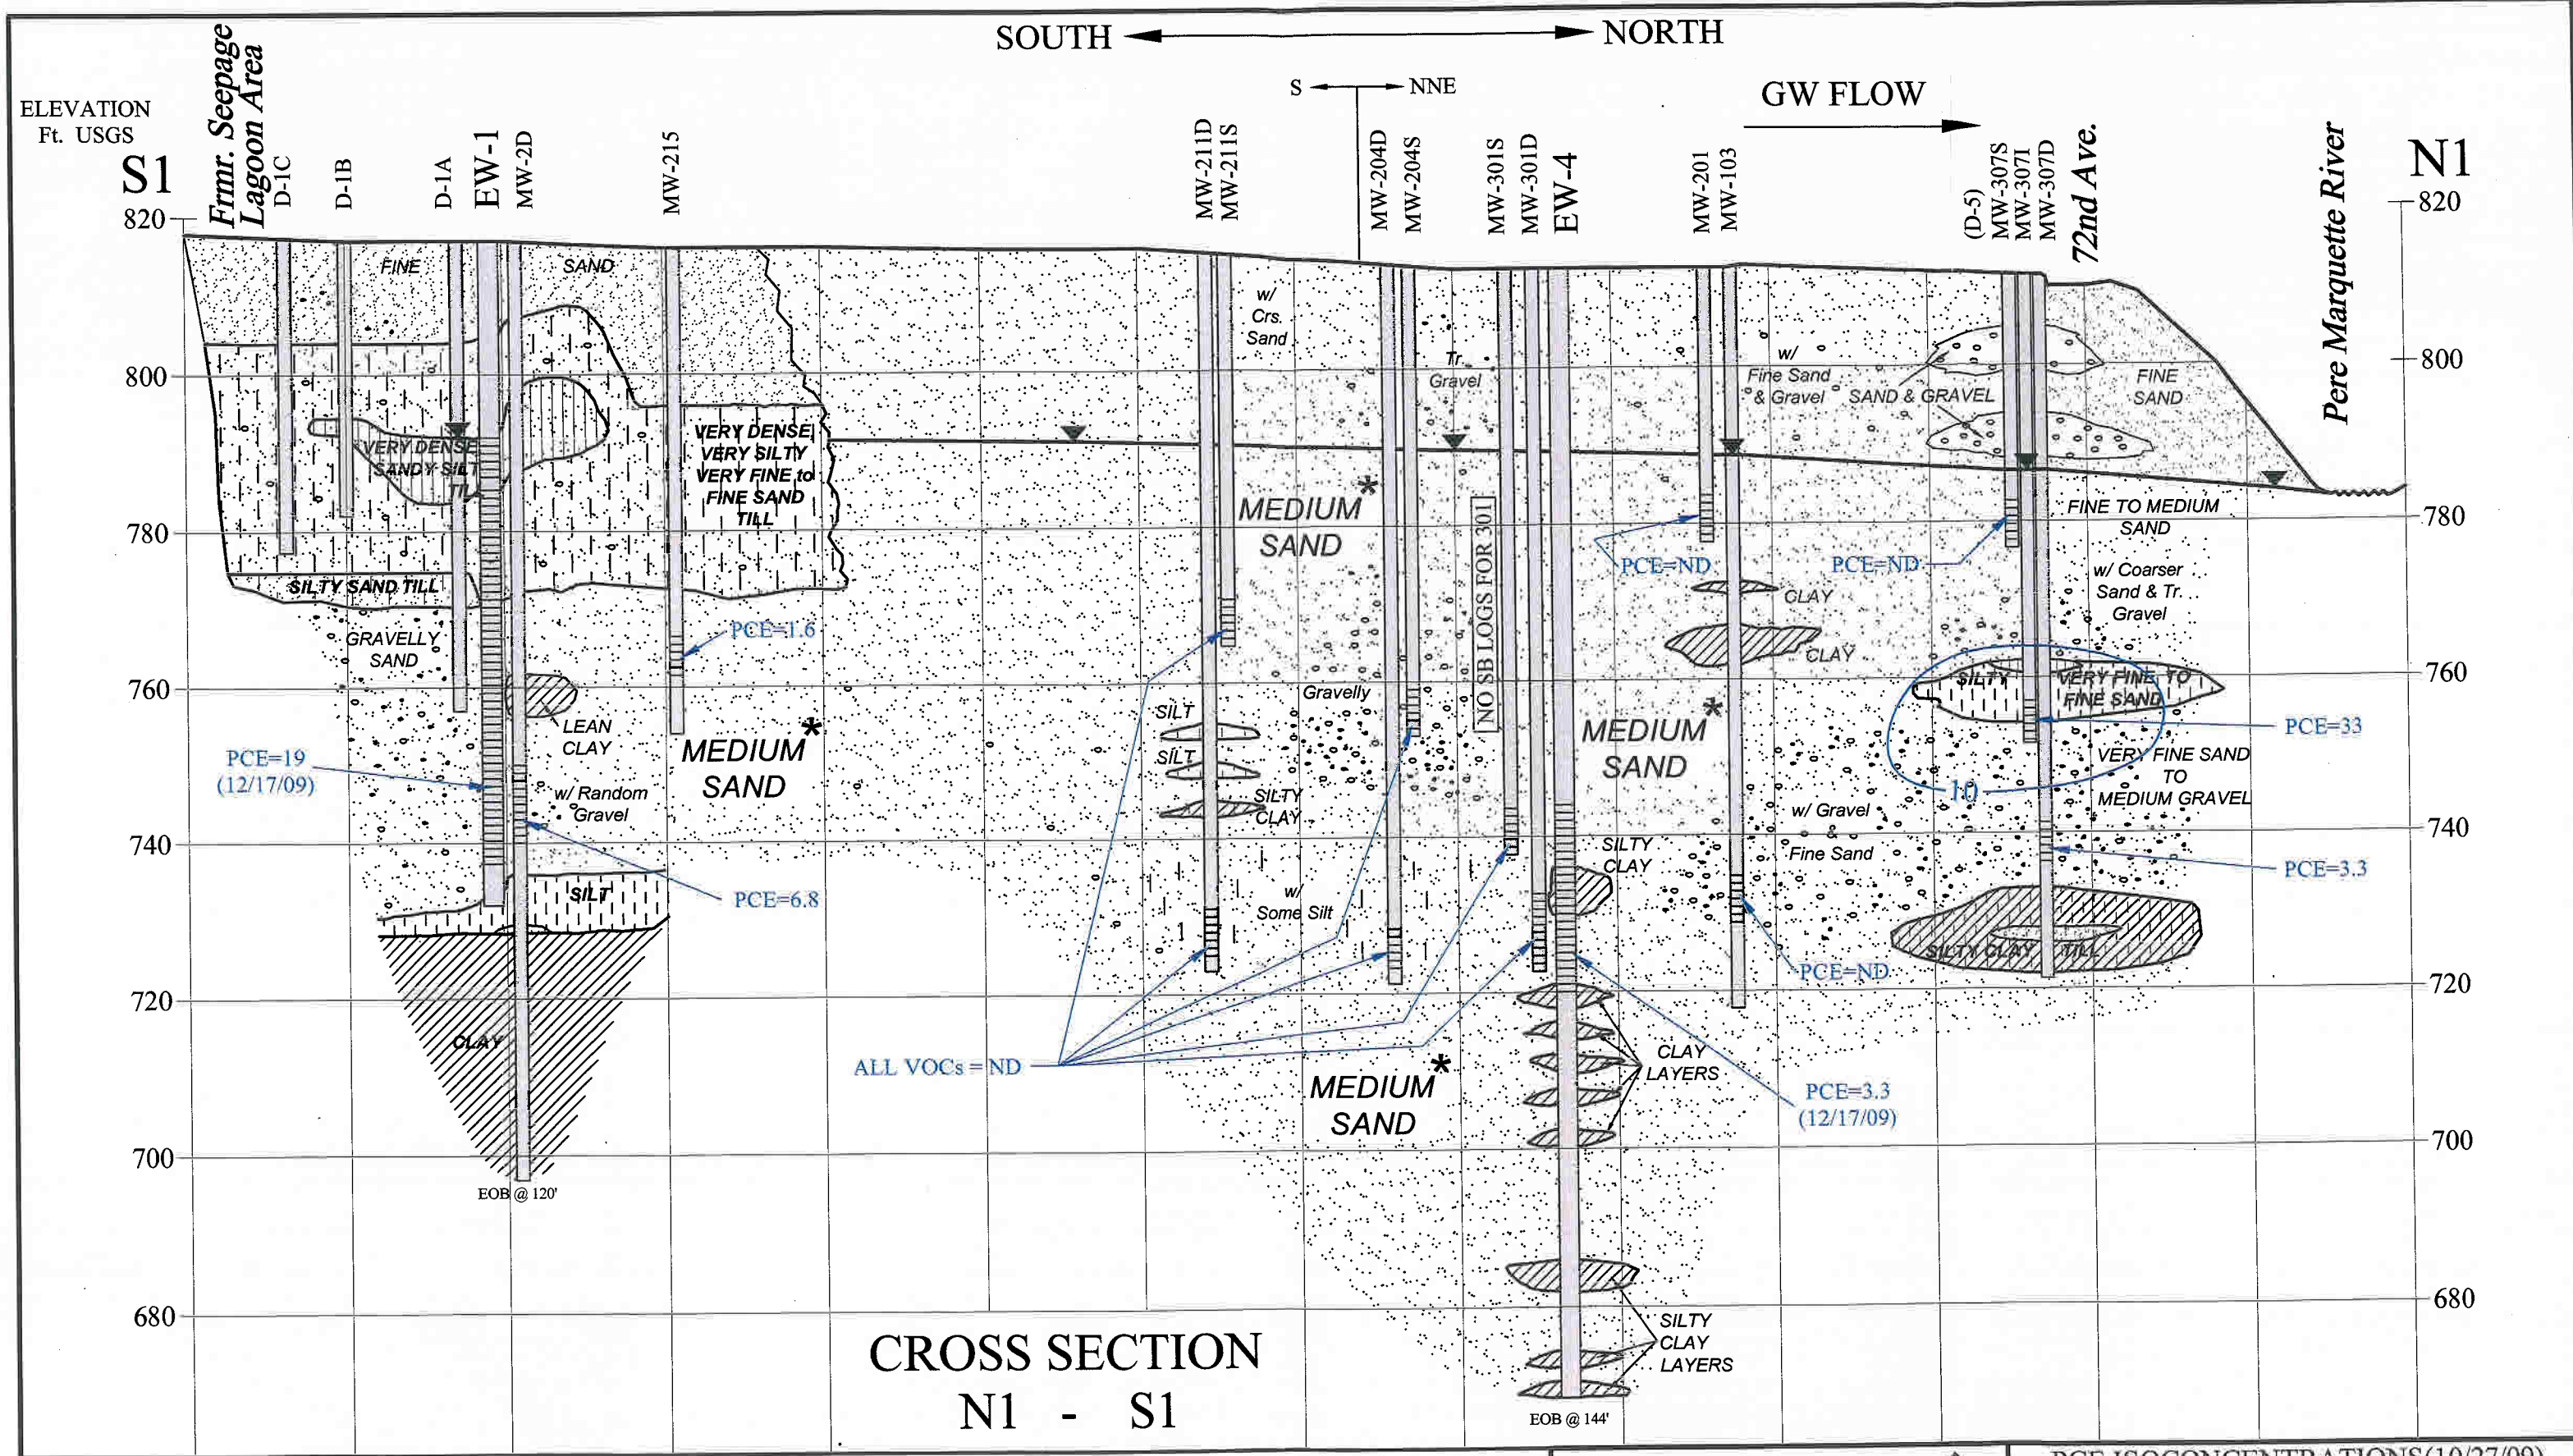
PCE ISOCONCENTRATIONS(10/27/09)		
CROSS SECTION N1 - S1		
WASH KING LAUNDRY		
9247 S. M-37		
BALDWIN, MICHIGAN		
06-712-01	FEBRUARY 2010	FIGURE 15 B

# CROSS SECTION N1 - S1

\* Based on the cumulative historical soil boring logs, the predominant and/or average grain size description for the fluvial deposits is "Medium Sand". Lesser amounts of Silt, Fine and Coarse Sand, and Gravel were also described as being present at random depths and locations, as clarified in smaller print. Discrete low permeability layers (i.e. Clays, Silts, Very Fine Sands, or poorly sorted mixtures thereof [e.g. Fine-Grained Tills]), layers of Coarse Sand and Gravel, and in some cases Fine Sand, are mapped as distinct units.

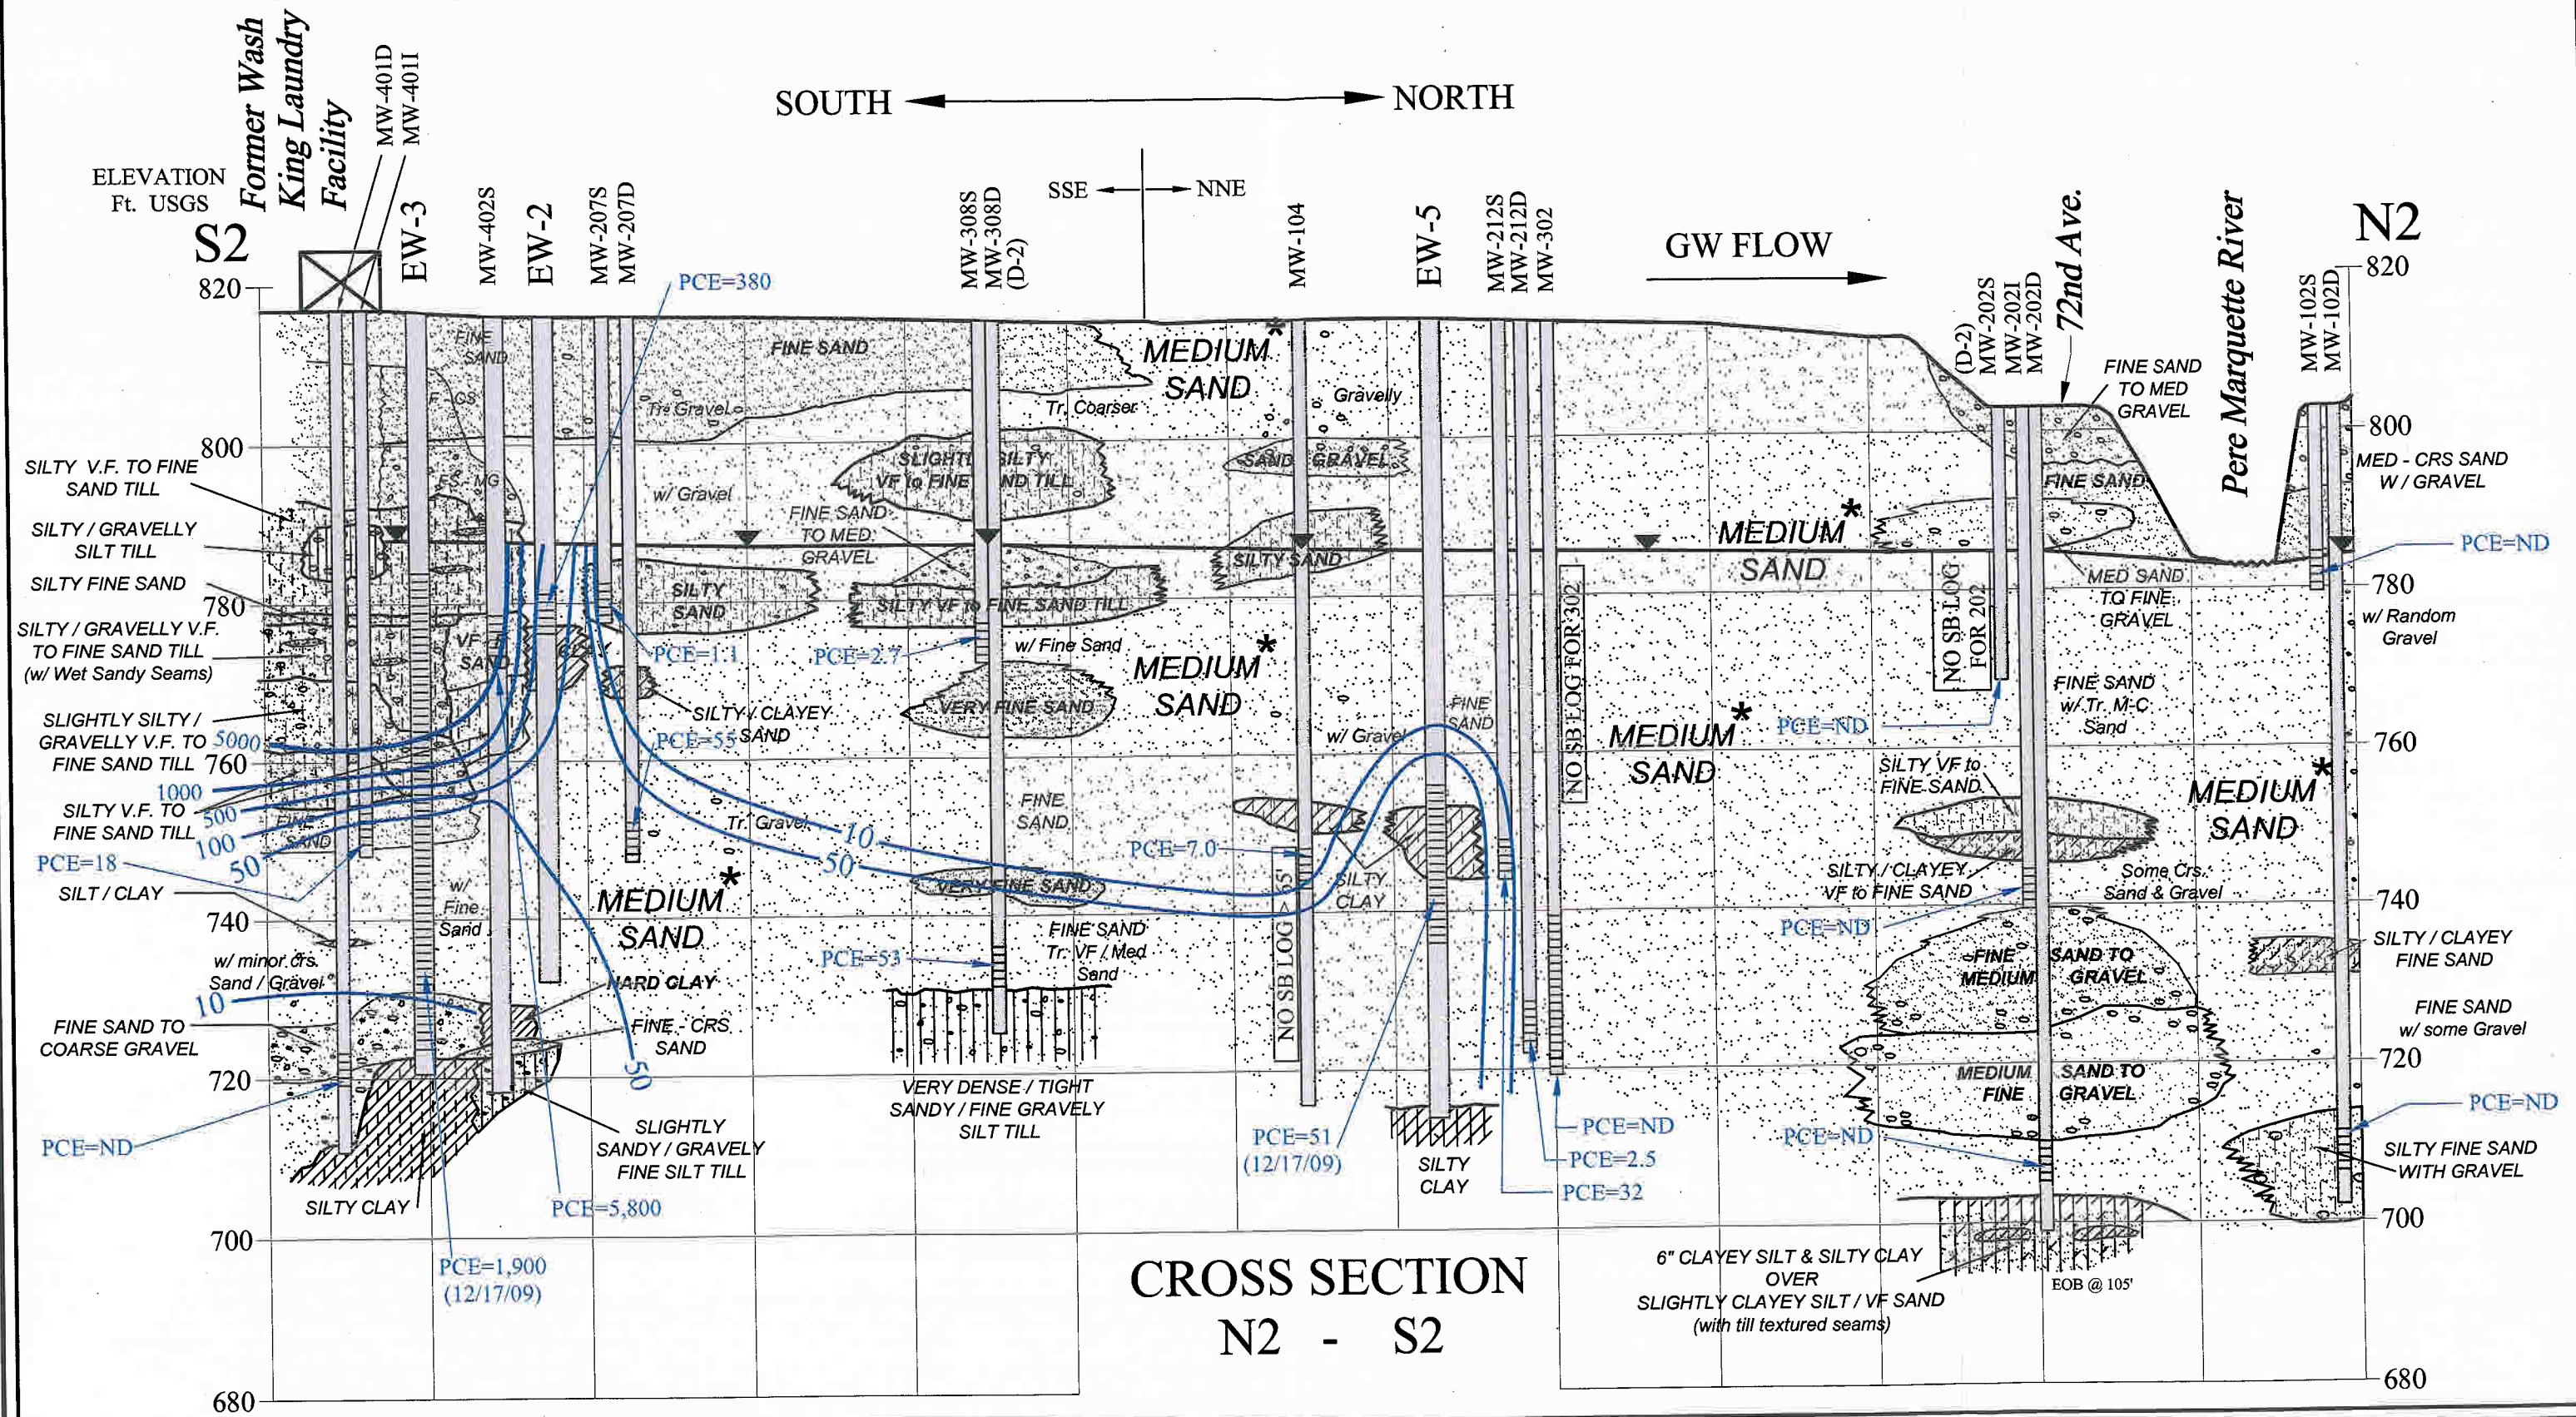
**PCE ISOCONCENTRATIONS (10-27-09)**  
**CROSS SECTION N2 - S2**  
 WASH KING LAUNDRY  
 9247 S. M-37  
 BALDWIN, MICHIGAN  
 06-712-01      FEBRUARY 2010      FIGURE 16 B

\* Based on the cumulative historical soil boring logs, the predominant and/or average grain size description for the fluvial deposits is "Medium Sand". Lesser amounts of Silt, Fine and Coarse Sand, and Gravel were also described as being present at random depths and locations, as clarified in smaller print. Discrete low permeability layers (i.e. Clays, Silts, Very Fine Sands, or poorly sorted mixtures thereof [e.g. Fine-Grained Silts]), layers of Coarse Sand and Gravel, and in some cases Fine Sand, are mapped as distinct units.

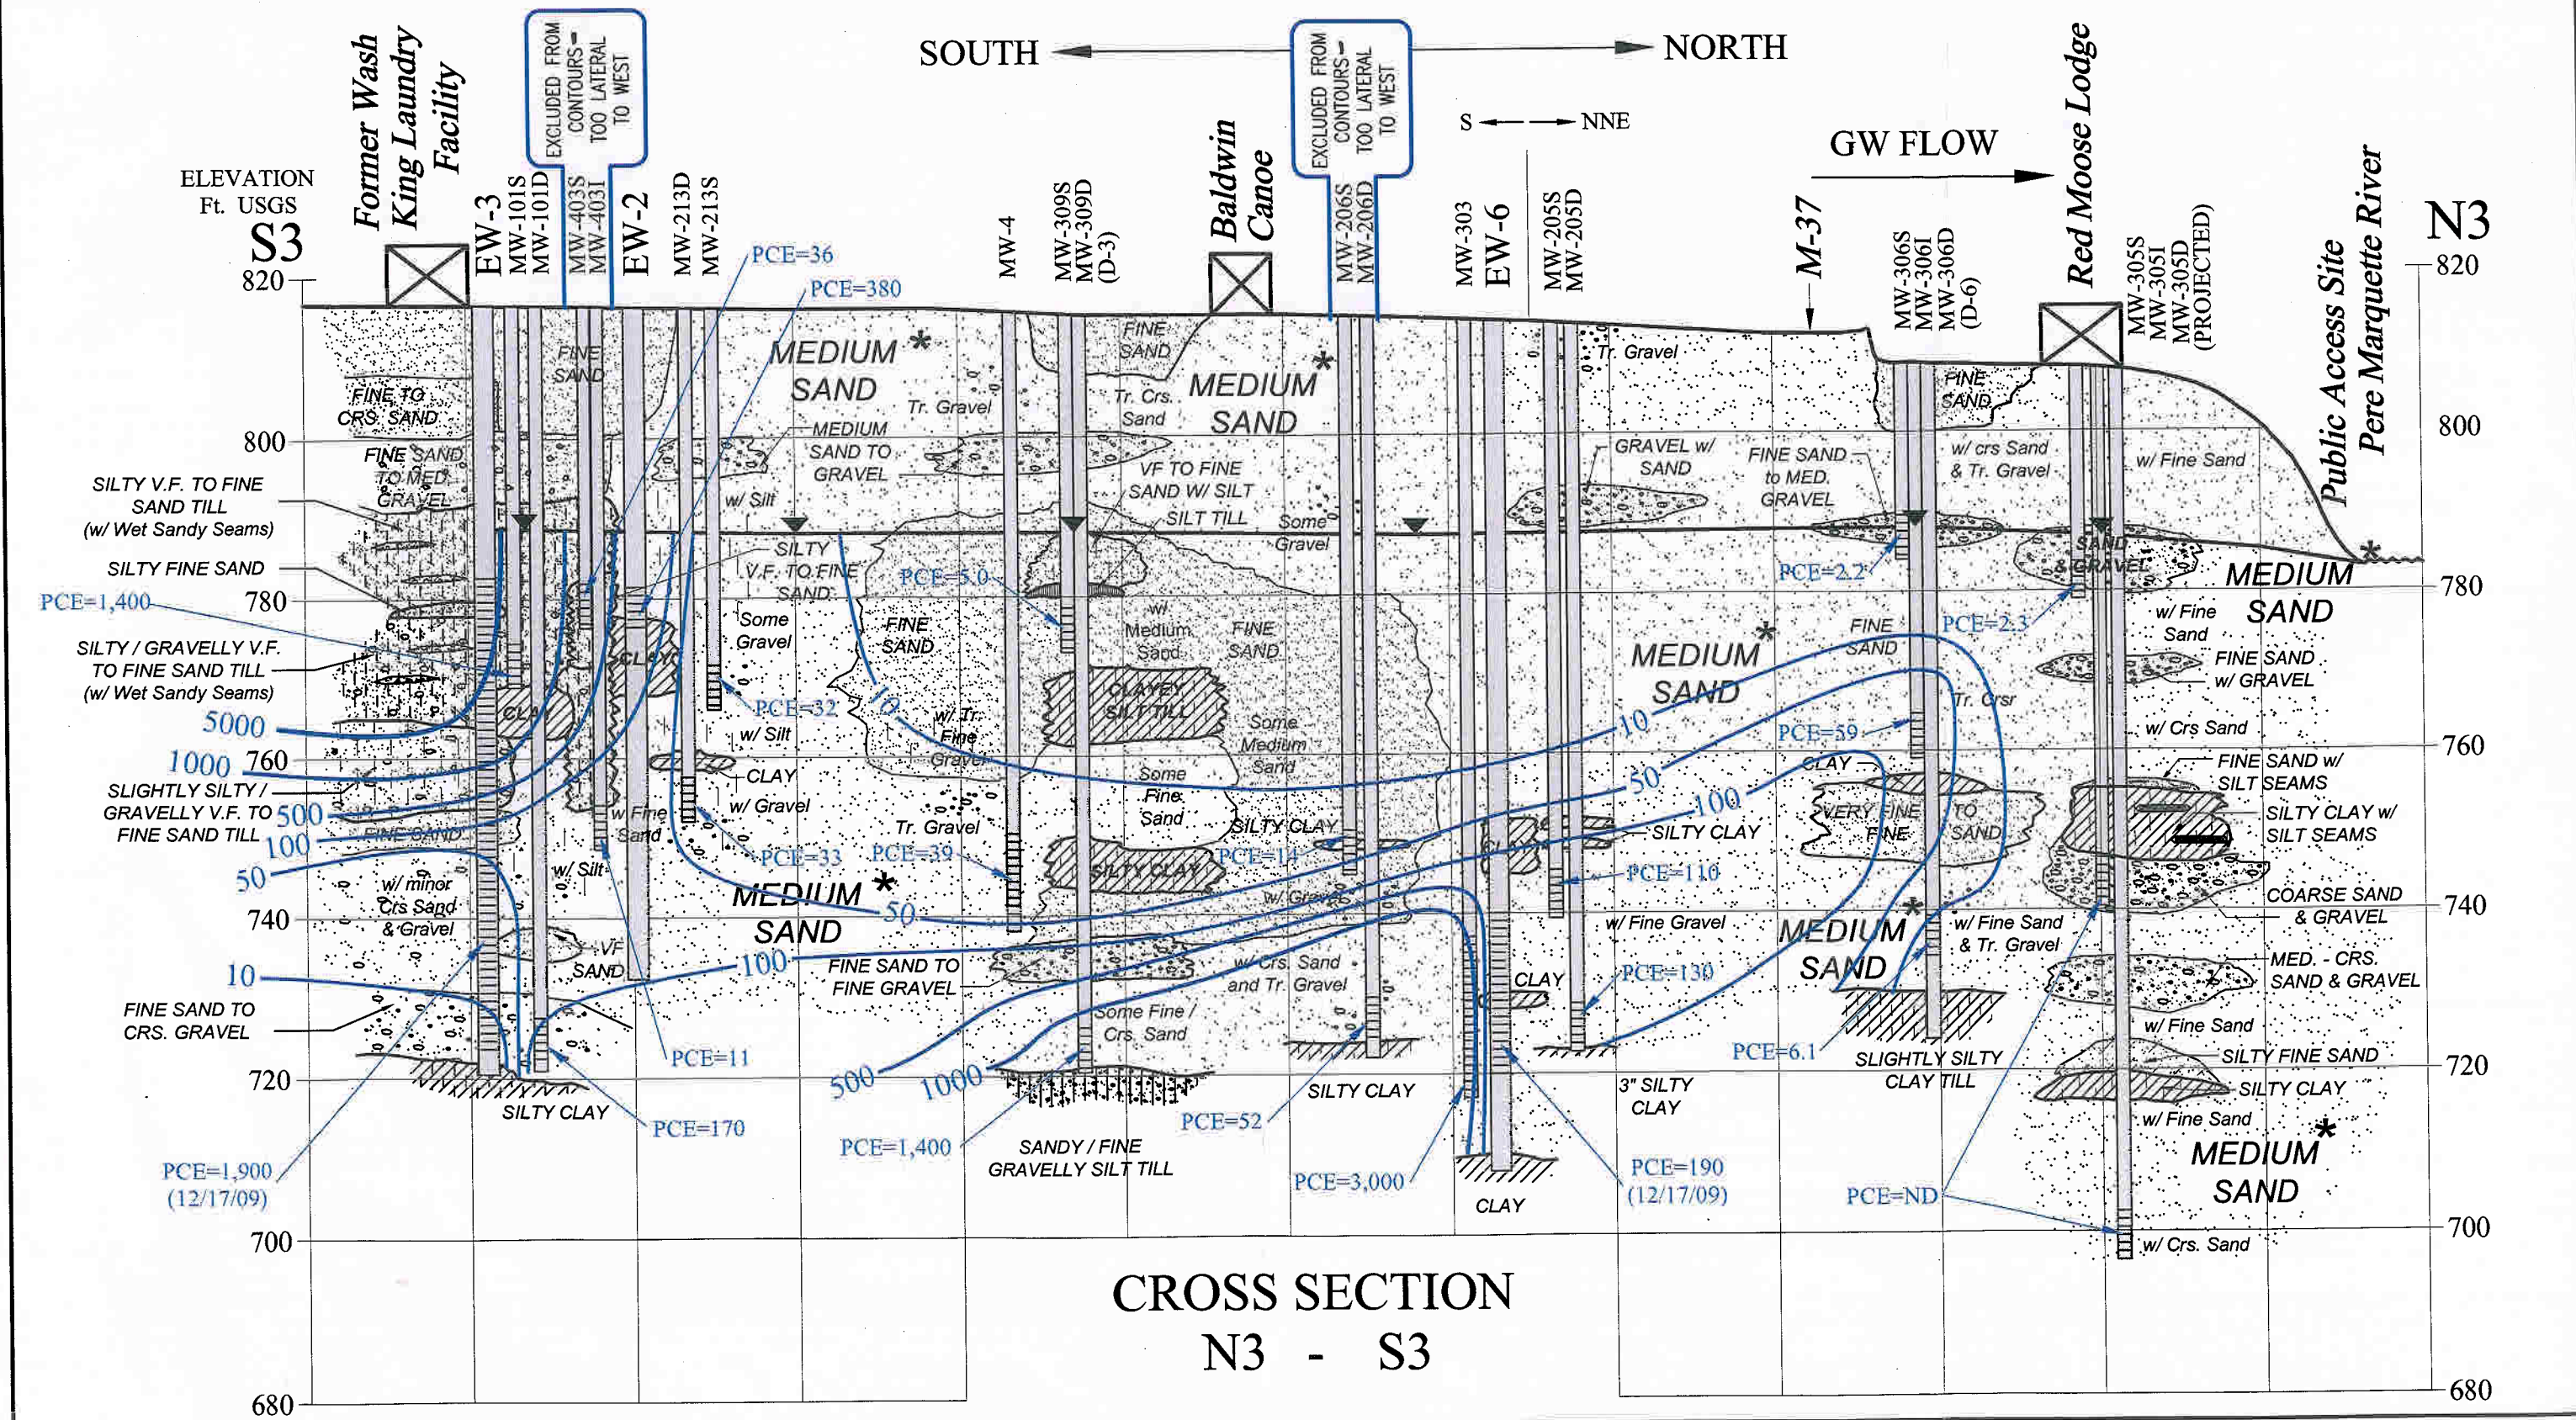
FIGURE 17 B

\* Based on the cumulative historical soil boring logs, the predominant and/or average grain size description for the fluvial deposits is "Medium Sand". Lesser amounts of Silt, Fine and Coarse Sand, and Gravel were also described as being present at random depths and locations, as clarified in smaller print. Discrete low permeability layers (i.e. Clays, Silts, Very Fine Sands, or poorly sorted mixtures thereof [e.g. Fine-Grained Tills]), layers of Coarse Sand and Gravel, and in some cases Fine Sand, are mapped as distinct units.

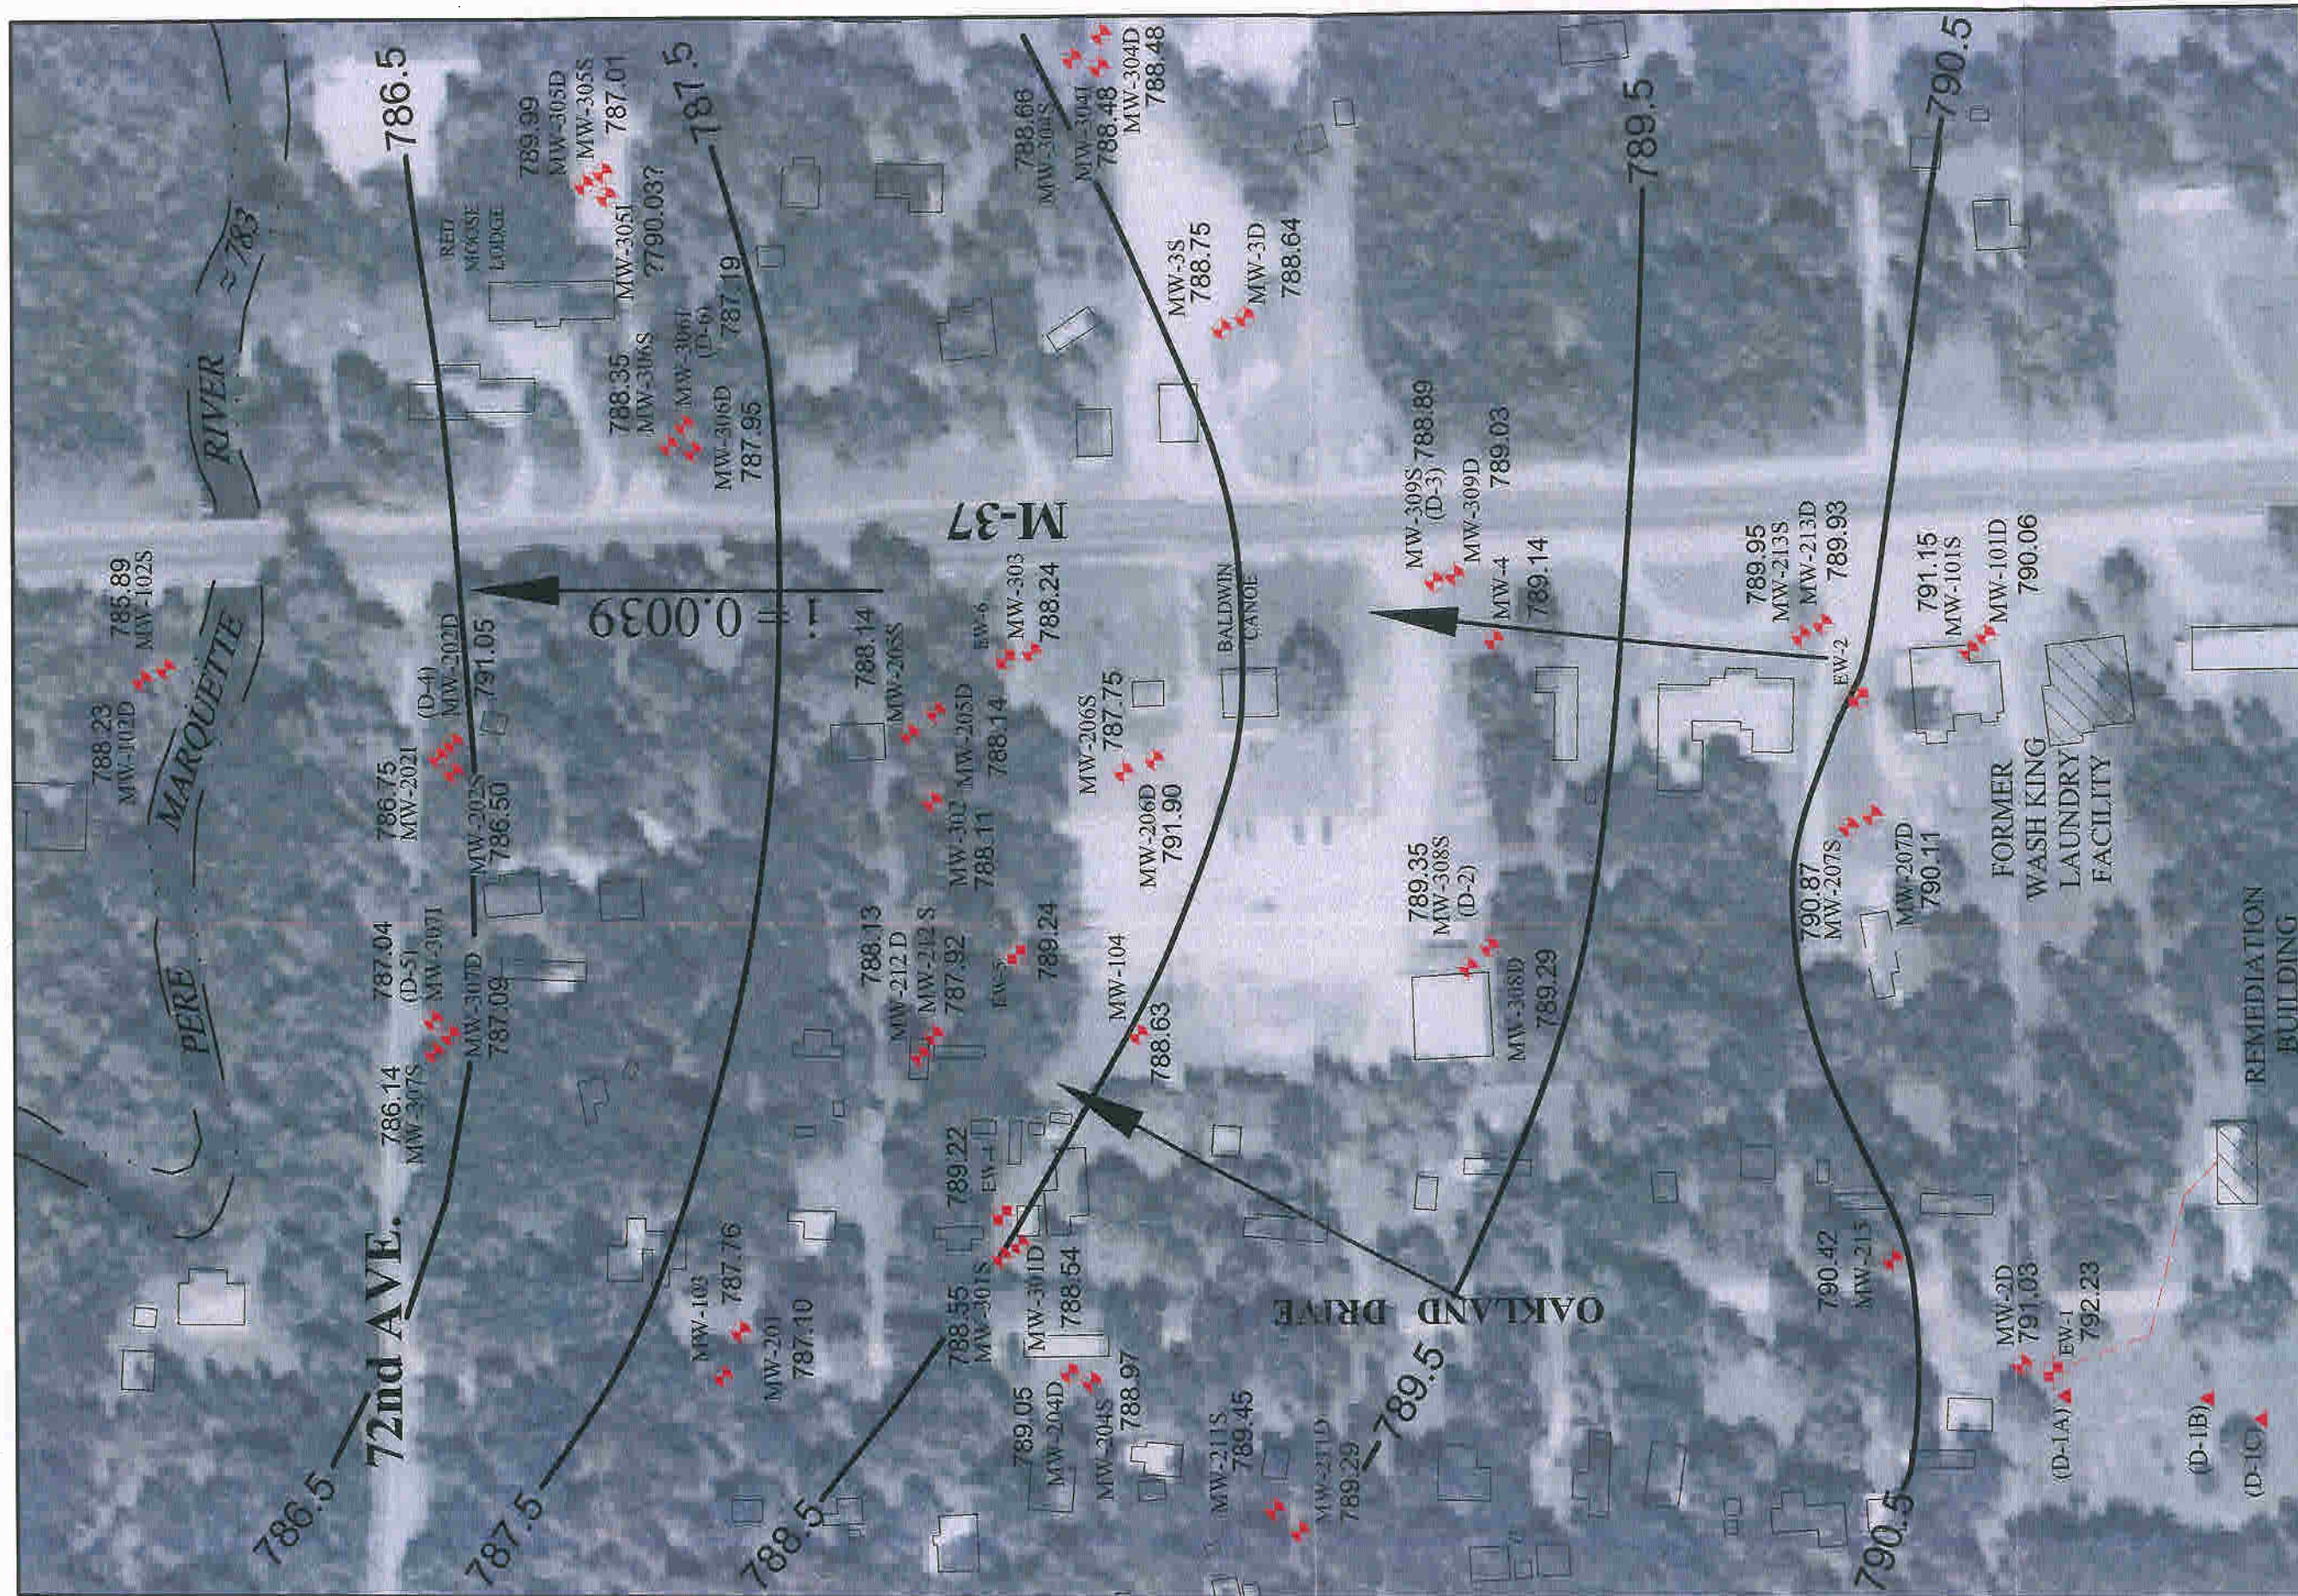
WASH KING LAUNDRY 9247 S. M-37 BALDWIN, MICHIGAN
06-712-01
MAY 2008
FIGURE 11

**GROUNDWATER ELEVATION CONTOUR MAP**  
**NON-PUMPING CONDITIONS (4/14/08)**

Groundwater flow under non-pumping and pumping conditions in 2008 (prior to the installation of EW-7) are presented in Figures 11 and 13 (see Attachment A). Figure 11 illustrates that groundwater flows to the north, north-east toward the river, and the slight curvature of the contours in the vicinity of EW-6 may result from incomplete aquifer recovery prior to collecting the non-pumping round of water levels. Figure 13 provides the site team's depiction of the horizontal capture zone. The RSE-lite team evaluated the water levels and potentiometric surface map and generally agrees with the interpreted potentiometric surface map and extent of the capture zone in the vicinity of EW-4, EW-5, and EW-6. In general, when evaluating capture in the area of these wells, the intermediate and deep wells should generally be used because that is the interval where most of the contamination is present. There are a few instances where water levels from individual wells do not appear accurate based on water level measurements from surrounding wells or other wells in the well cluster. MW-202D and MW-206D are a few examples. The inconsistencies appear to occur during each water level event, suggesting that a survey error may be the cause.
