**Streamlined Remediation System Evaluation**  
**Wash King Laundry Superfund Site**  
**Pleasant Plains Township, Michigan**

## **WASH KING LAUNDRY SITE PLEASANT PLAINS TOWNSHIP, LAKE COUNTY, MICHIGAN**

Report of the Streamlined Remediation System Evaluation  
Conference Call Conducted for the Wash King Laundry Site  
July 26, 2010

Revised Report  
February 18, 2011

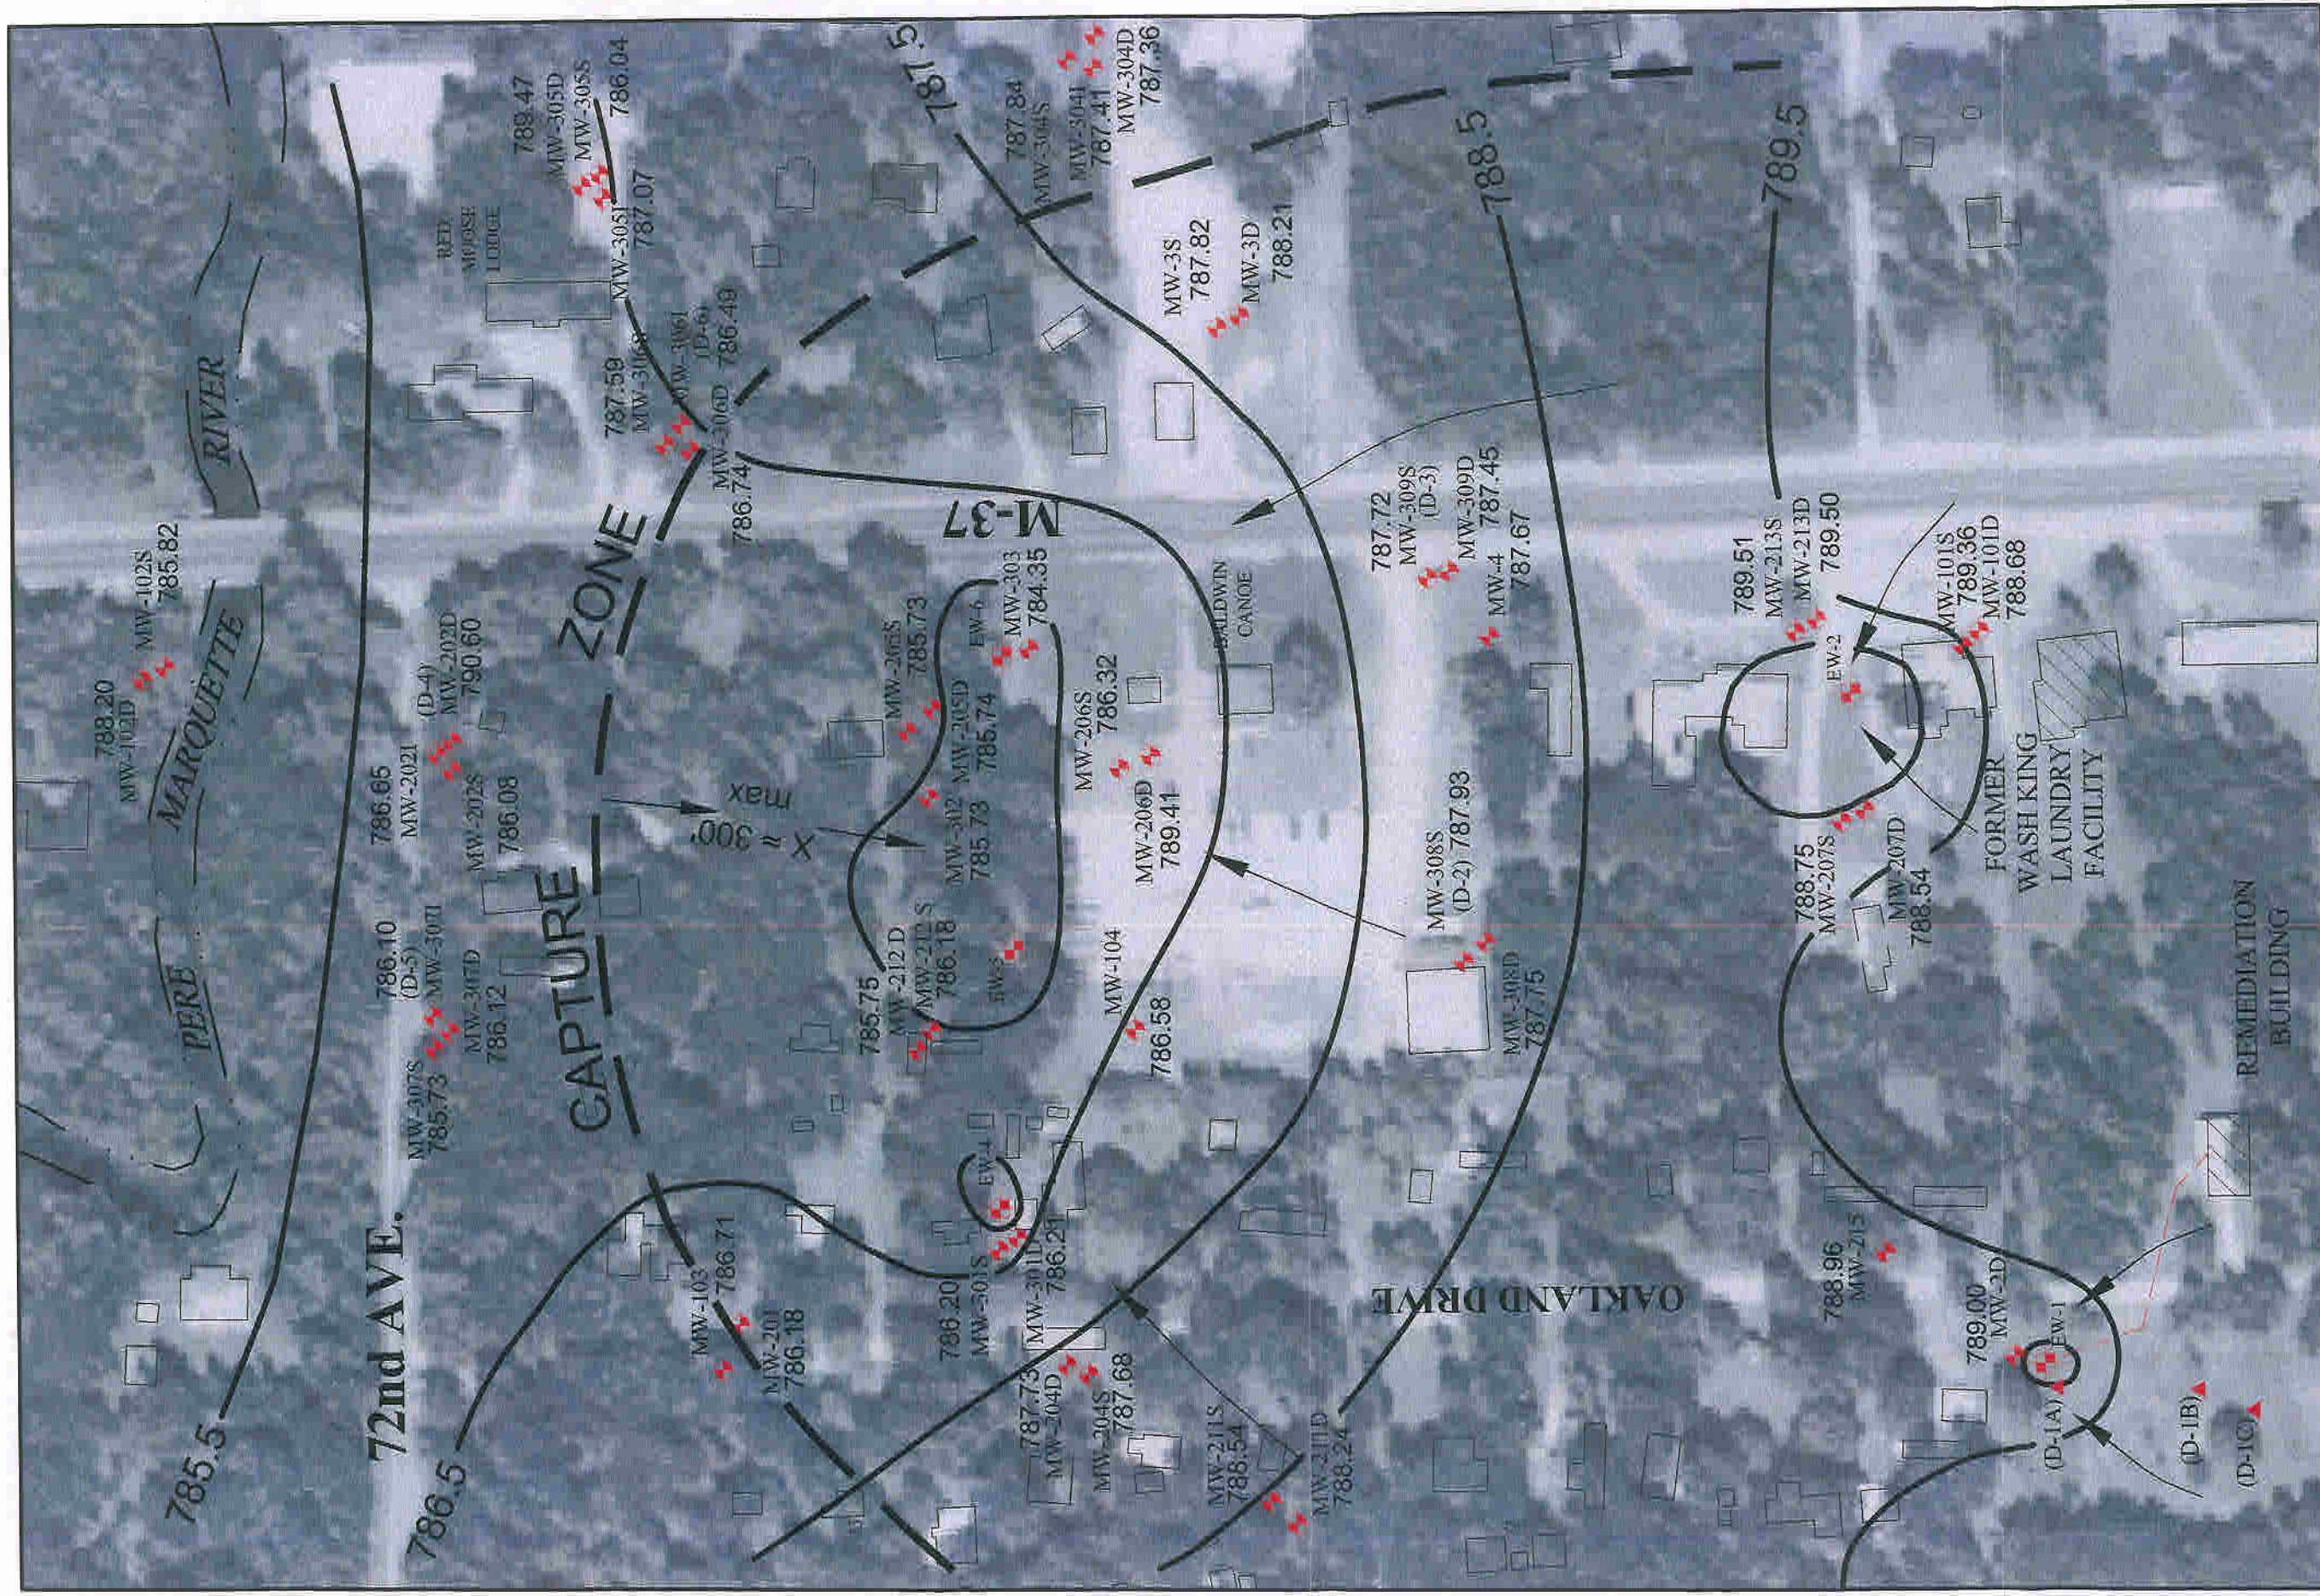
FIGURE 13

GROUNDWATER ELEVATION CONTOUR  
AND CAPTURE ZONE MAP (4-4-08)

Groundwater flow under non-pumping and pumping conditions in 2008 (prior to the installation of EW-7) are presented in Figures 11 and 13 (see Attachment A). Figure 11 illustrates that groundwater flows to the north, north-east toward the river, and the slight curvature of the contours in the vicinity of EW-6 may result from incomplete aquifer recovery prior to collecting the non-pumping round of water levels. Figure 13 provides the site team's depiction of the horizontal capture zone. The RSE-lite team evaluated the water levels and potentiometric surface map and generally agrees with the interpreted potentiometric surface map and extent of the capture zone in the vicinity of EW-4, EW-5, and EW-6. In general, when evaluating capture in the area of these wells, the intermediate and deep wells should generally be used because that is the interval where most of the contamination is present. There are a few instances where water levels from individual wells do not appear accurate based on water level measurements from surrounding wells or other wells in the well cluster. MW-202D and MW-206D are a few examples. The inconsistencies appear to occur during each water level event, suggesting that a survey error may be the cause.

The capture zones in the vicinities of EW-1 and EW-2 is based on limited data. The extent of capture from EW-2 may be overestimated in Figure 13. Use of water level data from the new 400 series monitoring wells will provide more information to interpret capture and extraction from EW-7, which is now occurring, will greatly improve capture in this area. Based on the observed drawdown and the background water hydraulic gradient, the interpreted capture zone near EW-1 is likely a reasonable approximation.

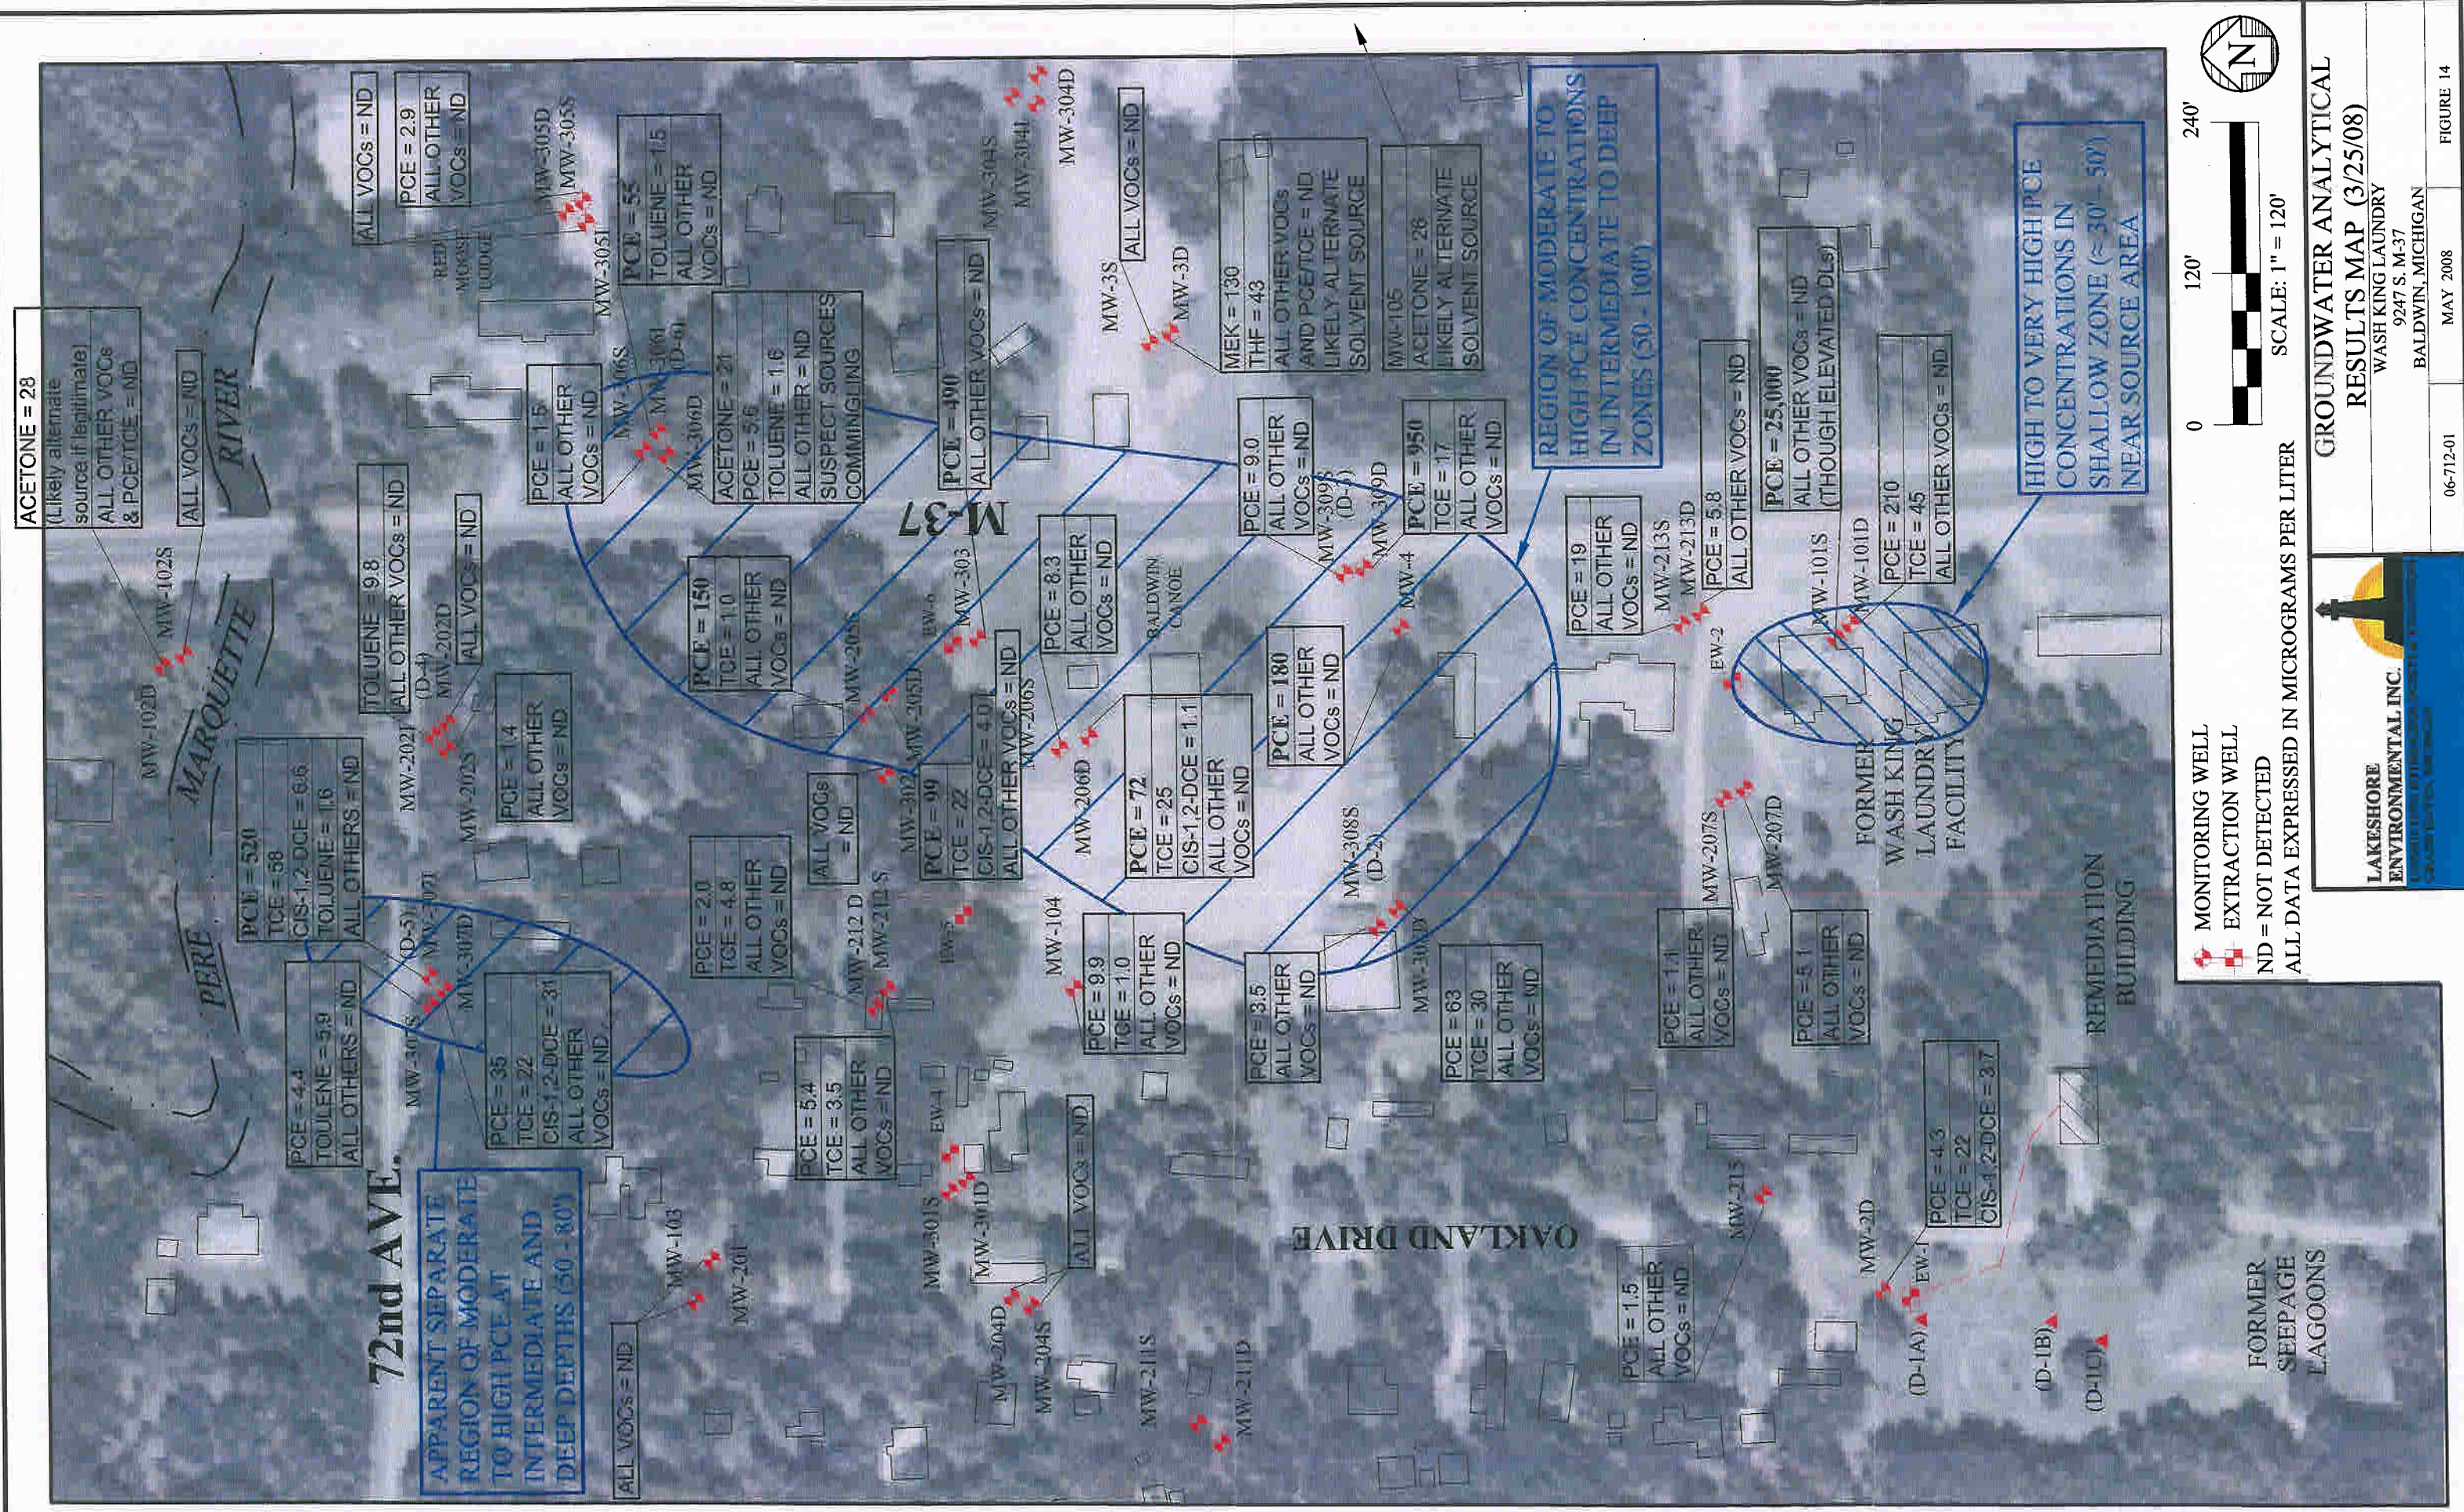
- 67 - INTERMEDIATE TILL FORMATION  
REMEDIAL INJECTION LOCATIONS.  
{2" PVC SCREENS SET BETWEEN 32-57'}
