Kennedy Space Center Medical and Environmental Services Division

# High Resolution Characterization Throughout Project Lifecycle

## High-Resolution Site Characterization

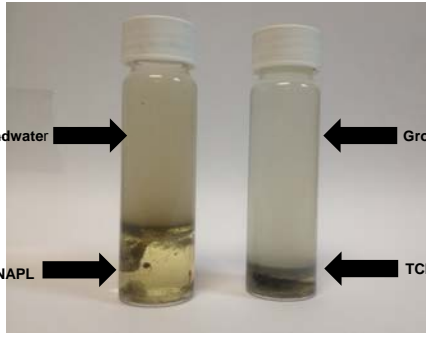
## Dense Non-Aqueous Phase Liquid

Groundwater → ← Groundwater

TCE DNAPL → ← TCE DNAPL

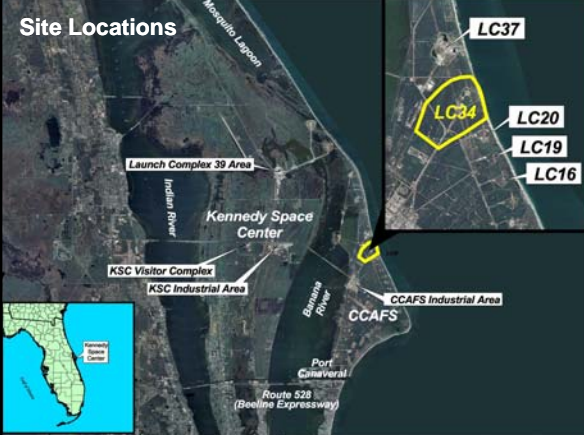
## Site Locations

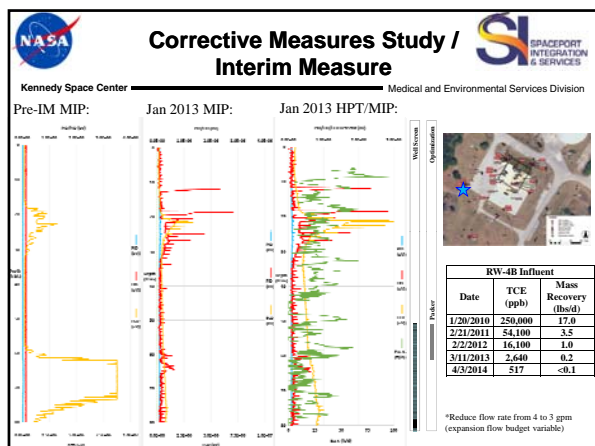
### Conceptual Model Refinement

- HRSC continuously refines the conceptual model for one of the most assessed sites in the state of Florida
  - Additional TCE mass identified between DPT sampling intervals +/- 18 feet bls in lower portion of Layer 1
    - MIPs identified an interval requiring VOC sampling
    - Delineated Hot Spot 4 with an estimated 4000 pounds of TCE
  - MIPs/HPTs confirmed extent of Layer 4 mass storage
  - HPTs identified that Layer 6 (60-80 feet bls) is more heterogeneous than identified via soil coring
  - MIP/HPT pairings narrowed the intervals capable of mass transport and storage within Layer 6
  - TCE concentrations > 250,000 ppb were remediated via pump and treat

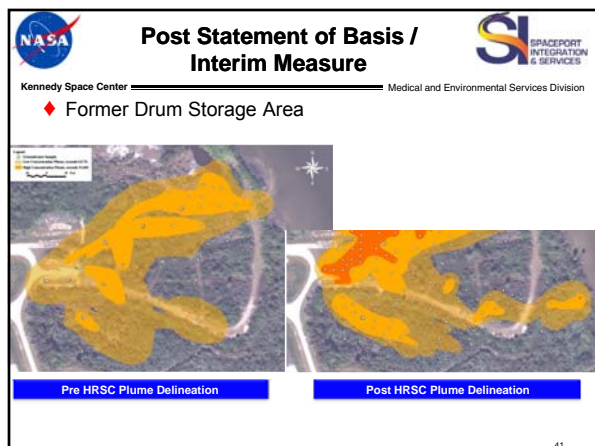
### Post Statement of Basis / Interim Measure

- Former Drum Storage Area
  - HRSC provided a well defined treatment zone
  - Remedy was re-evaluated
  - Air Sparging and In-situ Biogeochemical Transformation / Anaerobic Reductive Dechlorination
  - Air Sparging of the HCP and Hot Spot was selected and implemented as an IM
    - 137 air sparge wells
  - Treatment system has successfully operated for one year reducing maximum VOC concentrations by several orders of magnitude

Pre HRSC	Post HRSC
LCP (acres):	2.7	4.1
HCP (acres):	1.0	2.0
Hot Spot (acres):	-	0.5
Sample Locations:	54	248
Samples:	237	866
Average distance between Sampling points (feet):	125	40
